NSW Resources Regulator

INVESTIGATION REPORT

Report into the serious injury of an operator at the Mannering Colliery, Doyalson, NSW on 22 January 2016

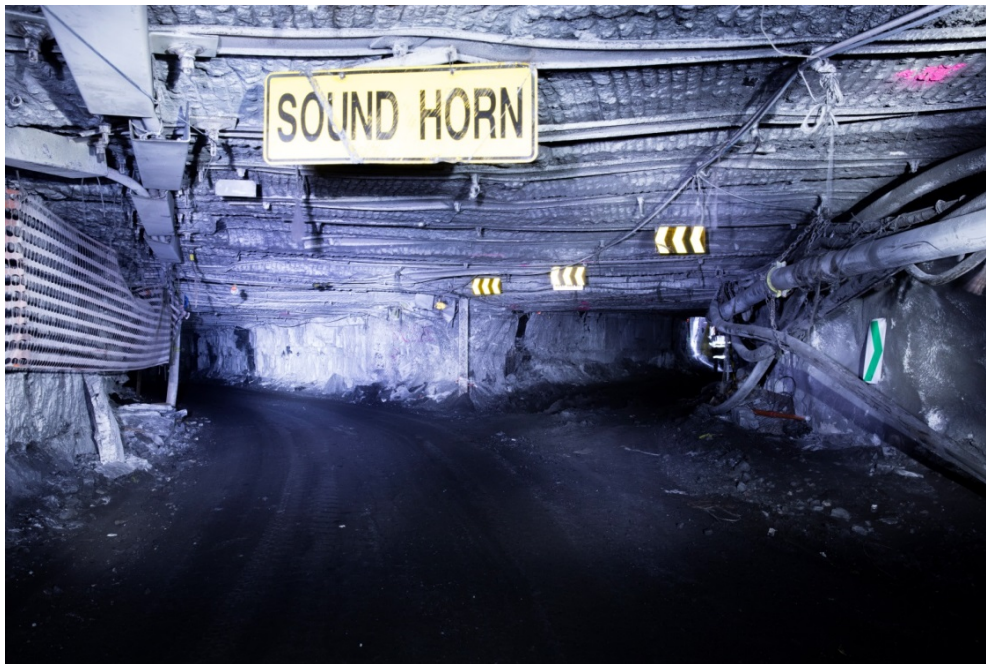
The contact with the broken W strap occurred at the entrance to the roadway that leads to Longwall 7. The entrance to the roadway was at a junction with the main travel road as shown below.

Figure 3: The incident scene looking inbye (from the side closest to the entrance of the mine) toward the scene. Roadway to Longwall 7 to the right.

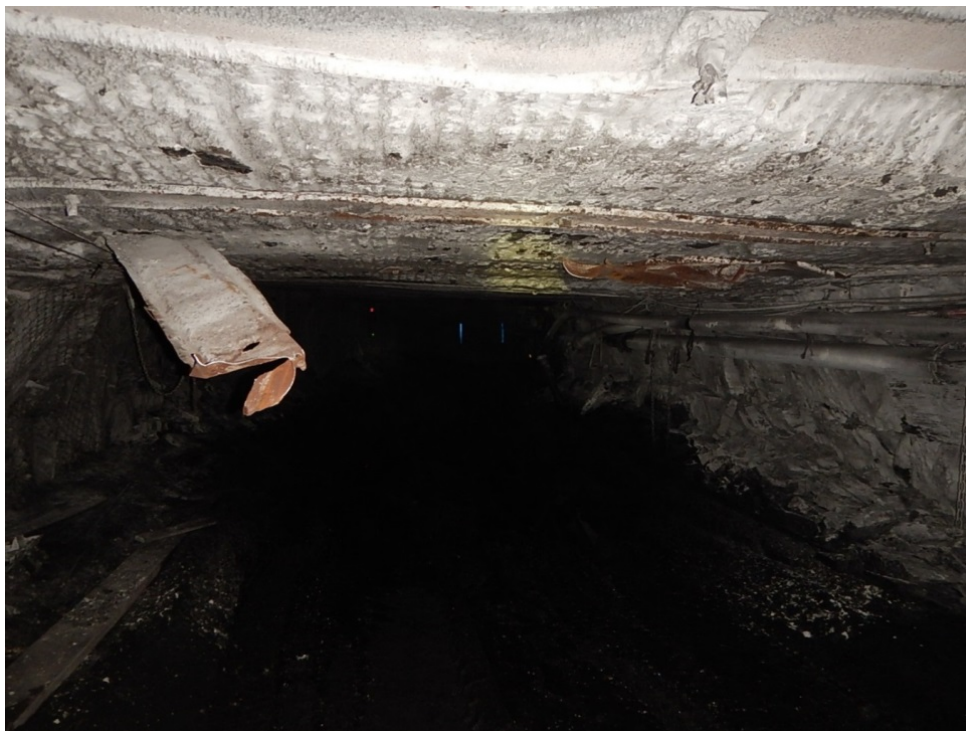
The other electrician then drove SMV003 out from the pump on his own and reported making similar minor contact with the roof at the same location. He did not stop and inspect for damage as he again felt the contact was of a minor nature. These circumstances suggest that this contact most likely caused the W strap to be broken in two as shown in figure 5.

Figure 5: Damaged W strap hanging in roadway looking inbye at the scene

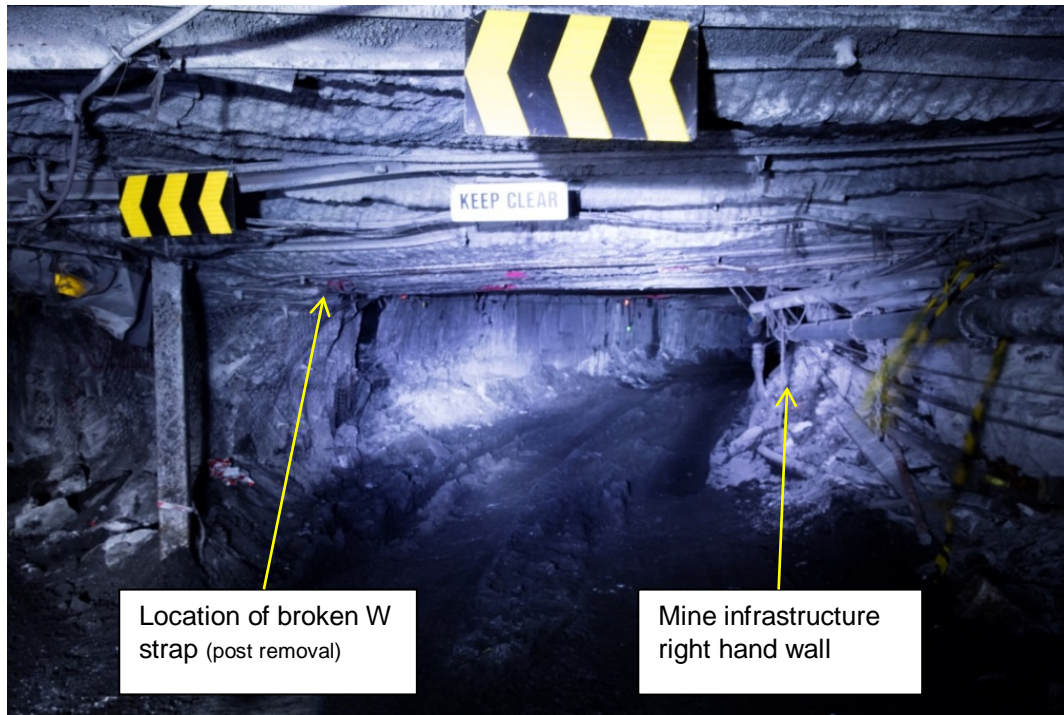
LHD to the right side of the vehicle. Mine infrastructure was against the right wall of the roadway as can be seen below. The broken W strap was on the left hand of the roof pointing toward the loader.

Figure 6: The incident scene looking inbye (from the side closest to the entrance of the mine) toward the scene.

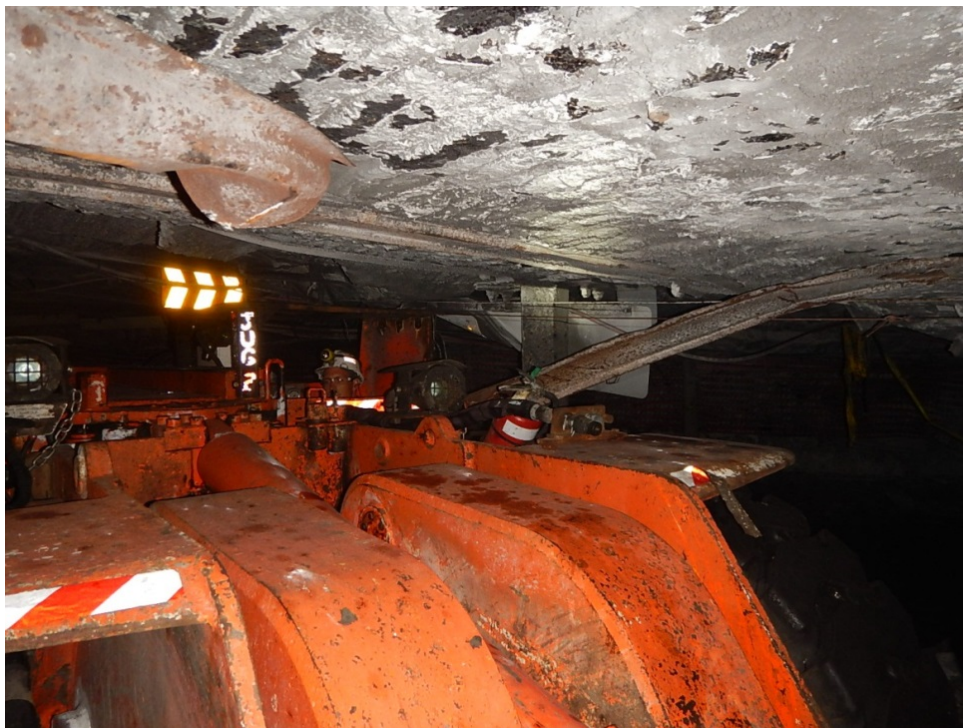
The operator said he was concentrating on the vehicle ahead of him at the same time as navigating the right hand bend in the roadway. The operator heard the W strap make contact with the canopy of the LHD as it entered the cabin and hit his head. Although the operator was wearing a hard hat, the broken W strap made contact near his left ear. Figure 7 shows the probable location of the LHD at the time of the incident and the broken W strap hanging from the roof.

Figure 7: Position of W strap and similar type of machine - looking outbye toward the scene.

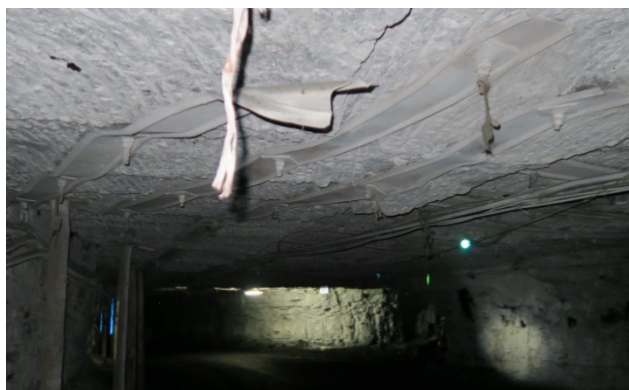
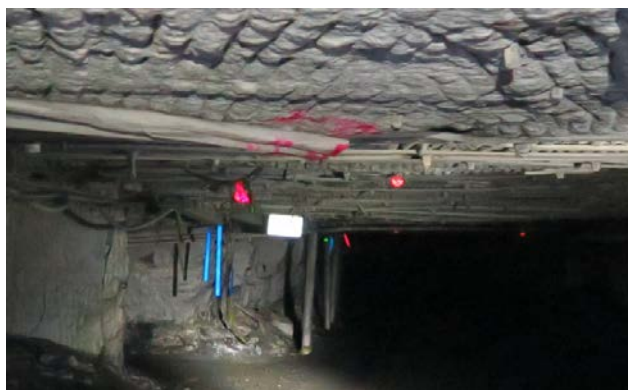
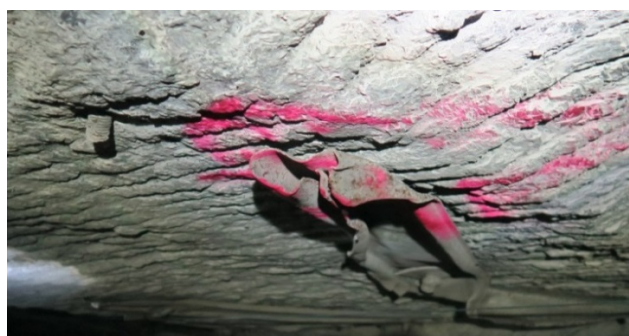
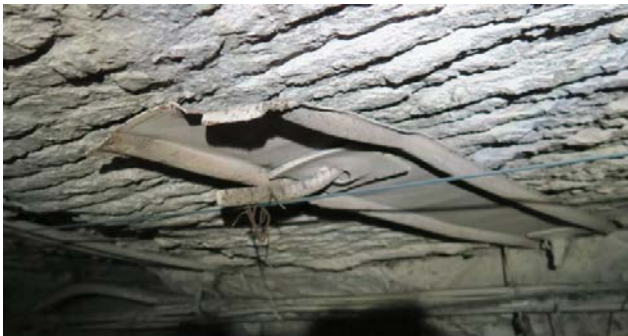
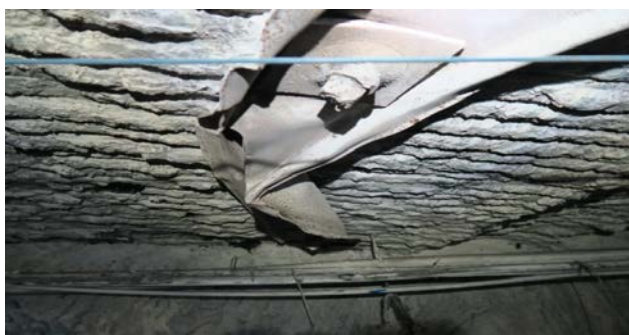
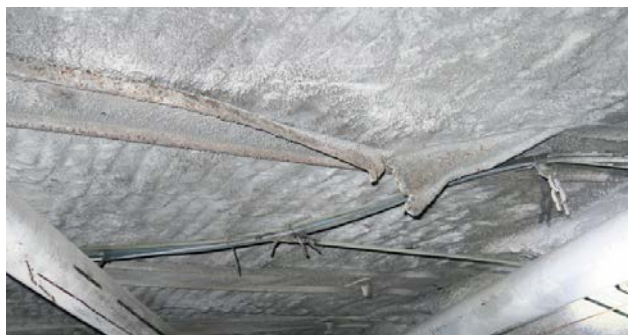
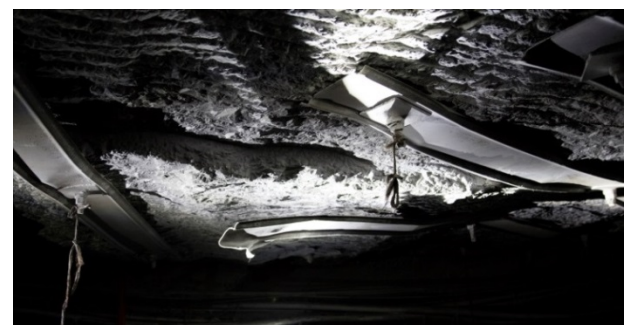
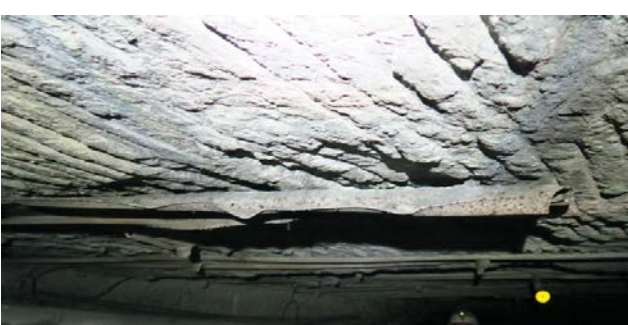
An examination by investigators of other W straps in the vicinity of the incident site identified numerous W straps that had been damaged from impacts.

Figure 12: Damaged W straps the vicinity of the incident.

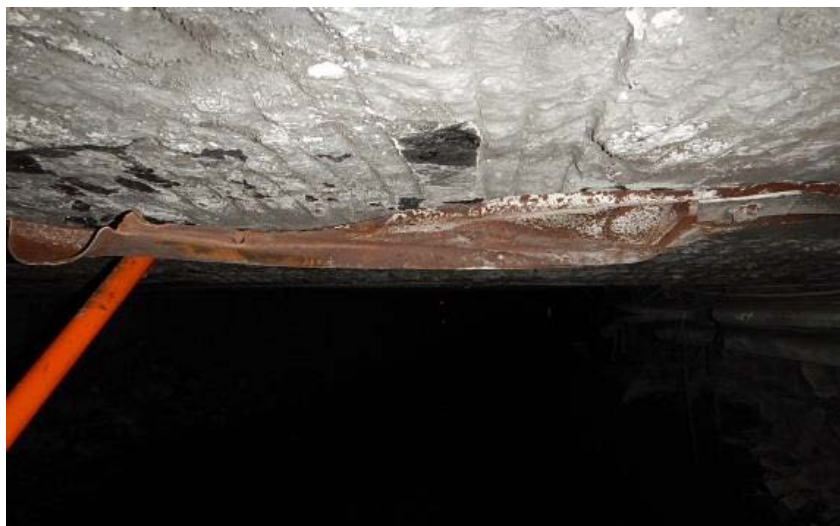
The section of W strap that remained attached to the roof showed signs of previous impacts.

Figure 14: Remaining section of W strap that was involved in incident showing signs of previous impacts.

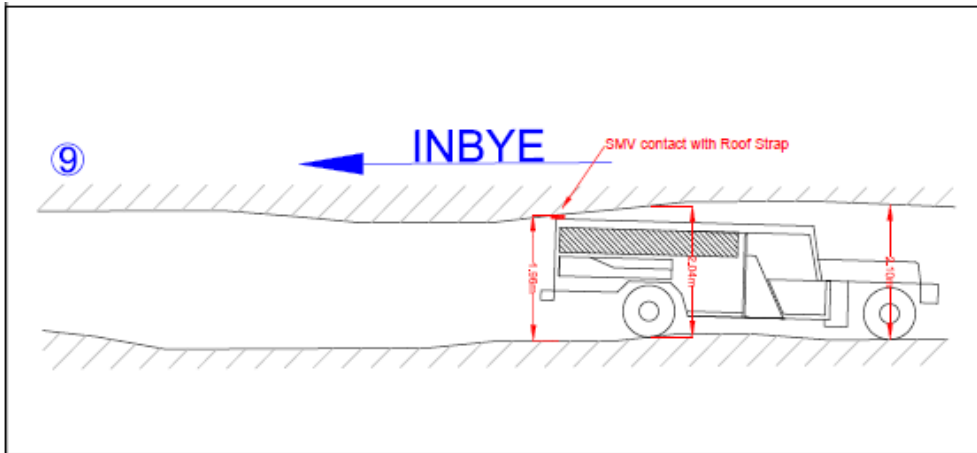
- the roadway measured as spot points was mostly to the required 1.9 m (1.897 m on the left hand side of the roadway and 1.990 m on the right hand side) as shown in figure 11
- spot measurements did not take into account the length of the vehicle and the effect of undulations in floor and roof, which results in the operational height being lower than 1.9 m
- the position of the strap in the roadway immediately before hitting the operator as indicated by the survey was as a result of SMV003 making contact with it when travelling outbye as shown in figure 16.

Figure 16: Survey plan of SMV travelling outbye and likely contact point.

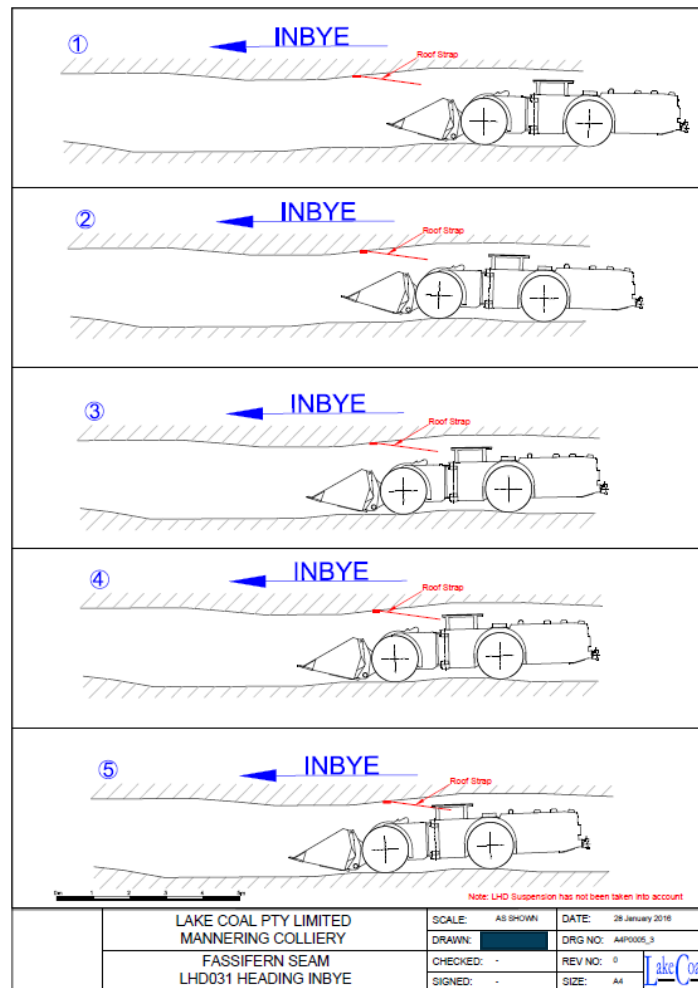
The mine survey also documented how the broken W strap interacted with the LHD as shown below.

Figure 17: Interaction of W strap and the LHD 031

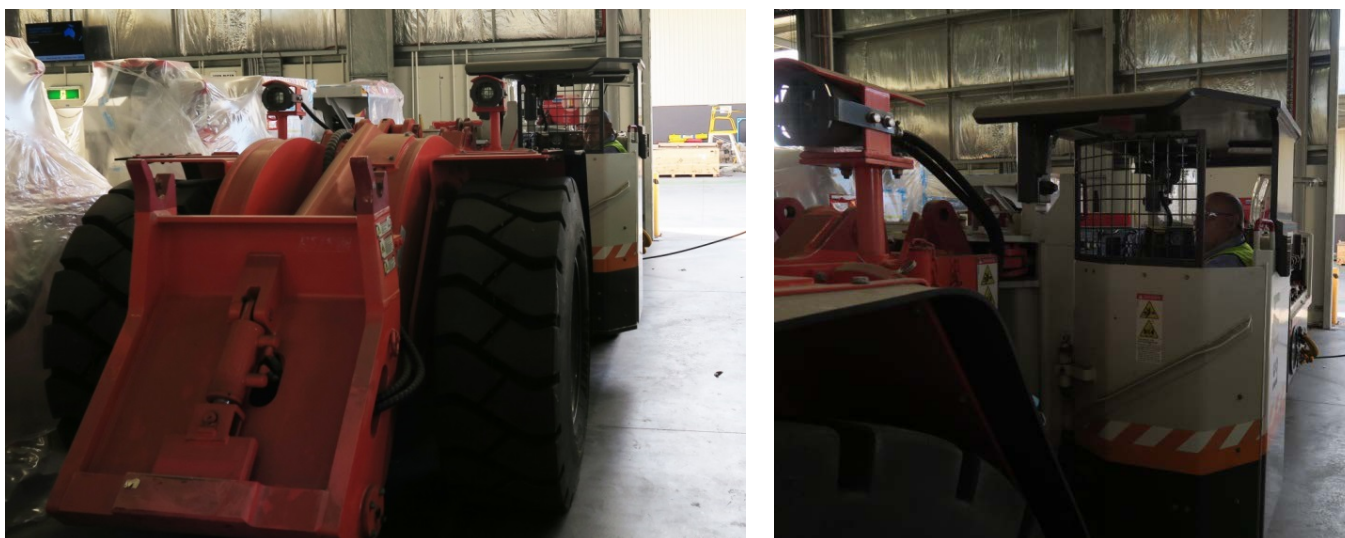
Figure 18: Guarding on a 7 Tonne LHD.

Mobile plant operator cabins should make provision for operator protective structures (refer clause 214 and 215 of the Work Health and Safety Regulation 2011 and clause 28 of the Work Health and Safety (Mines and Petroleum Sites) Regulation 2014). The investigation considered operator protective structures that are being installed on new types of LHDs that are similar to LHD 031. These structures are being installed to prevent operator interaction with the articulation of the vehicle but such structures would also guard against material entering the operator's cabin as can be seen in figure 18.

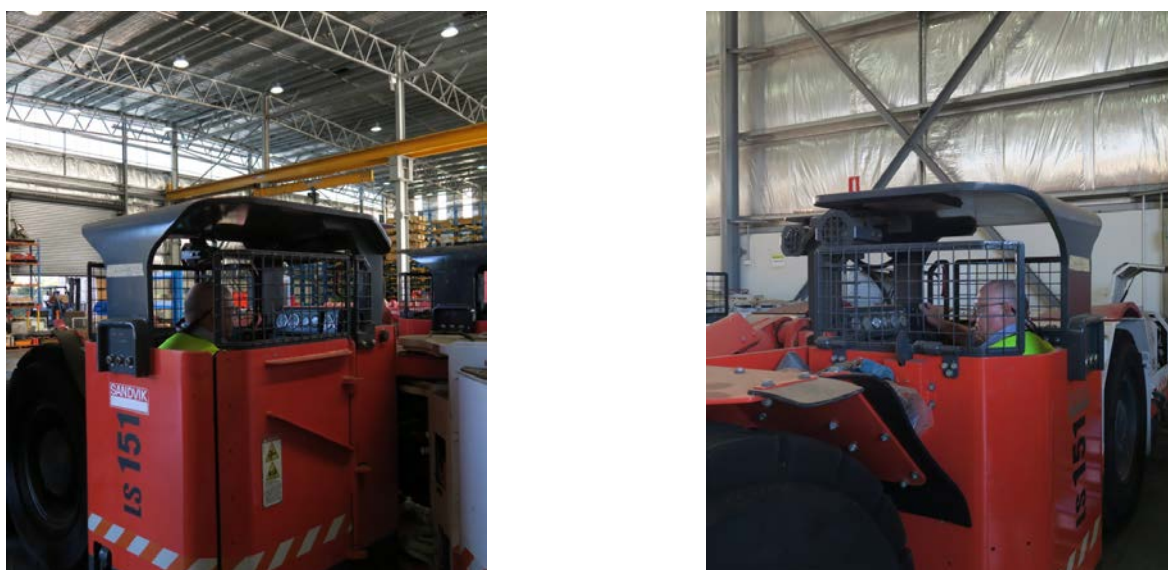
Figure 19: Guarding on a 5 tonne LHD.

Another type of new LHD had more comprehensive structure on the operator's cabin. This LHD was smaller in size and the articulation was located on the other side of the cabin when compared to LHD 031. The structures were on the three open sides of the canopy as shown in figure 19.
