# TECHNICAL REPORT

**Subject:** Analysis of Blakefield South Mine (BSM)  
Explosion

**Date:** First Draft 16 Feb 2012  
Revised 20 Feb 2012; 29 Feb 2012

**Report Prepared By:** Drs Hsin Wei Wu and Stewart Gillies

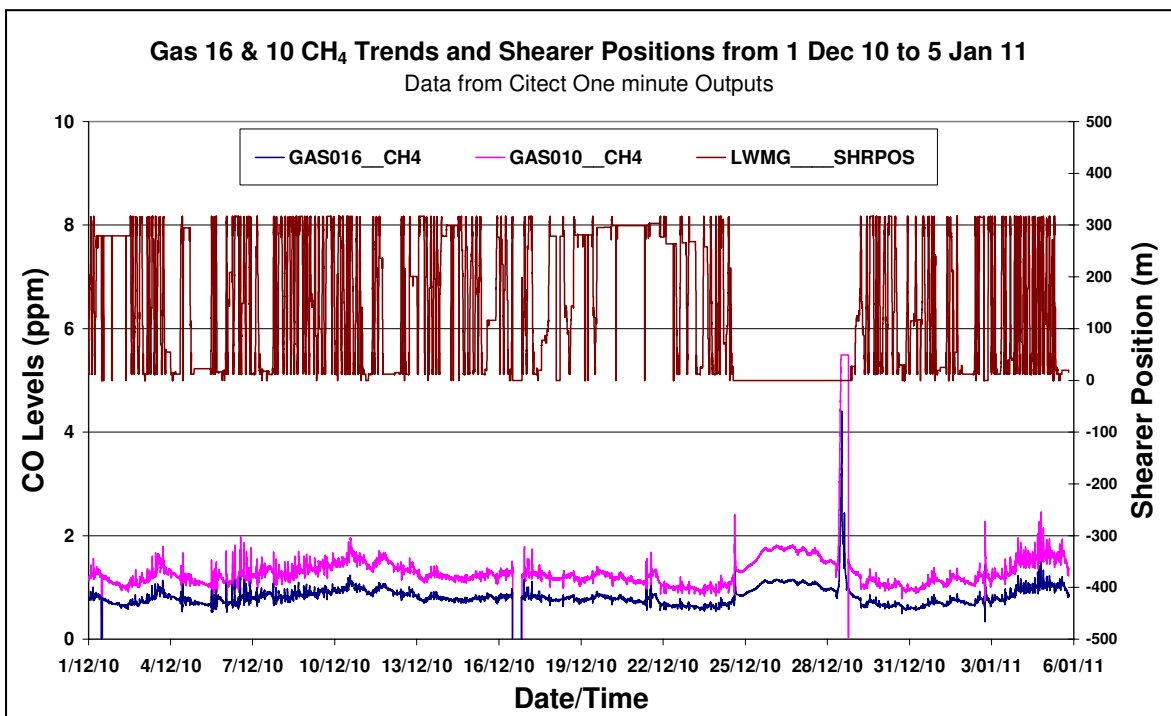
Figure 2.1 Methane gas trend recorded at Gas 16 & 10 Stations (1/12/10 – 05/01/11) and position of LW Shearer.

During the non production period from 24/12/10 to 28/12/10, CH<sub>4</sub> readings recorded at Gas Stations 16 and 10 gradually increased and stabilised. CH<sub>4</sub> readings shot up during the planned fan shut down on 28/12/10 but CH<sub>4</sub> levels decreased very quickly when fans were turned back on and the general trends of CH<sub>4</sub> levels were downward.

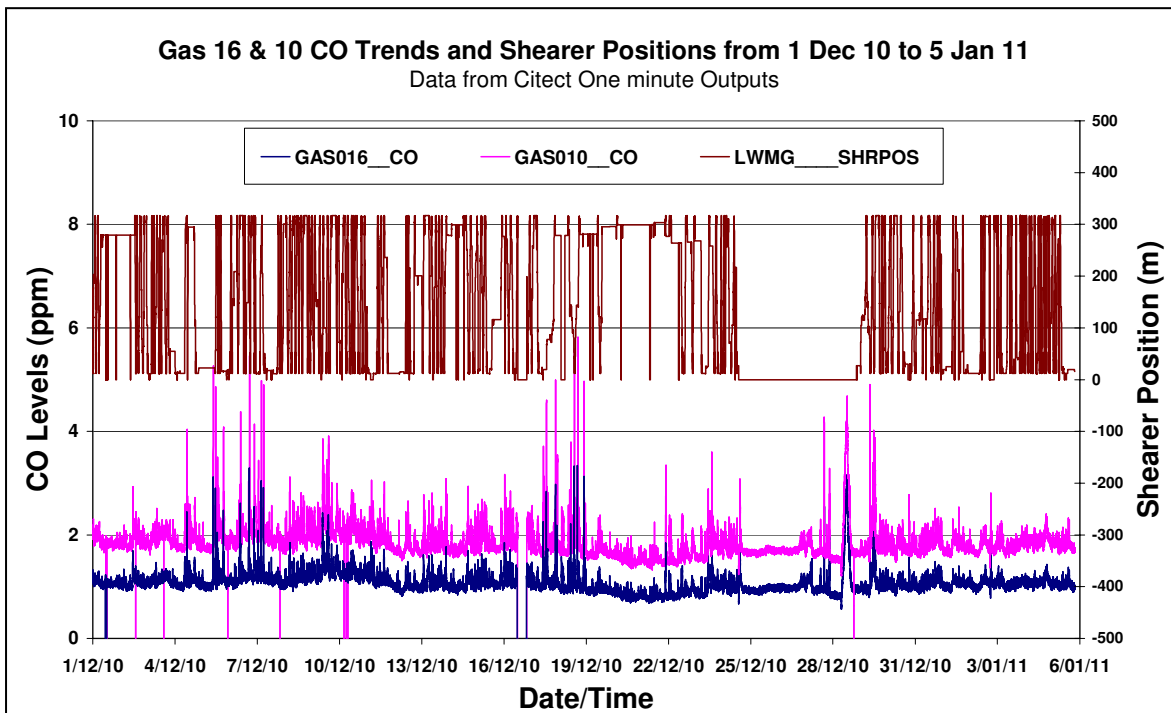
Figure 2.2 CO gas trend recorded at Gas 16 & 10 Stations (1/12/10 – 05/01/11) and position of LW Shearer.

CO levels at both stations on the other hand remained steady during the Christmas shut down period. Correlation between CO levels at both stations and LW production was not as obviously as CH<sub>4</sub>. However, the general trends of CO levels from 1 Dec 2010 to 5 January 2011 were steady and slightly downward in the second half the period.

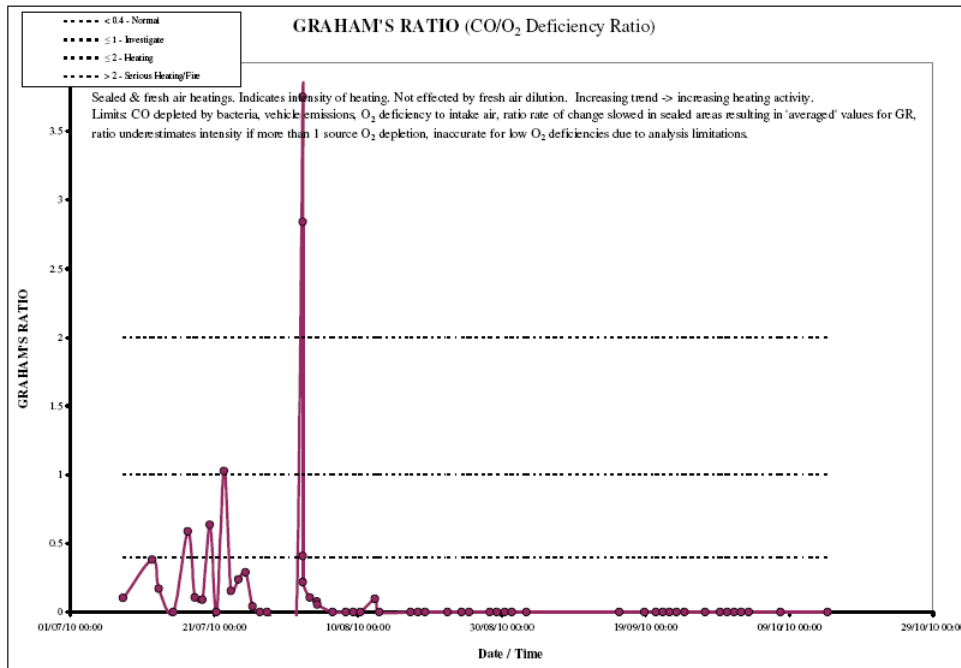
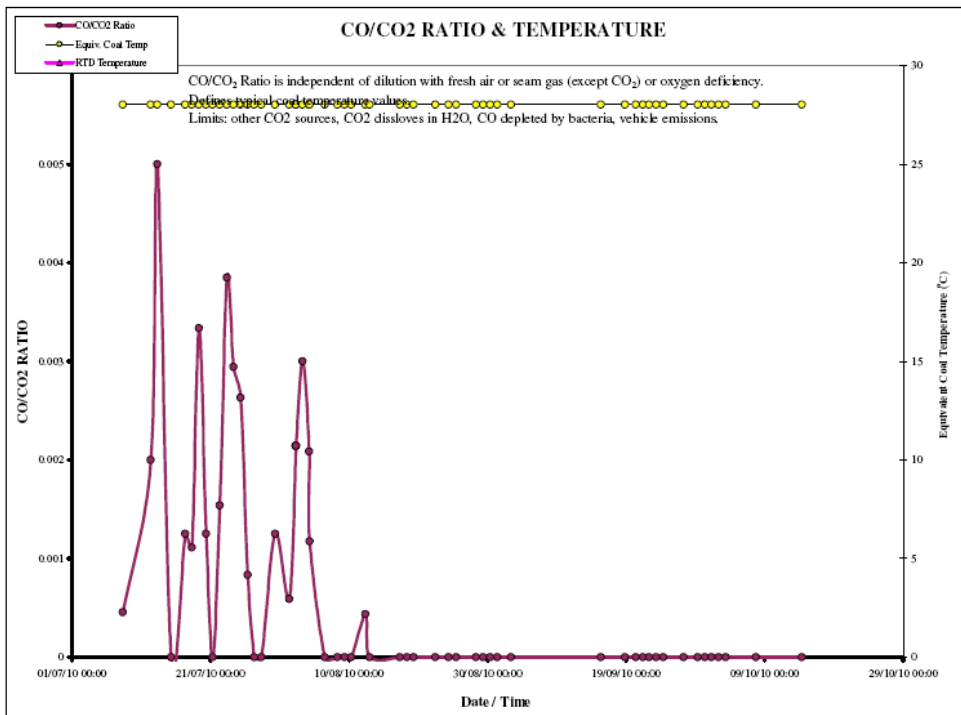
Figure 2.3 Graham's ratio trend from LW goaf bag samples.

Figure 2.4 CO/CO<sub>2</sub> ratio and temperature trends from LW goaf bag samples.

It can be seen that from these two figures that LW goaf gas environment after initial unstable period in July 2010 and by early August 2010 LW goaf gas environment had settled and stabilized.

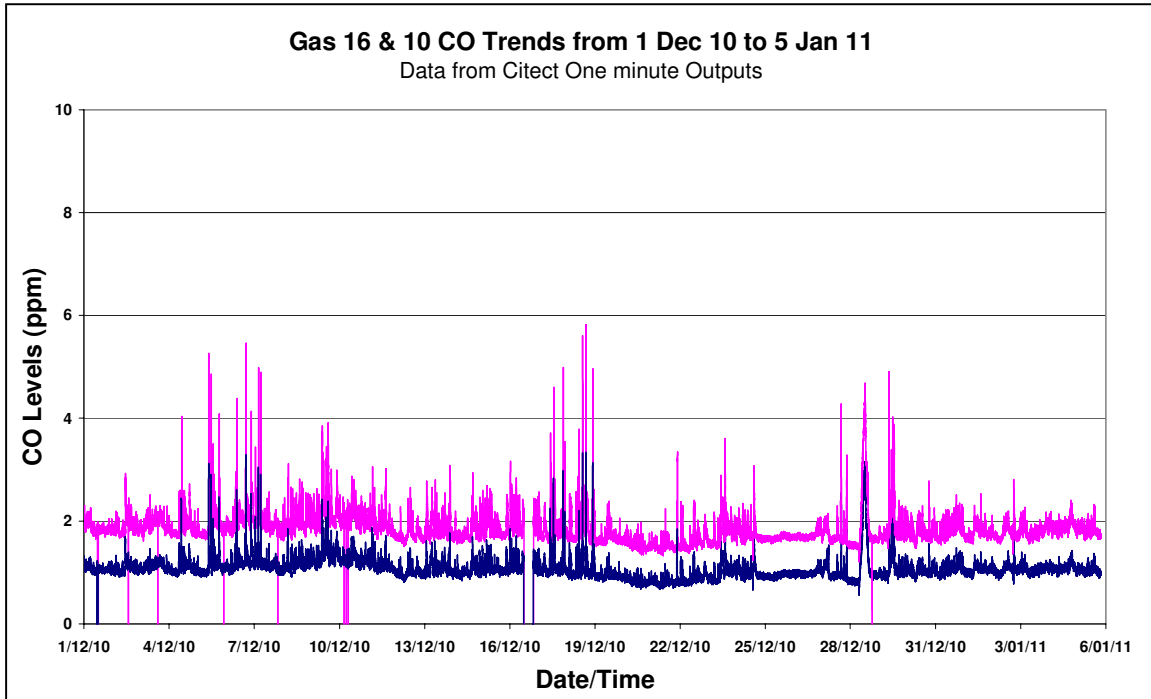
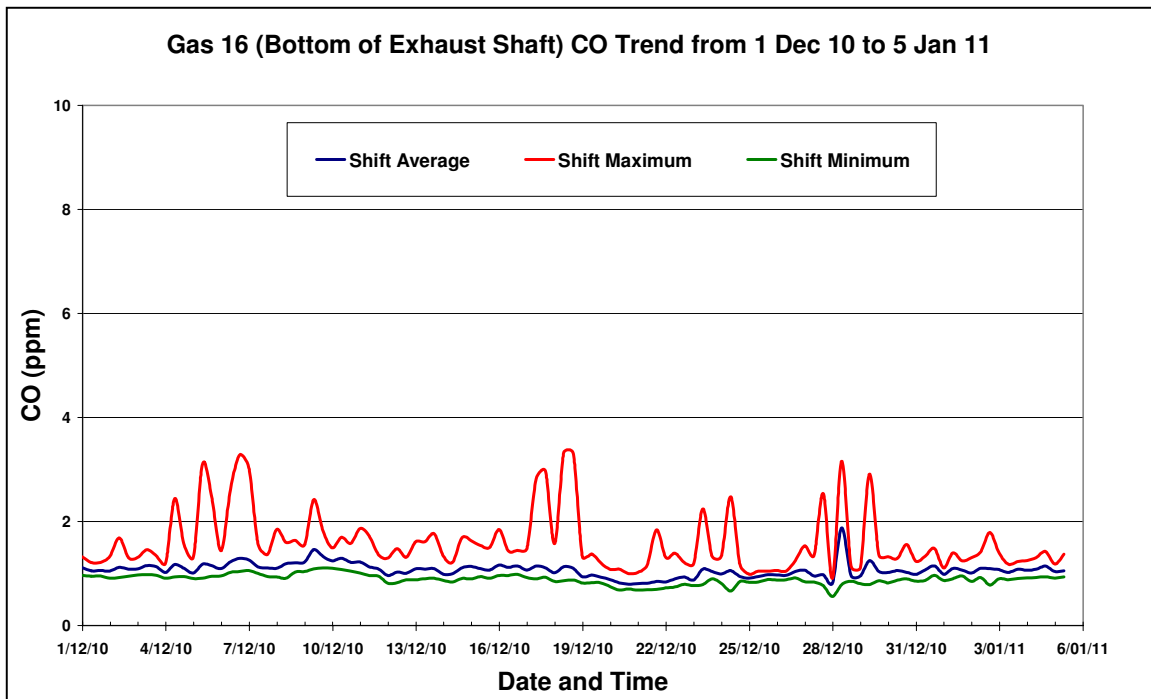
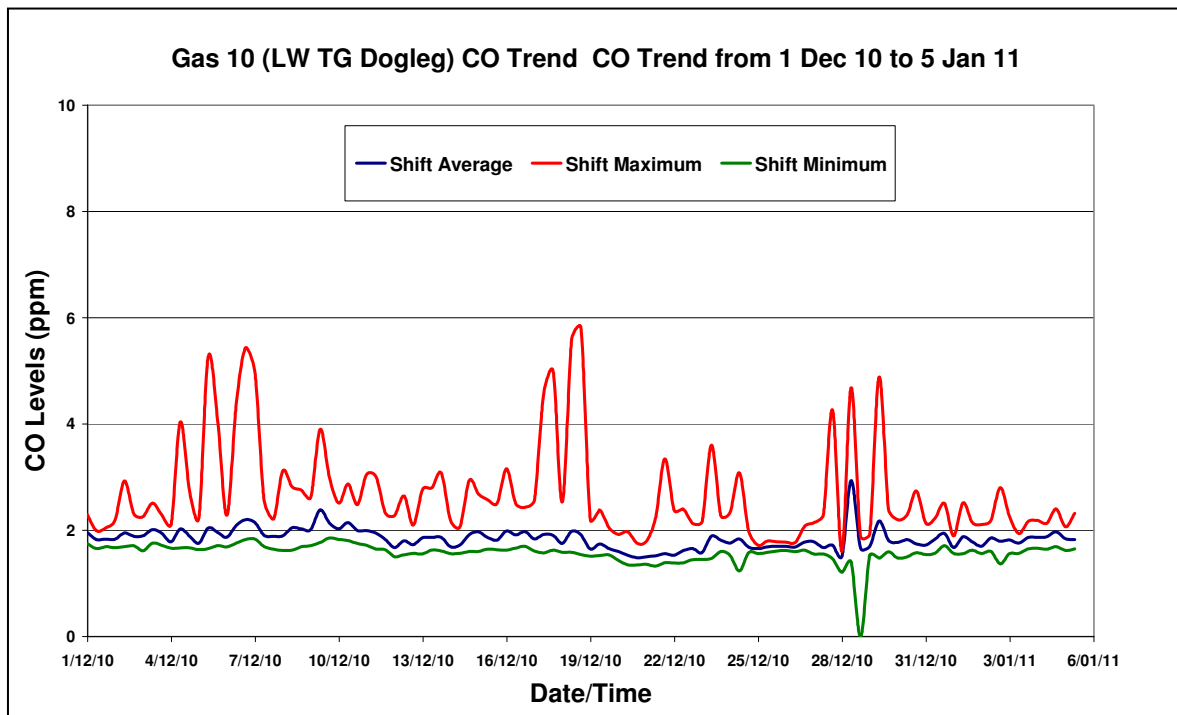
Figure 3.1 CO gas trend recorded at Gas 16 & 10 Stations (1/12/10 – 05/01/11).

Figure 3.2 CO gas trends of shift average, maximum and minimum at Gas 16 Station – Bottom of Exhaust Shaft (1/12/10 – 05/01/11).

Figure 3.3 CO gas trends of shift average, maximum and minimum at Gas 16 Station (1/12/10 – 05/01/11)

CO gas levels in a mine atmosphere are of interest as they may indicate the onset of a fire or spontaneous combustion heating (or may show an indication of exhaust fumes from a diesel powered vehicle). In the various figures above both Gas 16 & 10 Stations' data indicate that CO levels are below 4.0ppm almost all the time and never record greater than 6ppm and then only for a very short period. Furthermore readings are very stable with no indication of a long term rising trend that may indicate onset of a heating.

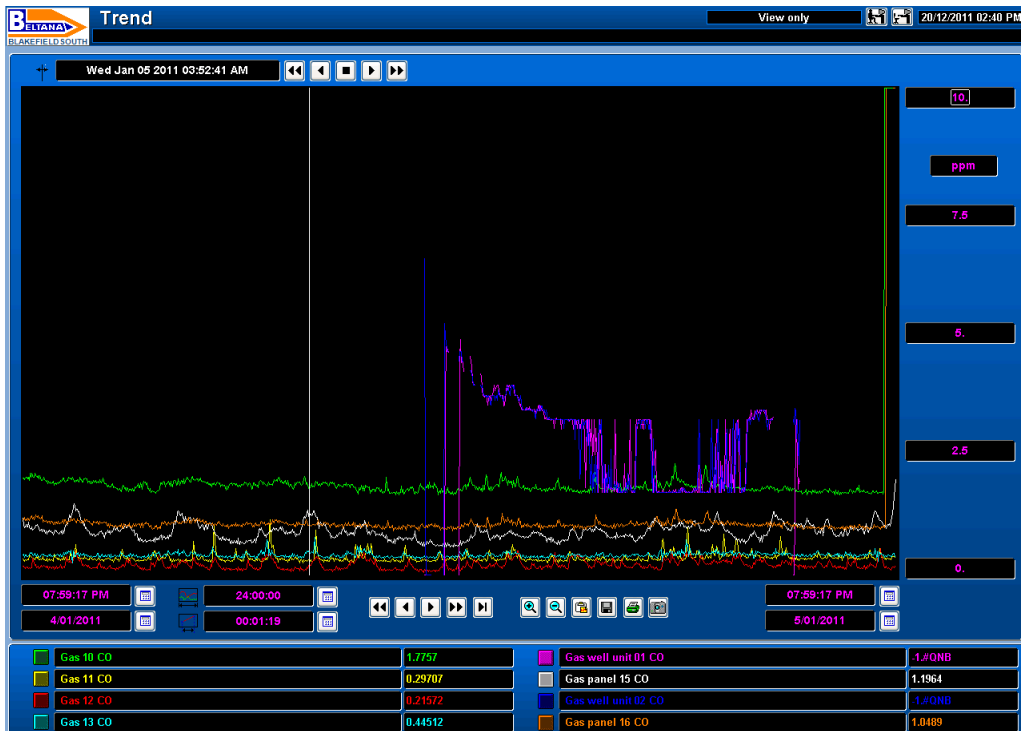
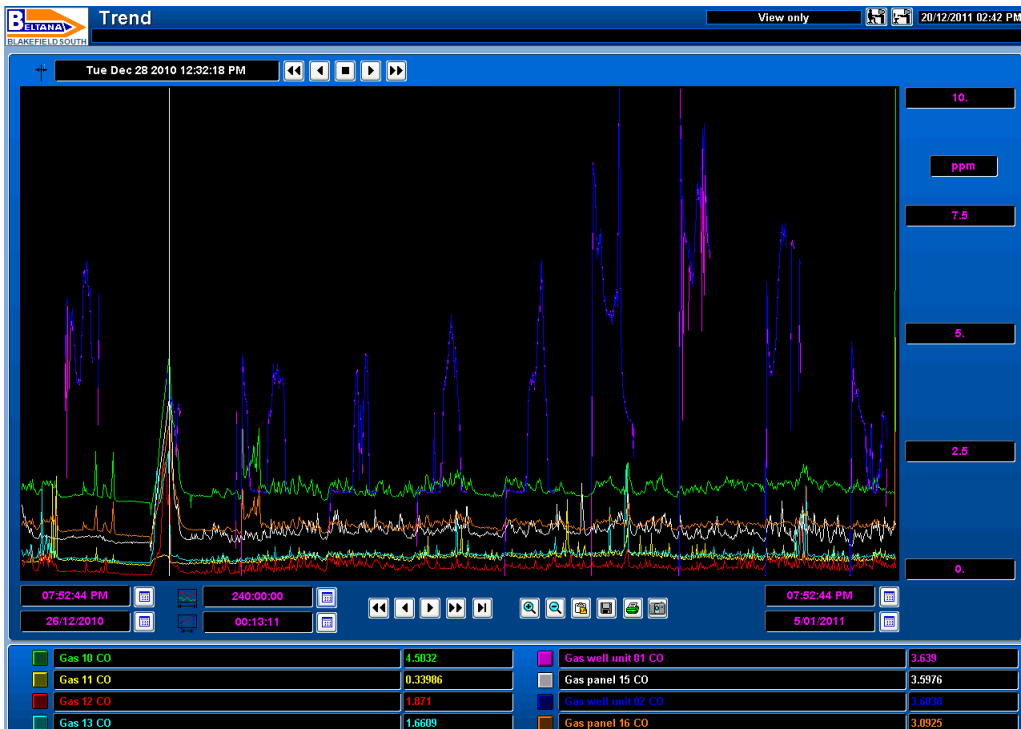
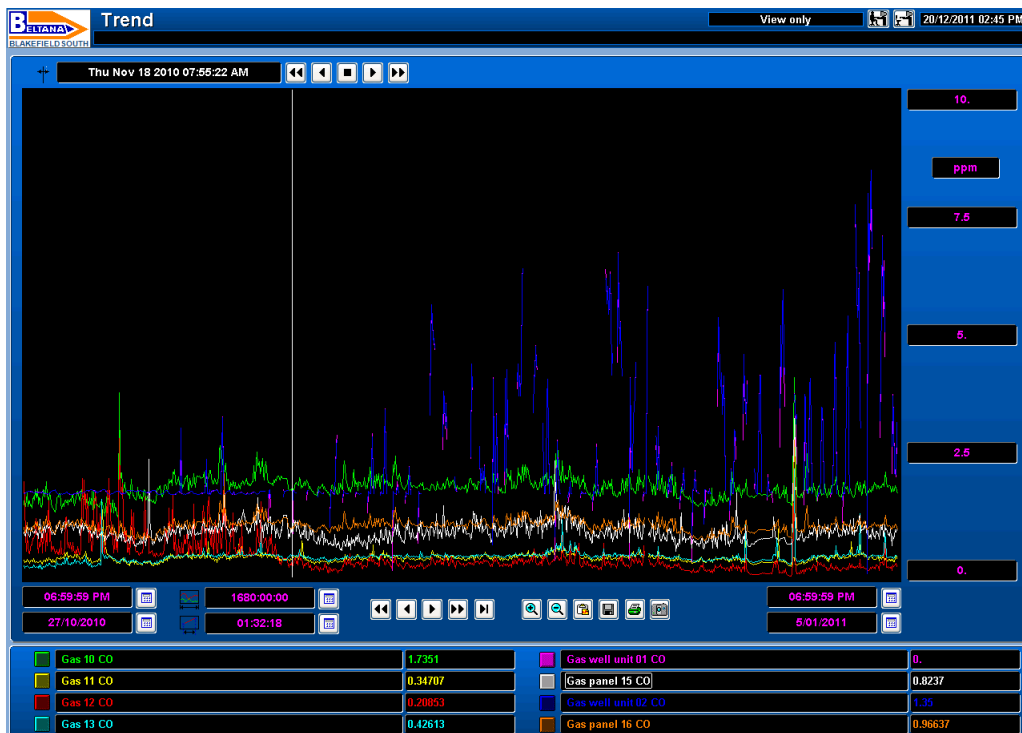
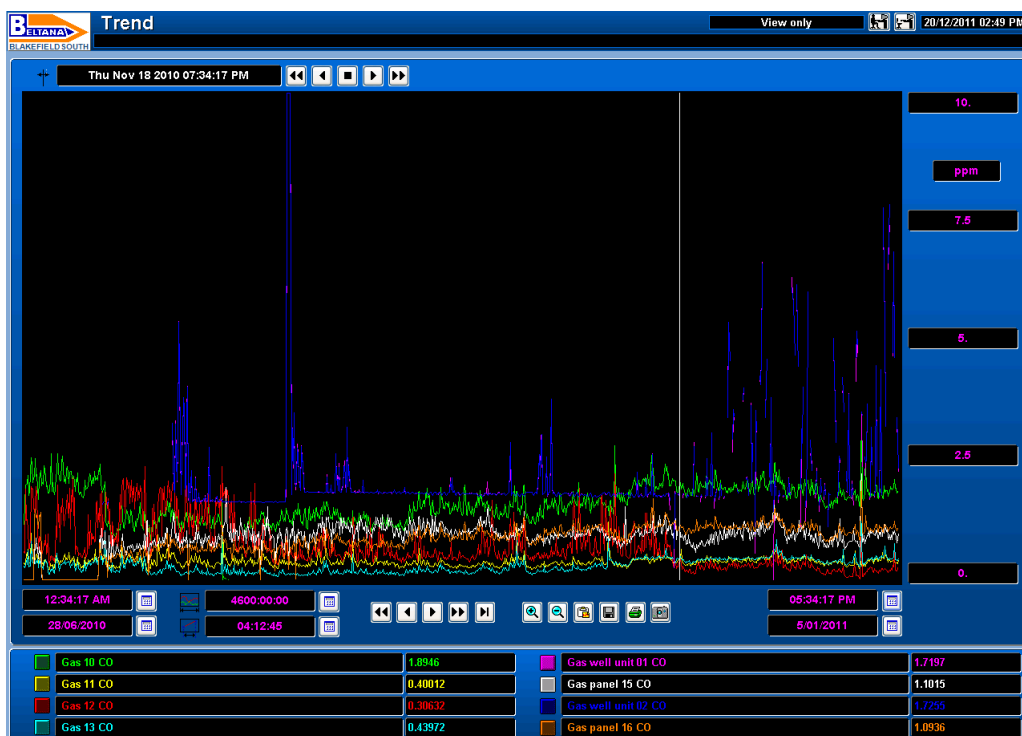
The indications of "high" CO levels in the range of 7 to 10 ppm from gas drainage wells recorded by the Citect gas monitoring system could come from a number of sources.

- Vehicular traffic working hard sporadically in the Main Gate that ventilated across the face and around the goaf to the TG could have been the cause.

- Also slow oxidation of coal in the goaf will cause some low level CO. As the goaf forming roof fell air would have pushed into the face area and across CO sensors. These wind blasts would have altered the normal air gas concentration near the sensor for a short period (an inrush possibly followed by a suck back).

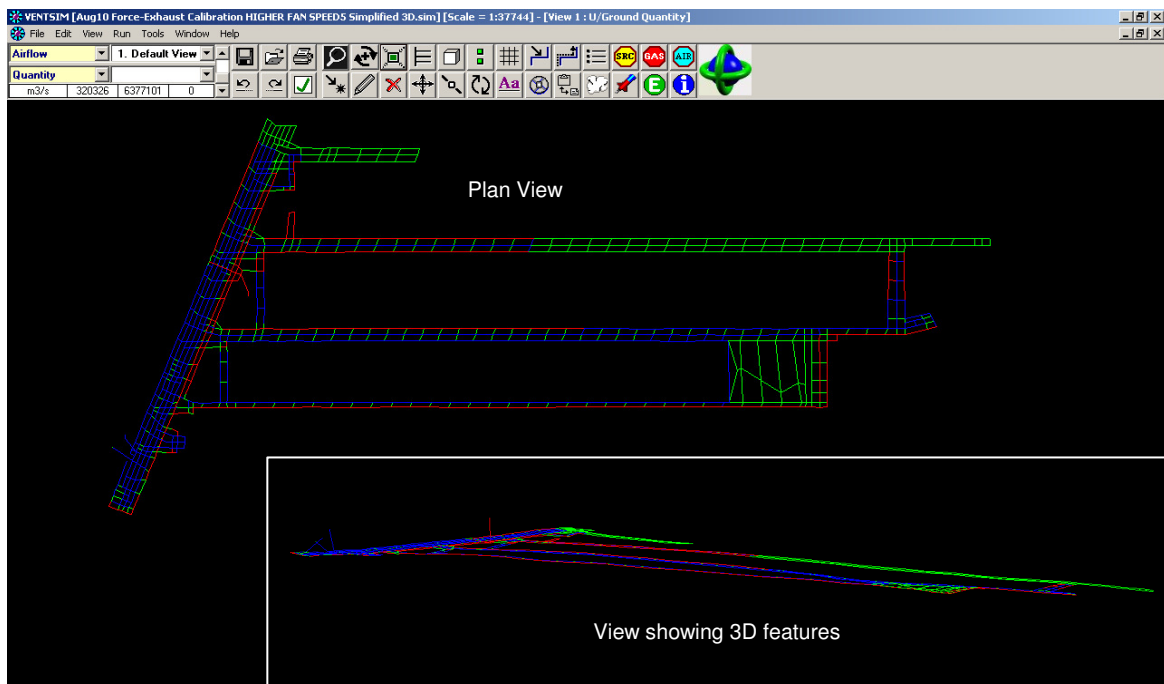
Figure 6.1 Screen snapshots of the 3D Ventsim converted based on 2D model supplied.

Mines typically keep Ventsim models updated monthly after the statutory ventilation survey. It can only be assumed that the mine was not maintaining an up-to-date Ventsim model for the short term planning of their ventilation system. The mine does not appear to have the capability to do so possibly due to the complexity of the push and pull ventilation system used at BSM.

The model supplied also does not include the attributes of the actual forcing fans and exhaust fans operating at the time. Instead, fixed quantities had been incorporated in the model at the locations of the fans at the intake and exhaust shafts to simulate the total mine airflows. This means that the model is not able to reflect/predict the effects from all changes made to the ventilation system in the model. It only represents a static snapshot of a particular time phase. This supports the recent interview statement obtained by the Investigation Unit from the former BSM ventilation officer that it was not possible to maintain a valid ventilation model for the push/pull ventilation system used.

These circumstances indicate that BSM's mine ventilation management system needs improvement when compared with the standards of current Australian underground coal mine ventilation accepted practice.

To be able to undertake proper Ventgraph model and simulation for the January 2011 incident, the 3D Ventsim model is to be updated to the status of the ventilation network just prior to the incident using the relevant information available from monthly ventilation reports and plans. This task is currently being undertaken and the following figure shows a screen snapshot of the updated 3D Ventsim model at 5 January 2011 prior to the incident.

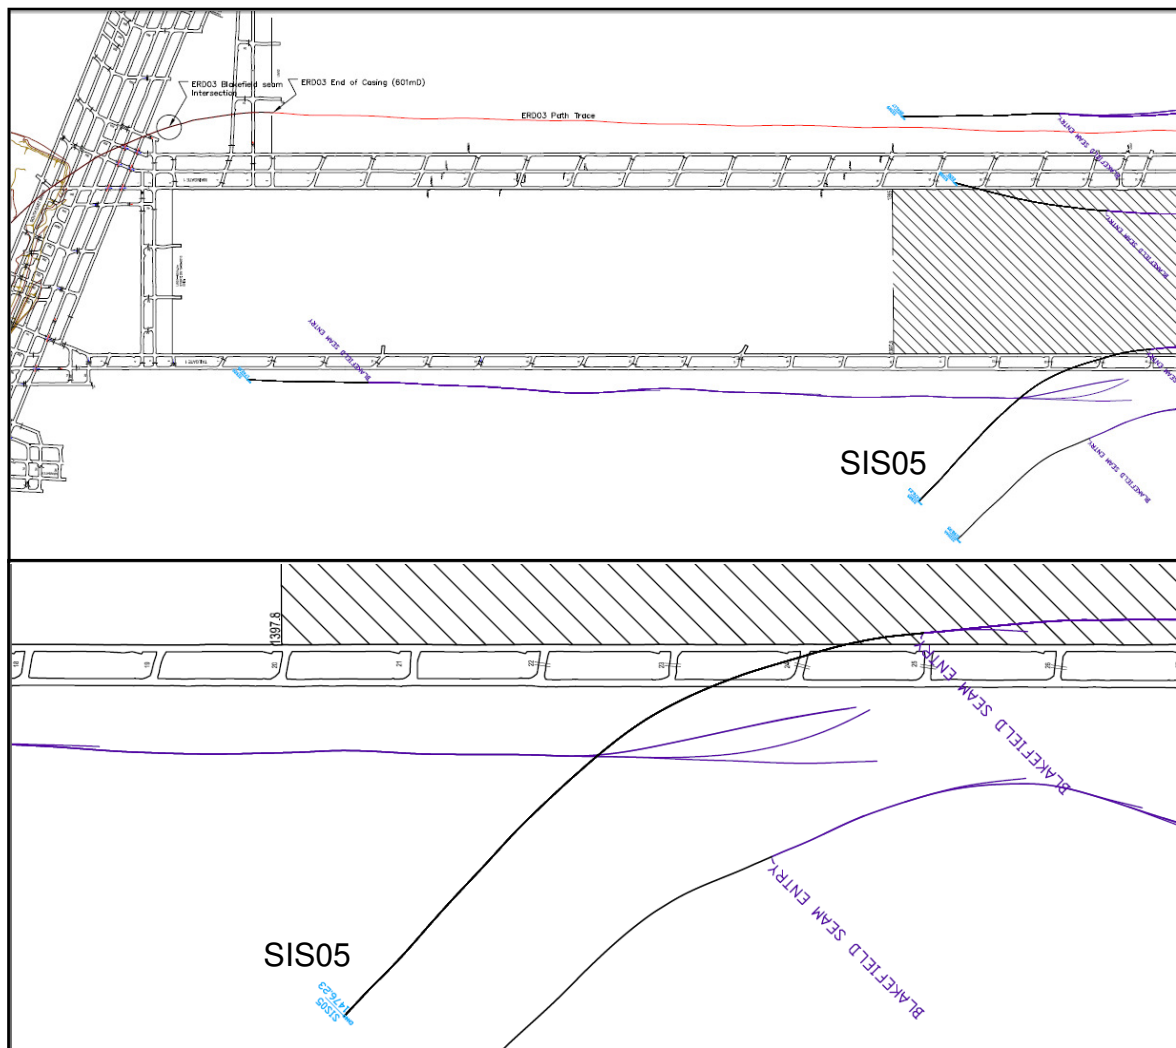
Figure 7.1 Extract from mine plan showing SIS 05 hole intercept LW TG at about 4 to 5 CTs inbye of the LW face line at the time of incident.

- (iv) Undertake Ventgraph modelling with an ignition assumed to originate where a borehole intersects the worked seam in the TG about 4 CT back or inbye the LW face. In this modelling assume that ignition is caused by lightening and model to parallel the observations and re-actions of the LW shift Deputy and the Maintenance Supervisor from the moment of lightening strike recorded on the surface above the borehole position.

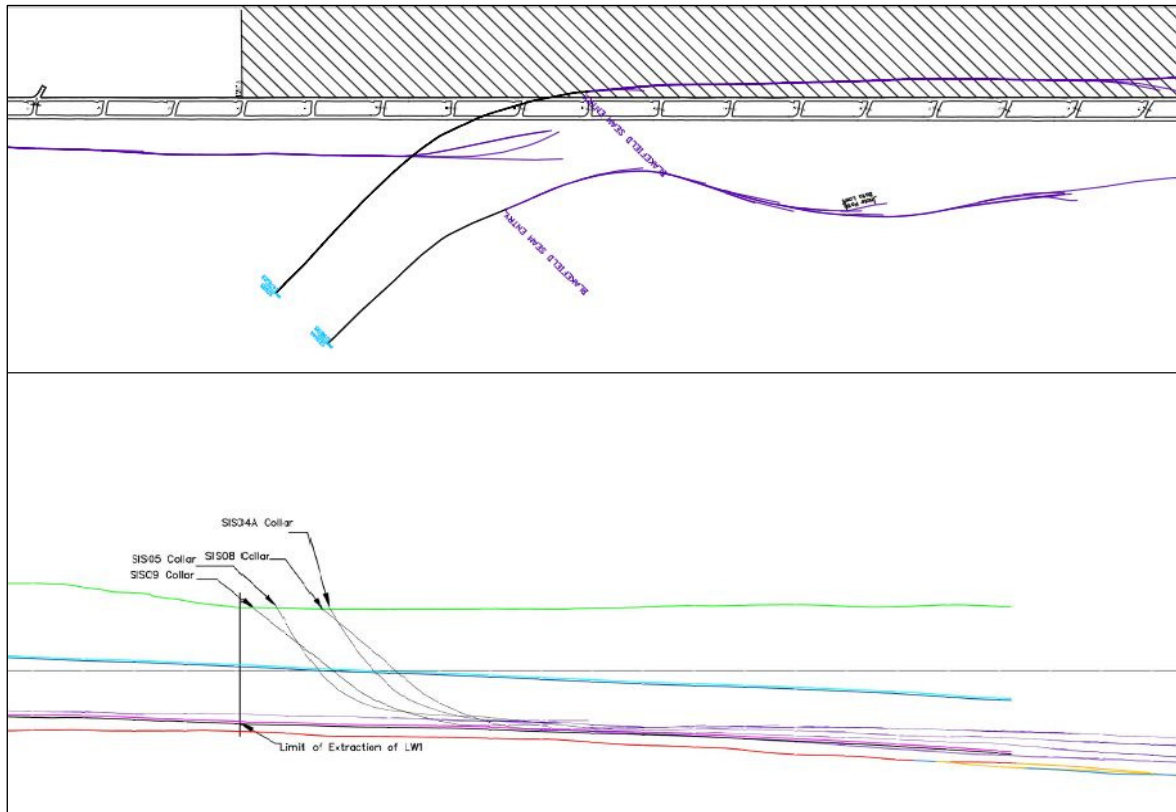
Figure 7.2 shows a plan and elevation view of the boreholes intersecting the upper and lower seams being worked in the vicinity of the TG on 5 January 2011. These demonstrate that there were a number of borehole connections between upper Wybrow and lower Blakefield South coal seams that could have held gassy atmospheres that possibly played a part in allowing CH<sub>4</sub> to pass from the upper seam to replenish CH<sub>4</sub> gas concentration levels immediately after dilution with ventilation as the longwall mined through a particular part of the coal seam being worked and goaf formation occurred.

Figure 7.2 Plan and Elevation view of the boreholes intersecting the upper and lower seams being worked in the vicinity of the TG on 5 January 2011.

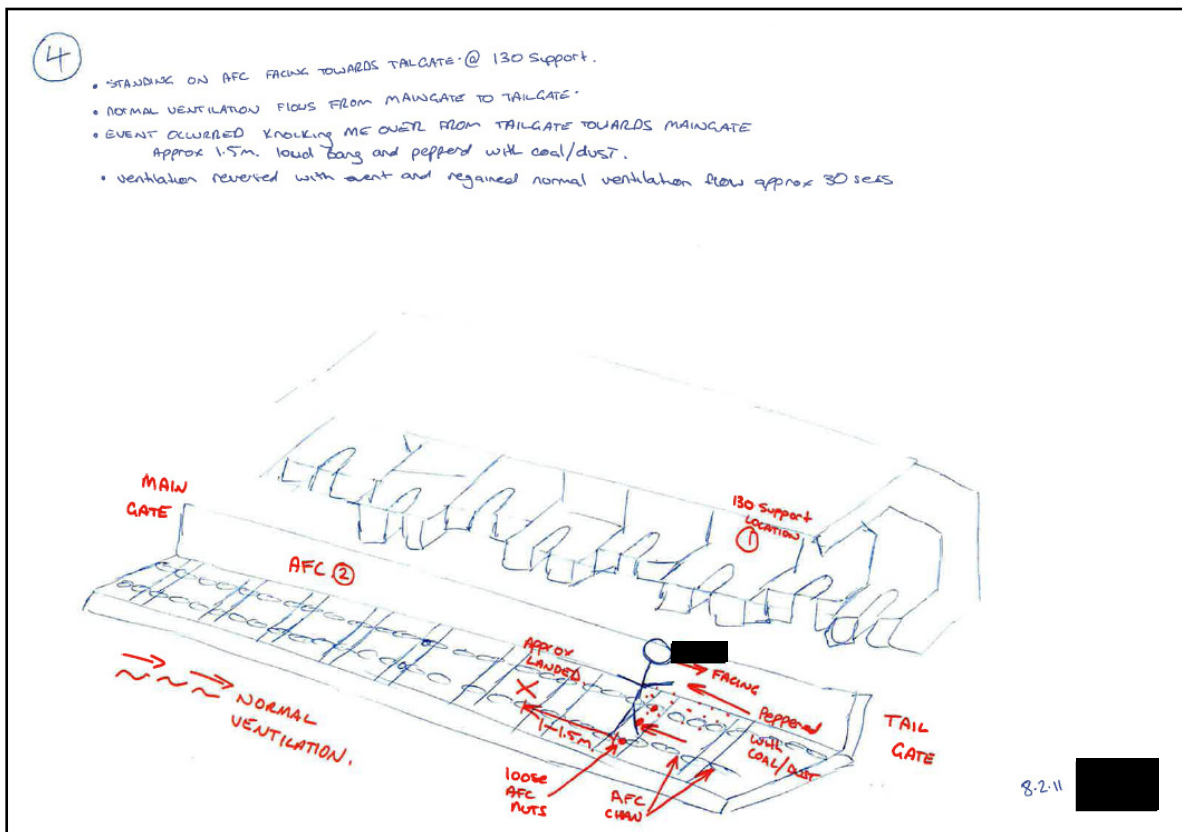
Figure 8.2 LW Maintenance Supervisor, [REDACTED], hand drawing indicating his position on LW face at Chock 130 at time of incident.

being knocked over. He noted when he was at Chock 130 a cloud of dust and he was peppered by dust. He recorded in the verbal interview that “something that was really different was the smell....it smelt like gunpowder.....like cordite....after you shoot....it’s got a real distinctive smell and I’ll never forget that smell”. ██████████ stated that he was aware of the mine’s spontaneous combustion management plan and expected to note signs of “...sweating of, of steel, heat, haze and.....” if this existed. He did not recall any of these effects at the time of the incident.

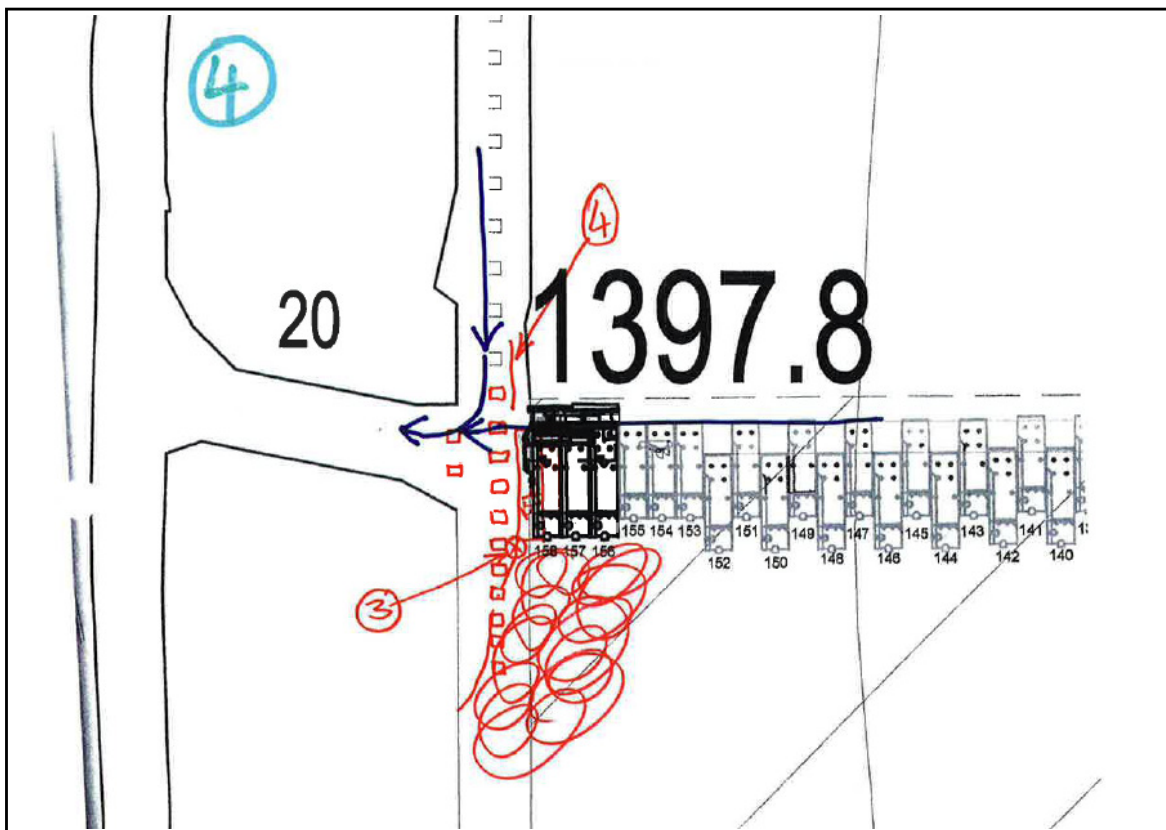
The Deputy stated that an unrecognised smell was experienced as he moved close toward the TG and a bit of a rumbling sound was heard. Just before he tried to step out from under 158 Support he saw flames coming back towards him from the goaf edge and from down the roadway as shown in the following drawing included in the record of interview provided.

Figure 8.2 LW Crew Deputy, ██████████ hand drawing indicating the locations of the flames he saw at TG end of LW.

Therefore, [REDACTED] observations indicate that a goaf fire burning gases and solid coal was occurring on the edge of the broken material forming the goaf and possible further inside the goaf. He was seeing a progression from the colder part of a diffusion (incomplete combustion) flame which is red, transitioning to orange, yellow, and white as the temperature increased as evidenced by changes in the blackbody radiation spectrum. In terms of the “fire triangle” oxygen was abundant from the mine ventilation airways surrounding the goaf, fuel was coal and seam gases and an ignition source existed (there
