Investigation Report

Fire and explosion on Longwall No 1 Tailgate
at the Blakefield South Mine
5 January 2011

Published report prepared by the
Investigation Unit, Thornton

May, 2012 www.resources.nsw.gov.au/safety

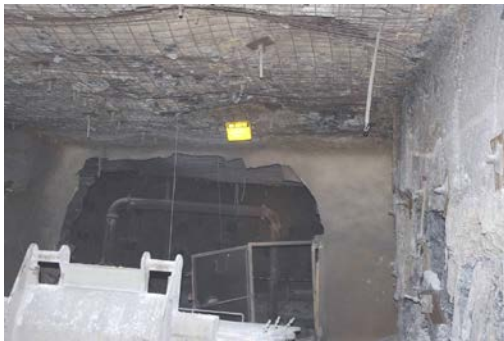
This fact, taken in conjunction with the fact that the stoppings at 13 cut-through and 14 cut-through had been found to be severely damaged when the mine had been re-entered, supports the view that the initial explosion was not of sufficient intensity to burst the bat bags and, hence, the subsequent fire was able to melt them. If, however, there was insufficient energy to burst the bat bags there should not have been sufficient energy to knock over the stoppings. Thus, it would appear from the above that the stoppings were knocked down by the subsequent explosion.

In heading 'B' of the tailgate from 14 cut-through outbye there were further signs of both the fire and the explosion. The clearest signs of an explosion were the blown out stoppings as shown below.

Figure 10: 14 cut-through in the tailgate with stopping blown out

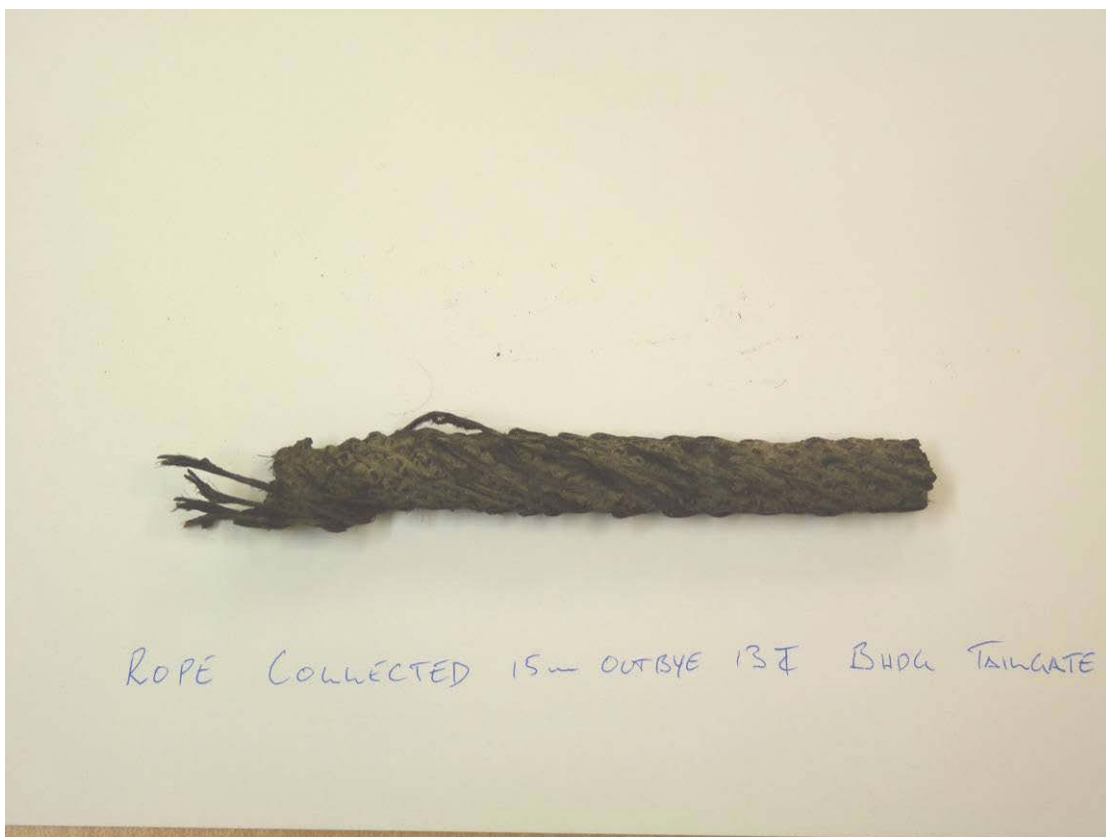
Figure 12: Sample 1 - A piece of heat-affected rope from 15 m outbye of 13 cut-through heading 'B' tailgate 1

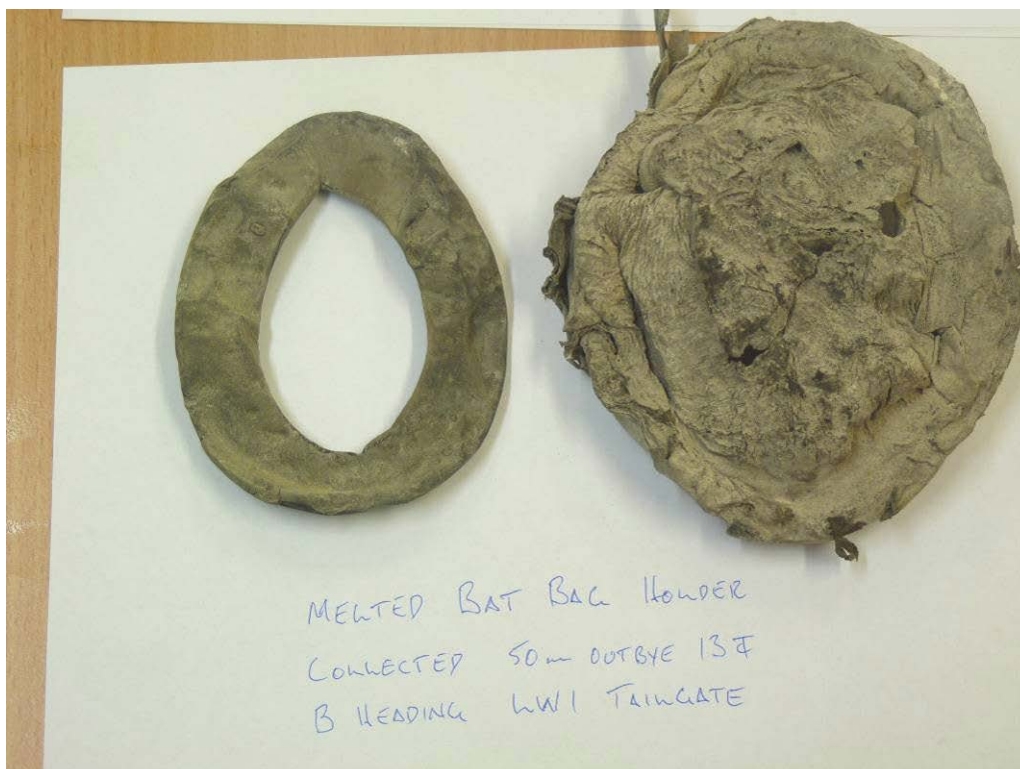
Figure 14: Sample 3 – Heat-affected bat-bag holder from 50 m outbye of 13 cut-through heading 'B' tailgate1.

This item comprised parts of a softened and rehardened polymer assembly, containing more than one polymer. The appearance indicated that high density polypropylene was probably one of the components. As with sample 1, the rigid nature indicated a loss of plasticiser consistent with prolonged heating. There was no visible burning residue, which suggested that the plastic did not reach ignition temperature or it only did so in a low-oxygen environment (below about 11%).

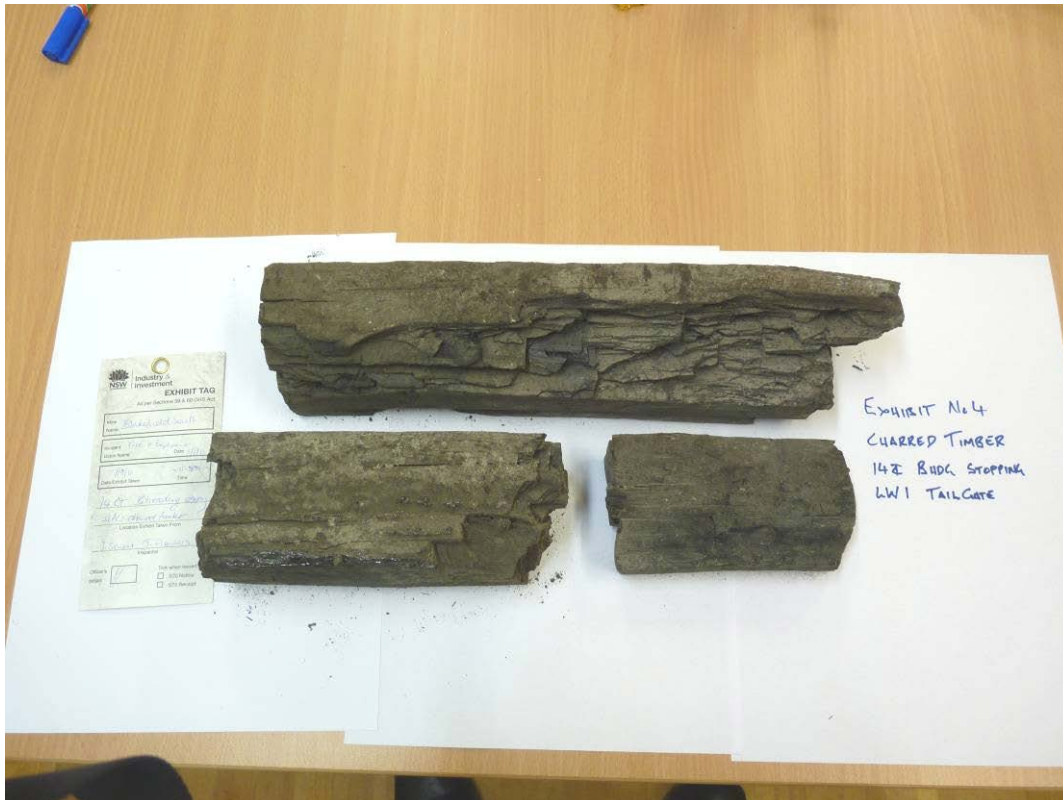
Figure 15: Sample 4 – A piece of heat-affected wood from 14 cut-through stopping Tailgate1
Photographed by Tim flowers 9 September 2011

The sample comprised sections of heavy gauge timber, evenly charred through but without distinctive surface burning. This appearance is similar to that of charcoal produced by traditional pyrolysis methods. In my opinion, the most probable explanation is that the wood was in a low-oxygen environment (less than about 8%) for a period of time exceeding 2-3 days. There were no directional indicators which could orientate the wood with respect to a heat source."²⁴

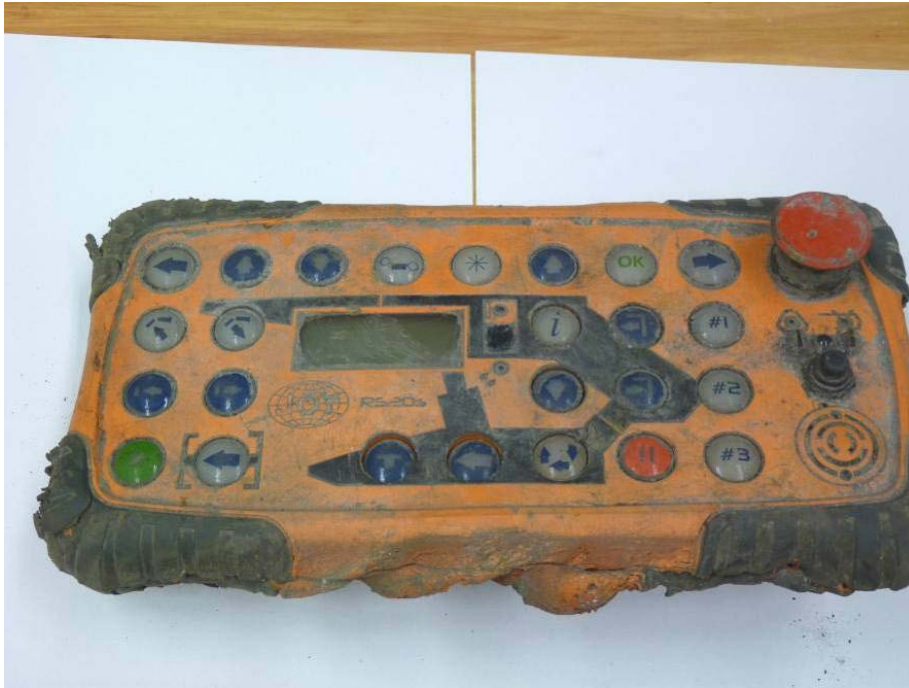
Figure 16: Joy Mimic Unit IECEx TSA 06.0029X located chock 158 LW1 top of box
Photograph by Tim Flowers 24 November 2011

Figure 17: Joy Mimic Unit IECEx TSA 06.0029X located chock 158 LW1 bottom of box
Photograph by Tim Flowers 24 November 2011

"3.09 There was a gap along one edge where the controller appeared to have been broken away from a bracket or mounting. The clean edge showed that this occurred after the heating and I was further advised that the unit was broken away from its location on the chock by the recovery operators. Other than this, the casing remained intact with no heat penetration in either direction.

3.10 Initial inspection of the interior through this gap showed no heat, smoke or other internal damage to the electrical components. The unit was then cut open in the presence of interested parties.

3.11 This revealed no heat or smoke damage to the interior, no indications of dry solder joints, component failures or other localised heat sources.

3.12 In my opinion, the controller was damaged only by exposure to external heating at relatively low temperatures (probably under 300°C)."²⁵

5.2 Sample 5 as seen was not a viable ignition source for a methane-air mixture, and in my view a malfunction of the controller did not cause this incident.

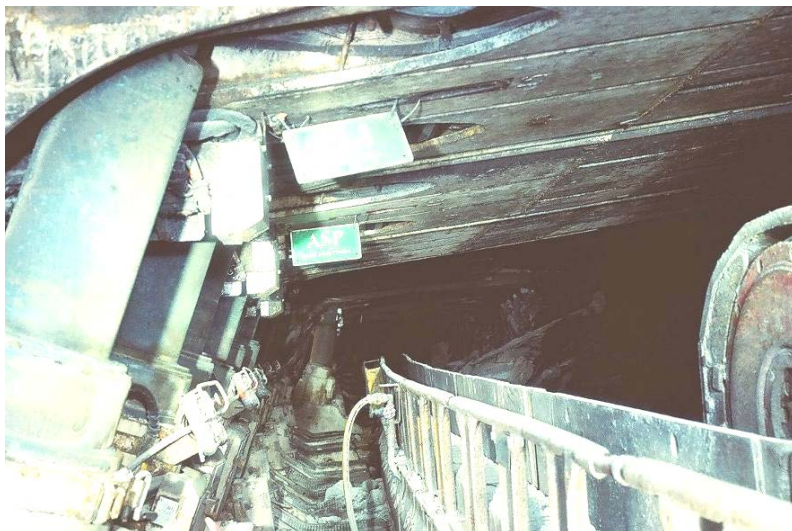
The examination of the LW1 face disclosed that there was no extensive damage along the face from the explosion and subsequent fire.

Figure 18: Longwall as it looked on re-entry

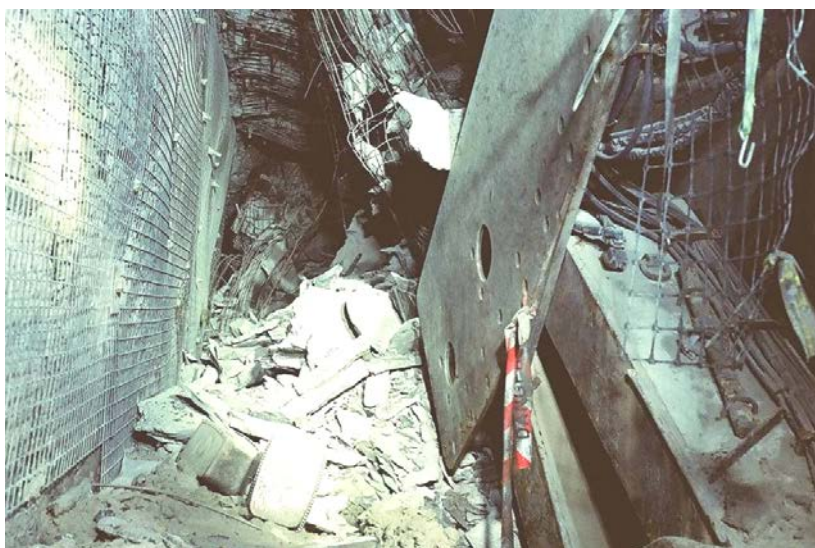
Figure 19: Looking at the goaf between the chain pillar rib and chock 1 at the main gate

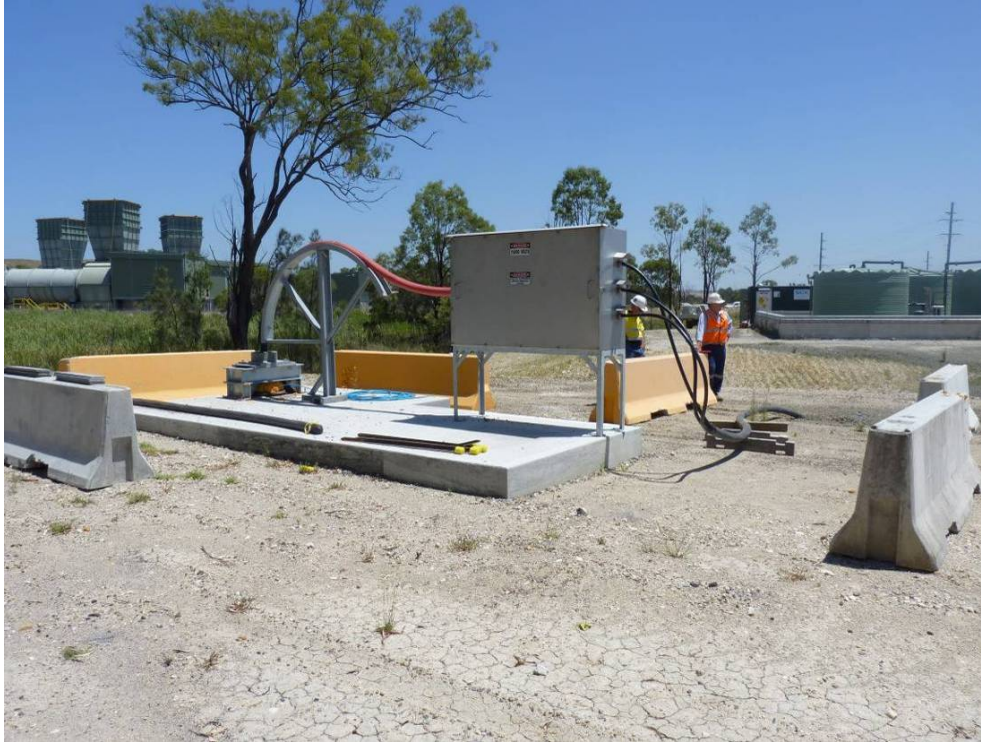
Figure 26: Junction box and entry point for LW1 11 kV cable entering Blakefield South Mine. Note: the installation is not fenced and cable leading into the junction box is unprotected.

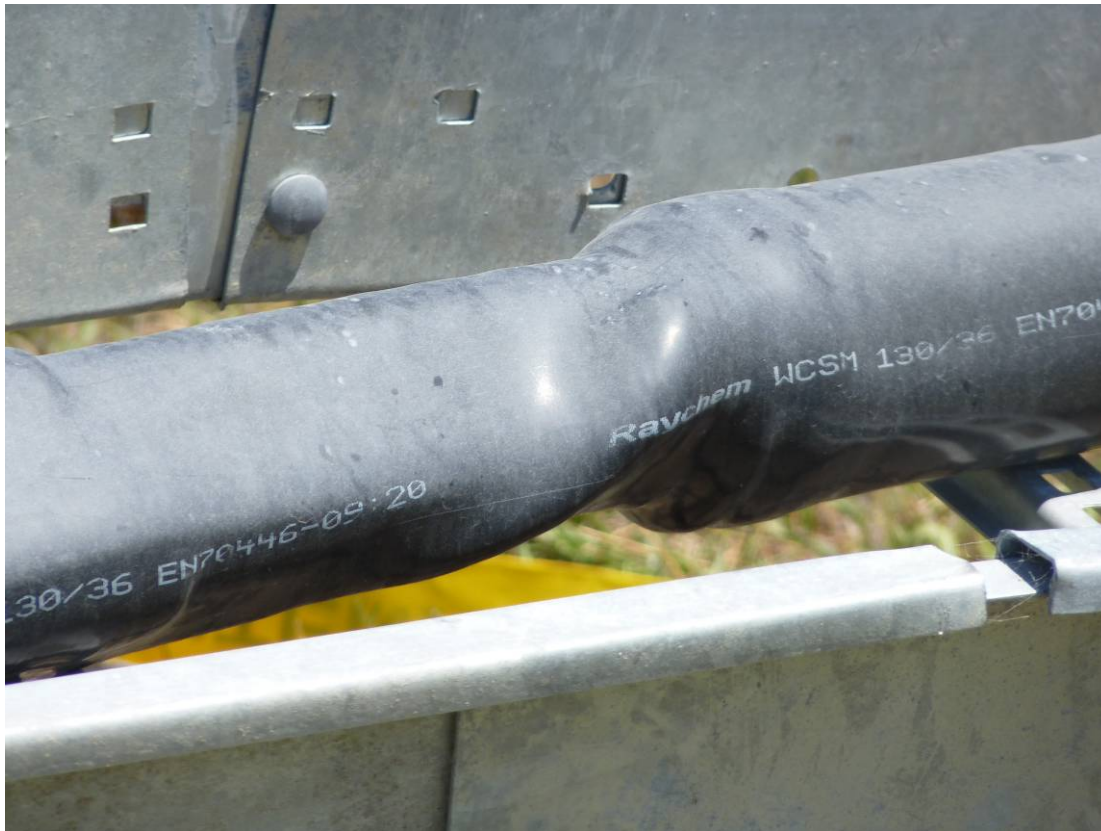
Figure 28 – High tension cable joint showing poor quality join

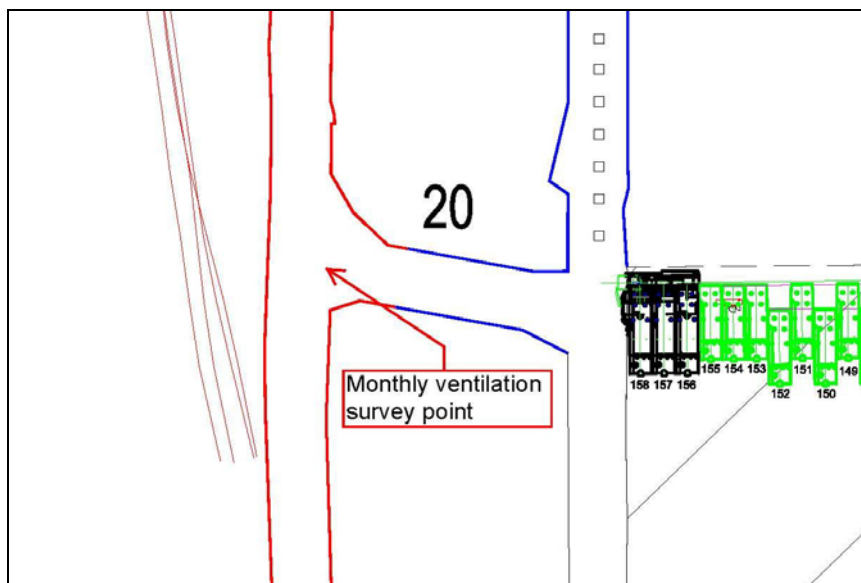
At the time of the incident, the person taking the ventilation surveys was also acting as an undermanager at Blakefield South Mine at the time of the incident⁴³. He carried out the last ventilation survey before the incident in early December 2010 which is recorded as the November Monthly Ventilation Survey⁴⁴. In his interview of 17 October 2011 he describes the location at which the reading is taken in heading 'B' in the tailgate (Figure 33).

He also observes that Bulga Underground Operations has not invoked a Level 1 response for Blakefield South Mine in accordance with the SCMP, even though the June 2010, October 2010 and November 2010 ventilation surveys taken over the six months that LW1 had been working, had identified that the Level 1 TARP had been exceeded in the tailgate in heading 'B' adjacent to the longwall face.

Figure 33: Location of monthly ventilation survey point

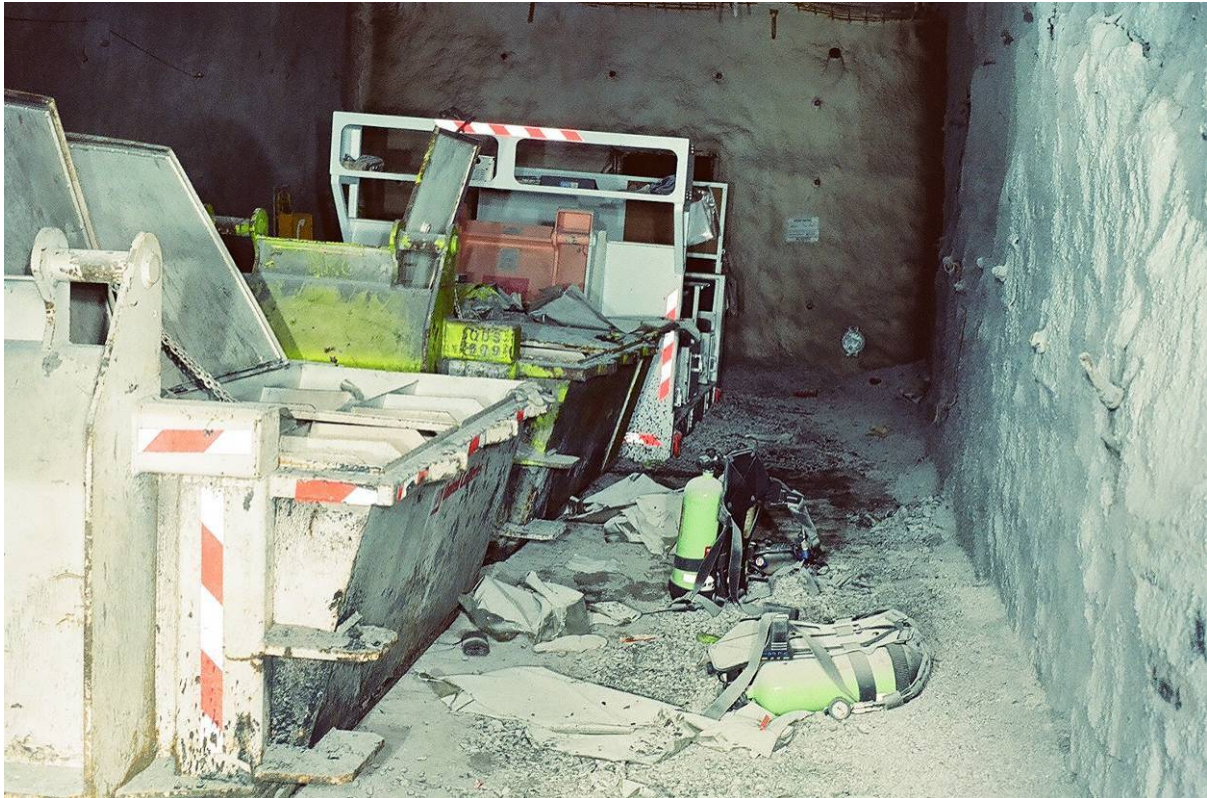
Upon re-entry of the mine both CABA units were recovered from the crib room in 18 cut-through of the Maingate .

Figure 34: Photo of the two discarded CABA units as found in the crib room
