Engine 5670 Cab Electrical Fire 03/10/18

During the evening of 03/09/18, the BLM CFO fire engine 5670 caught fire. The fire was caused by a small flashlight plugged into the cigarette lighter. Despite the engine being off and the main switch to the engine placed in the “off” position, the current to the electric cigarette lighter was still live. The flashlight apparently overheated to the point that it ejected and exploded from the cigarette lighter. Hot fragments of the flashlight caught the driver’s seat on fire.

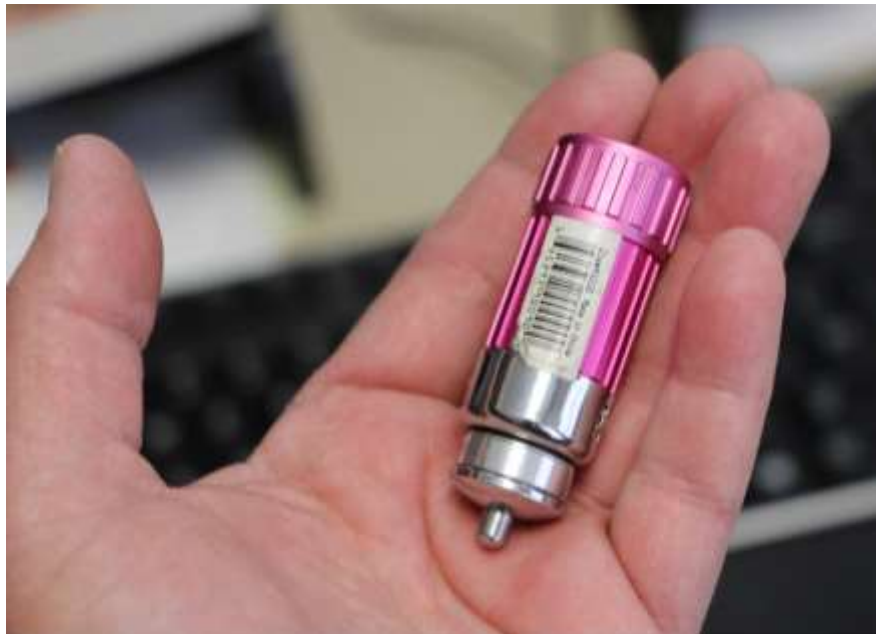
A small rechargeable flashlight like the pictured above caused the fire.

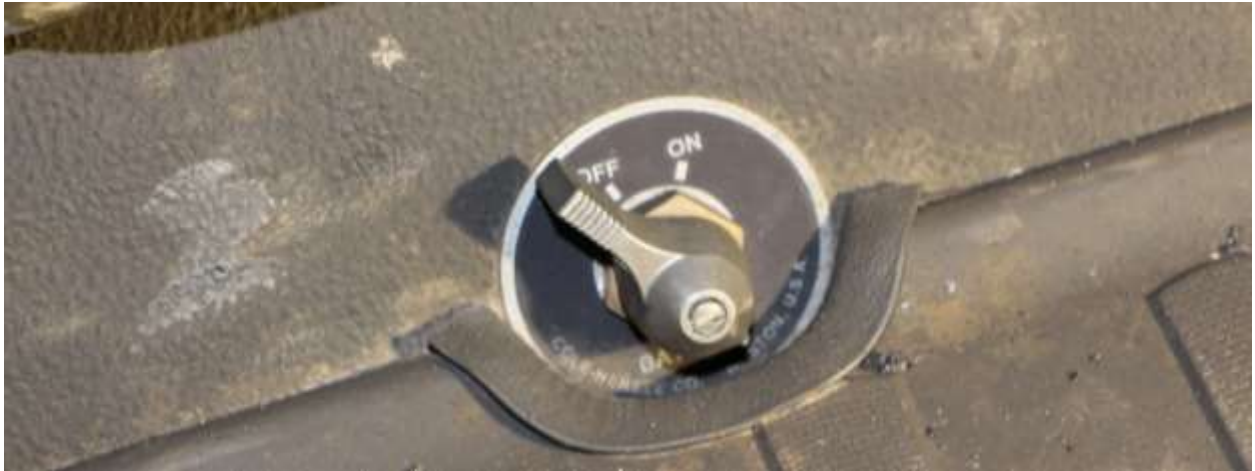
The engine power switch in the "off" position.

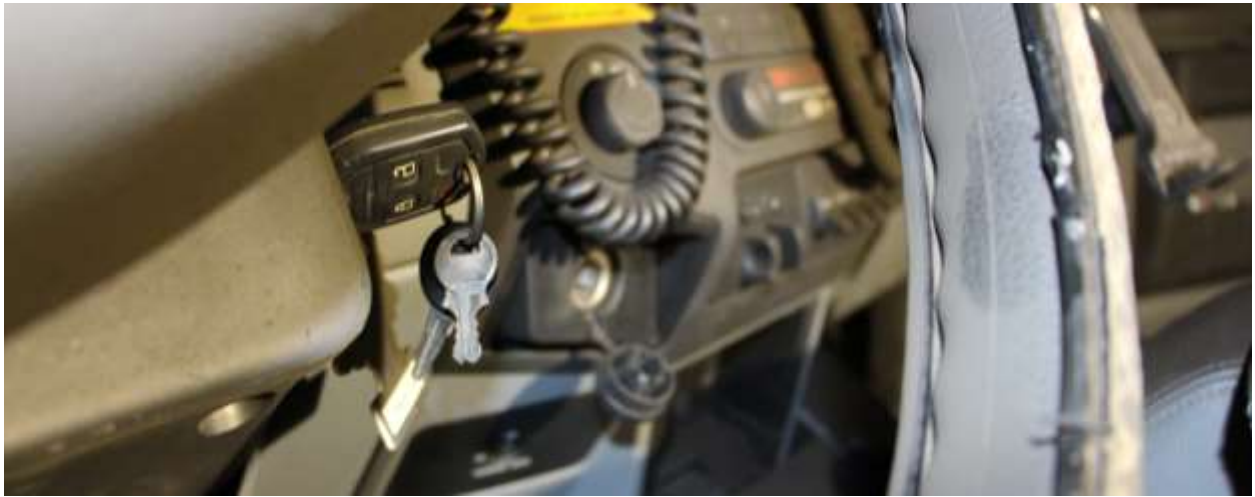
The engine dash and cigarette lighter component.

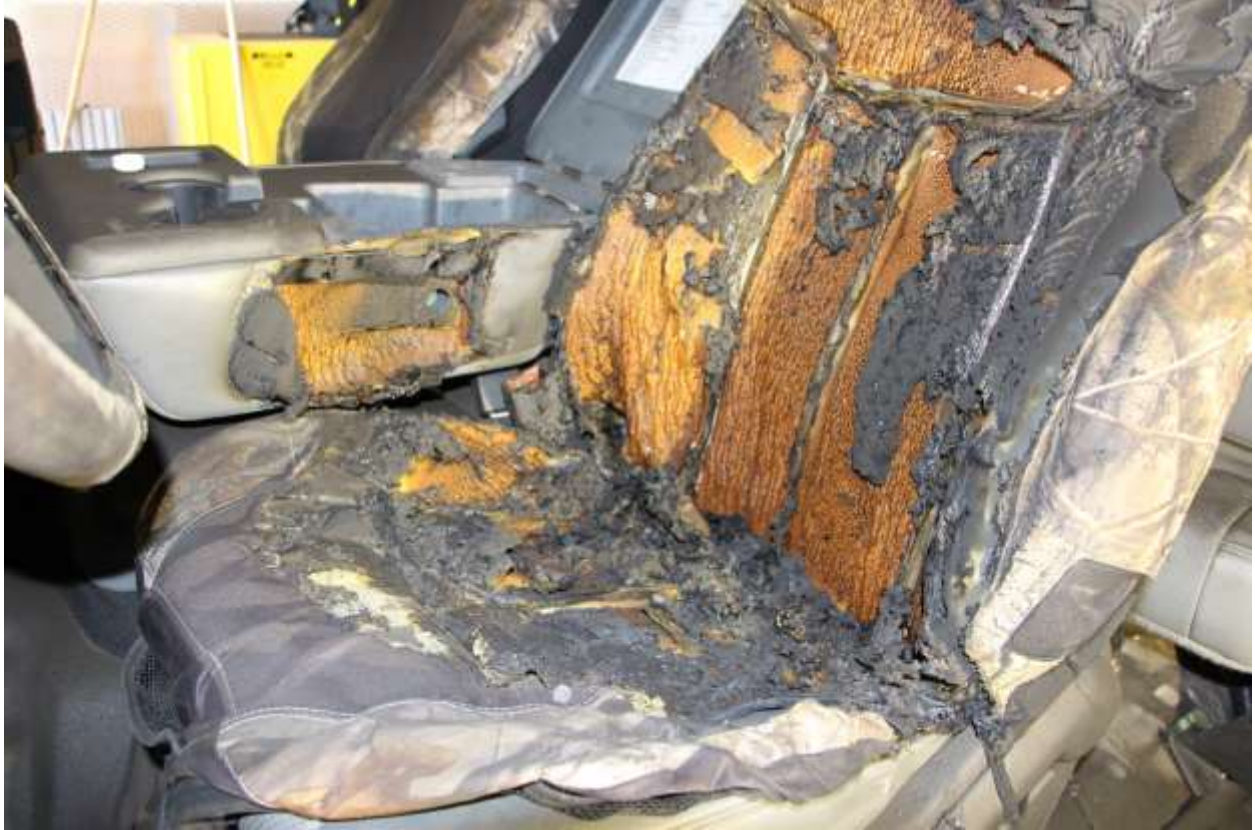
Fire damage to the driver's seat of the vehicle.

A fire investigation was conducted on 03/10/18 and the engine will be taken out of service until the fire damage to the cab is mitigated.

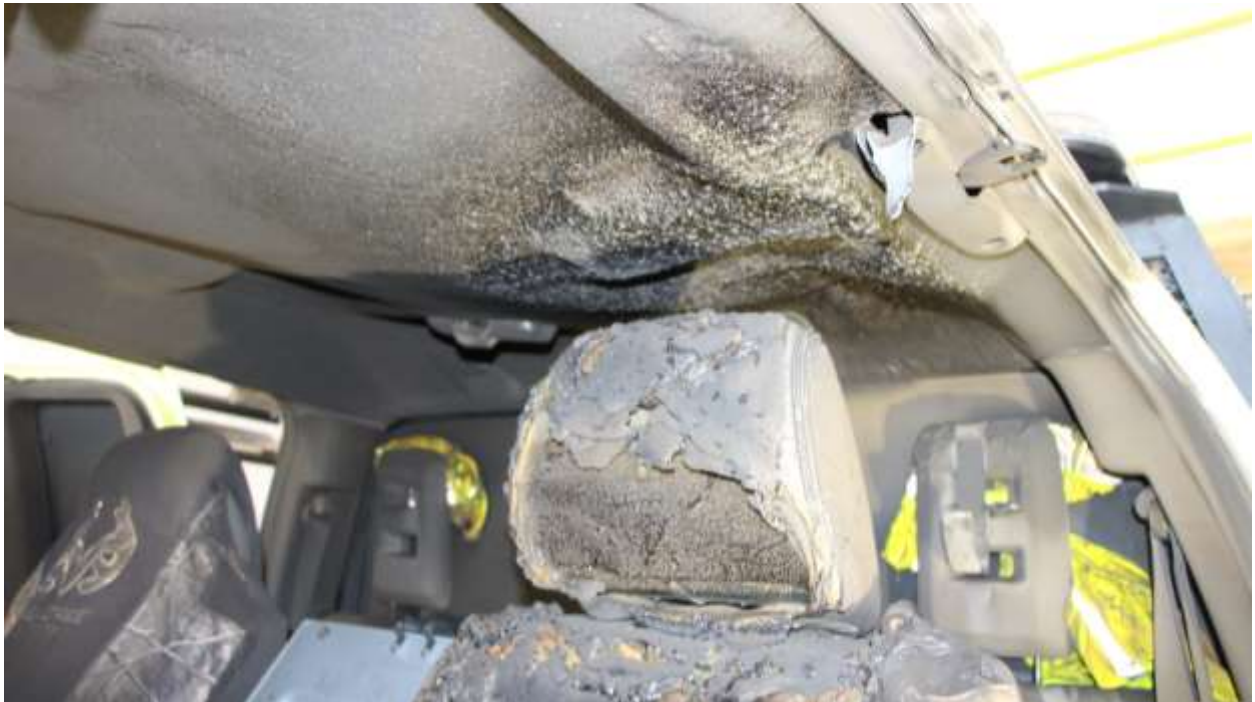
Heat damage to the headliner of the cab.

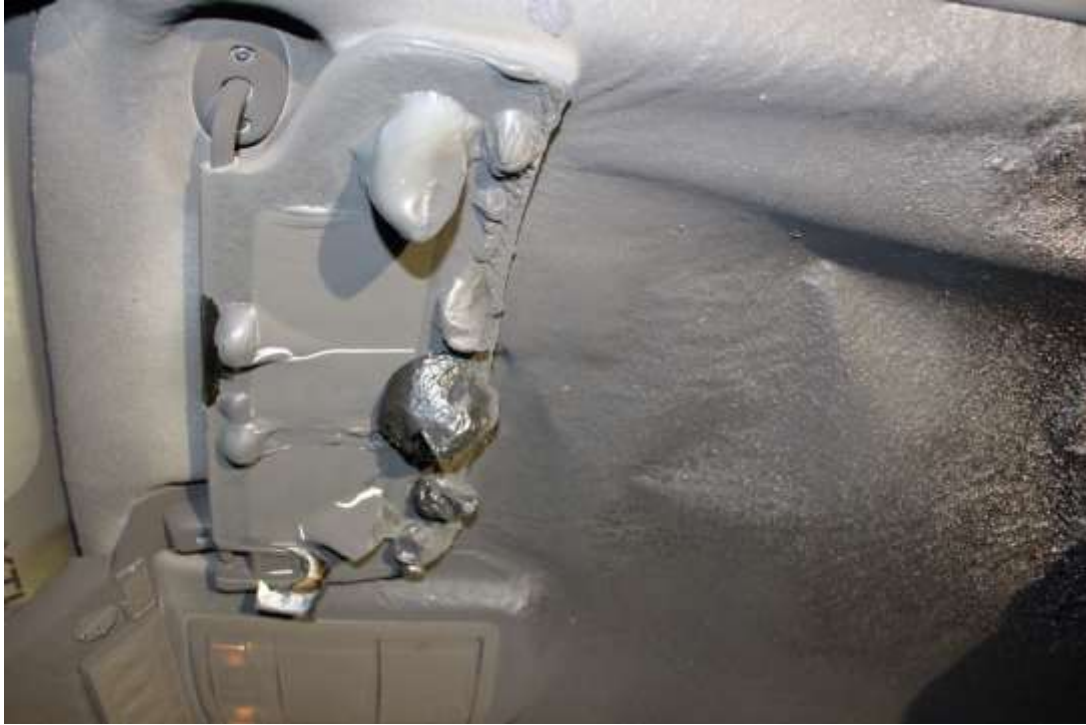
Head damage to driver's visor components.

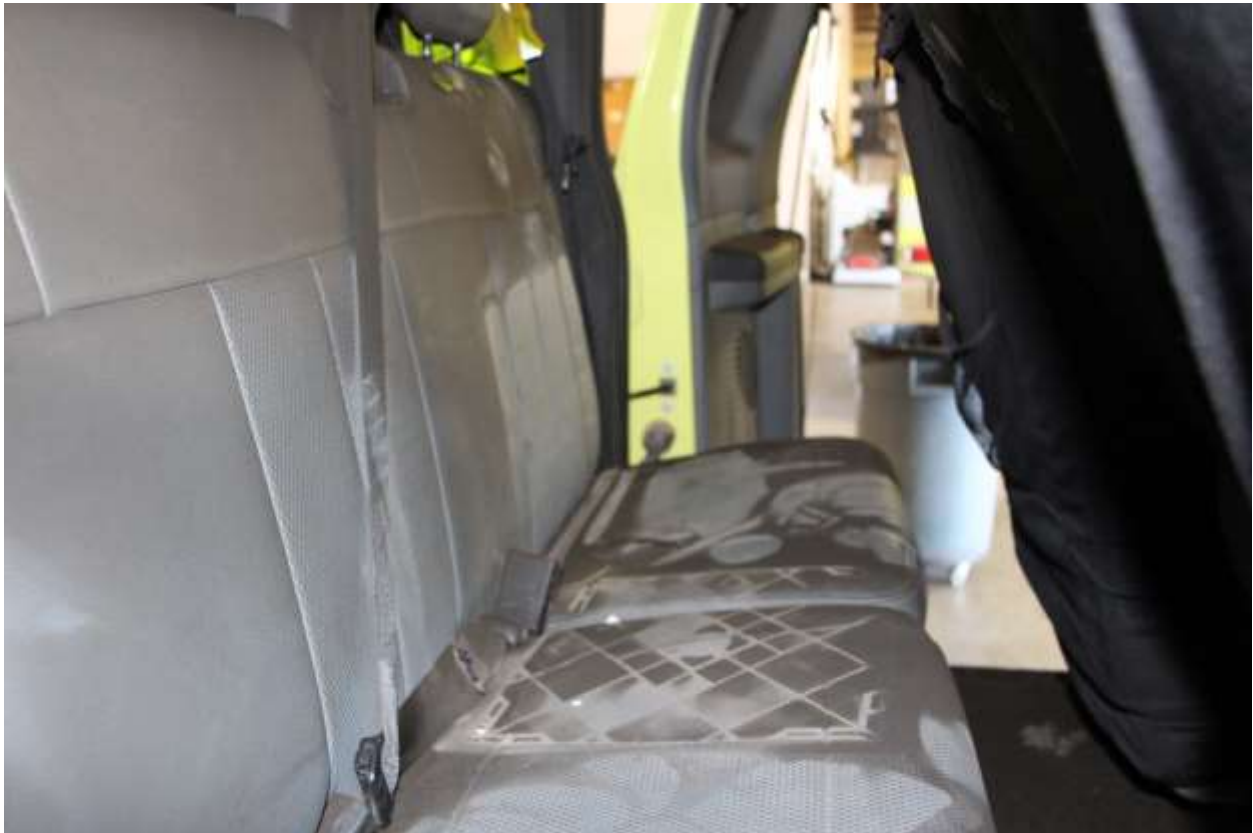
Smoke damage to back seat of cab.

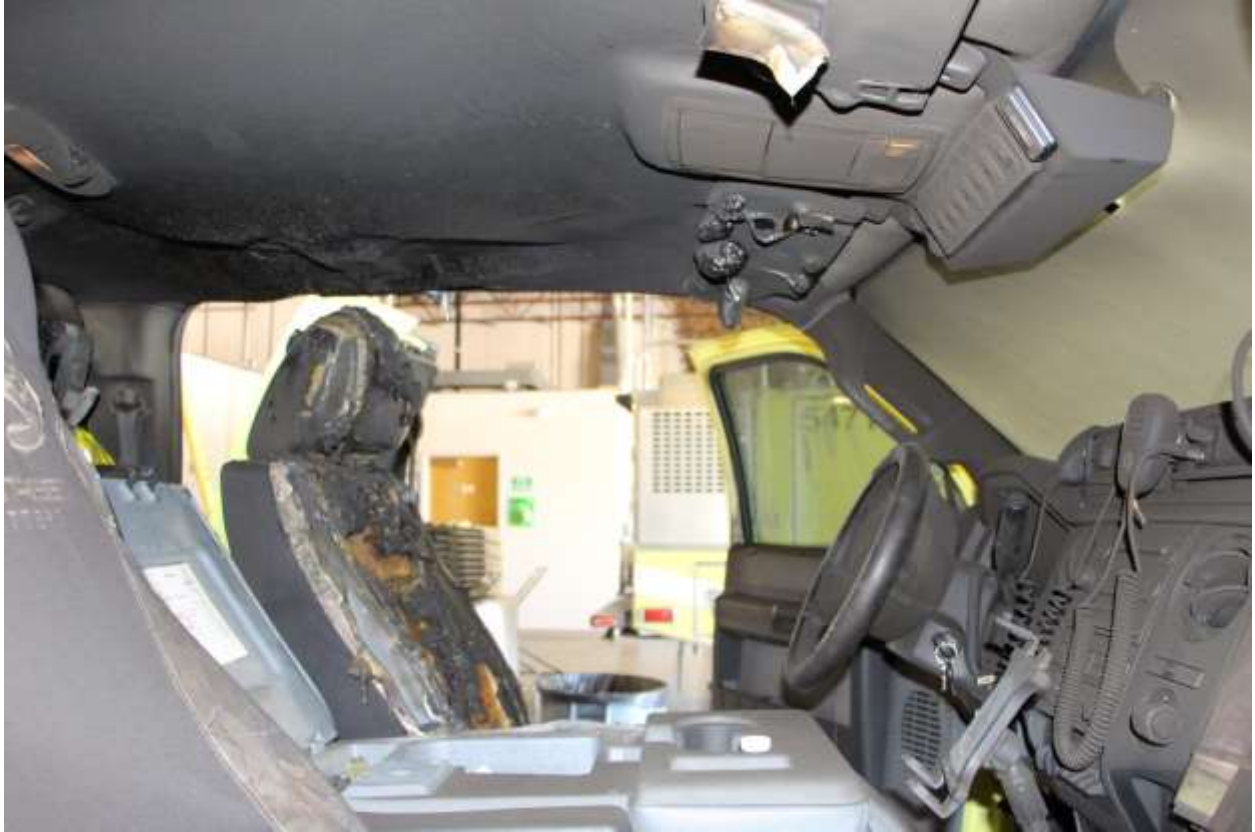
Overall view of cab interior from passenger side of engine.

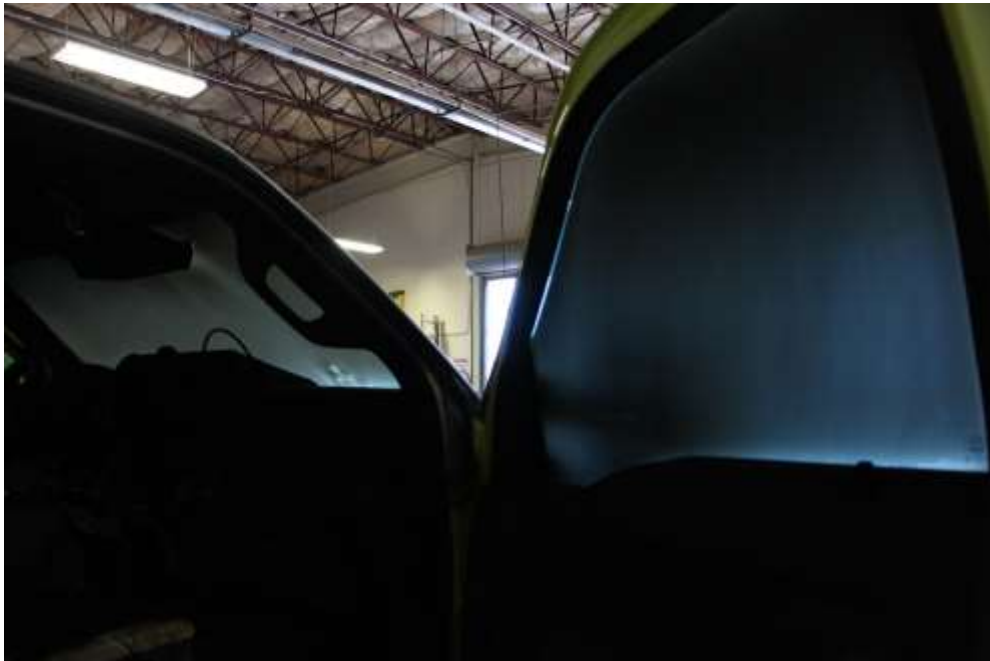
Cab windows blackened with smoke.

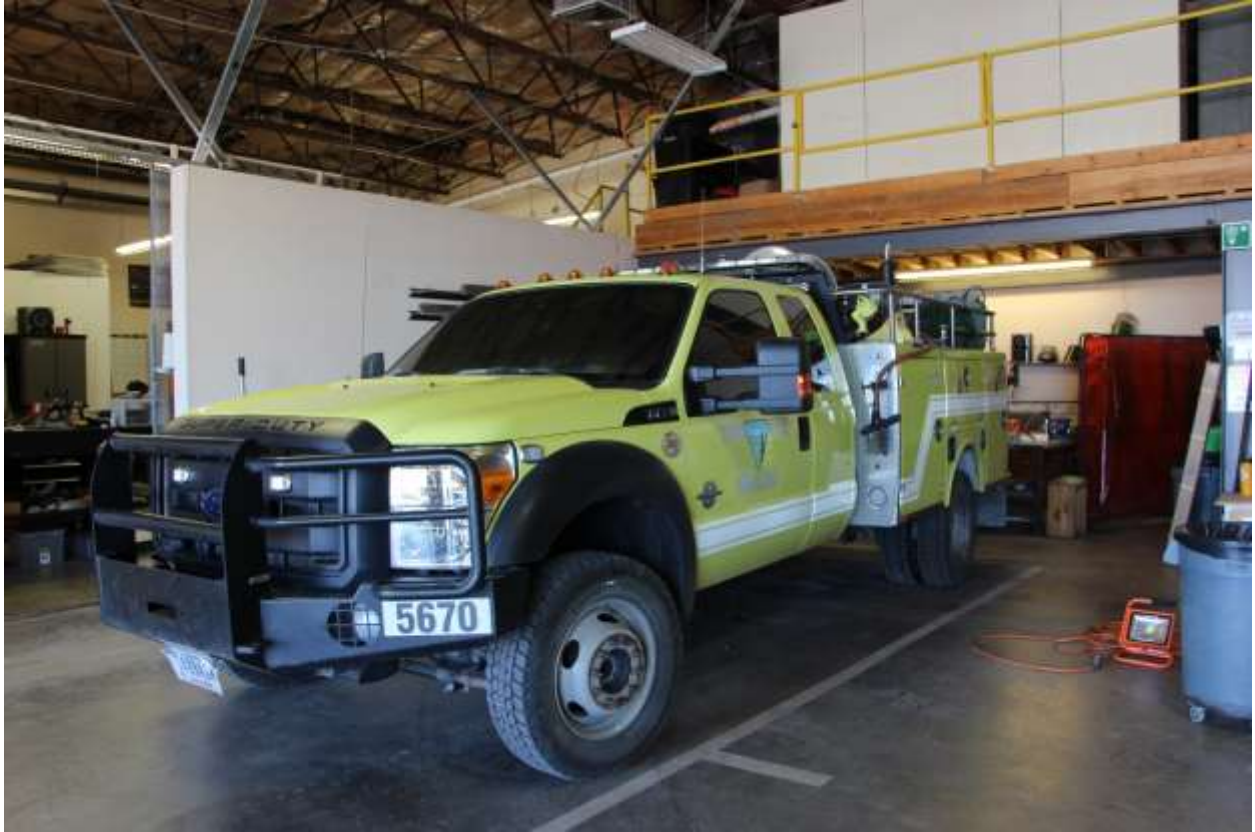
Undamaged exterior of fire engine.
