## Causal investigation: catastrophic engine failure in underground coal mine

- **Incident date:** 4 July 2017
- **Event:** Catastrophic failure of diesel engine system
- **Location:** Wongawilli Colliery, Wollongong, NSW

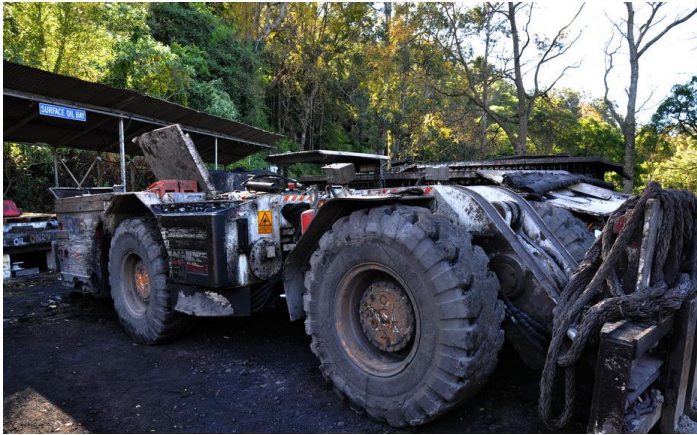
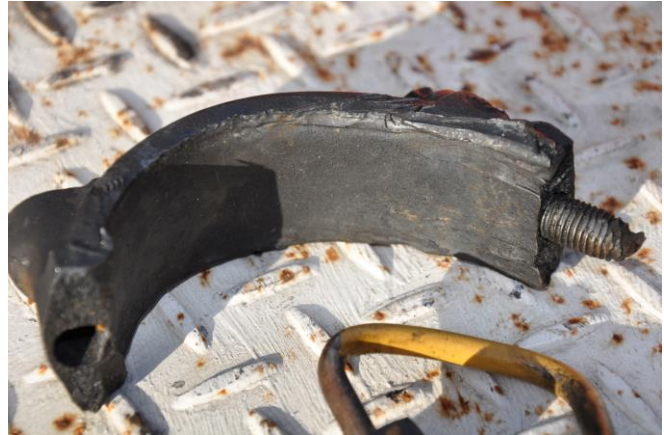
The incident occurred on 4 July 2017, and involved the failure of an unloaded Bucyrus 3126DITC engine, operating in the main intake airway. The failure caused internal engine components, such as the conrod cap, to be exited from the engine block, exposing the mine atmosphere to the high-temperature engine components and possibly the combustion chamber. No person was injured as a result of the incident.

**Engine failure:** The FBL10 involved in the incident (left), and internal engine components (right). Photos: Resources Regulator.

A scene preservation notice was issued to enable the plant to be removed off-site for inspection by an independent assessor. A preliminary investigation indicated a damaged oil supply pipe, possibly as a result of or as a precursor to, a big-end conrod damaging the engine block. The focus of the causal investigation will centre on the exact causes of the failure.

- mine operators ensure maintenance of diesel engine systems and inspection and testing of the safety related controls be carried out in accordance with the vehicle and the engine manufacturers' recommendations
- when designing explosion-protected diesel engine systems, it is essential that consideration of the likelihood for a rare malfunction be given in the design ignition risk assessment. Refer to [MDG 43 Technical Standard for the design of diesel engine systems for use in underground coal mines](#).
