CAUSAL INVESTIGATION

# Catastrophic engine failure in an underground coal mine

Title: Causal investigation: Catastrophic engine failure in underground coal mine

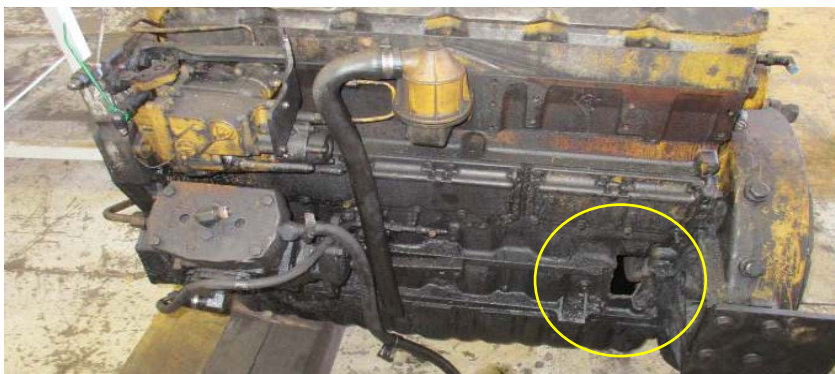
In the early hours of 4 July 2017, the Caterpillar 3126 DITA engine in the FBL10 (the engine) catastrophically failed in the main intake airway of the mine. The failure caused internal engine components, including the connecting rod end cap and fragments of the piston skirt to be ejected from both sides of the engine block (adjacent to No 6 cylinder bore).

**Figure 1: The hole in left rear of cylinder block (circled below) after the parts were ejected from it.**

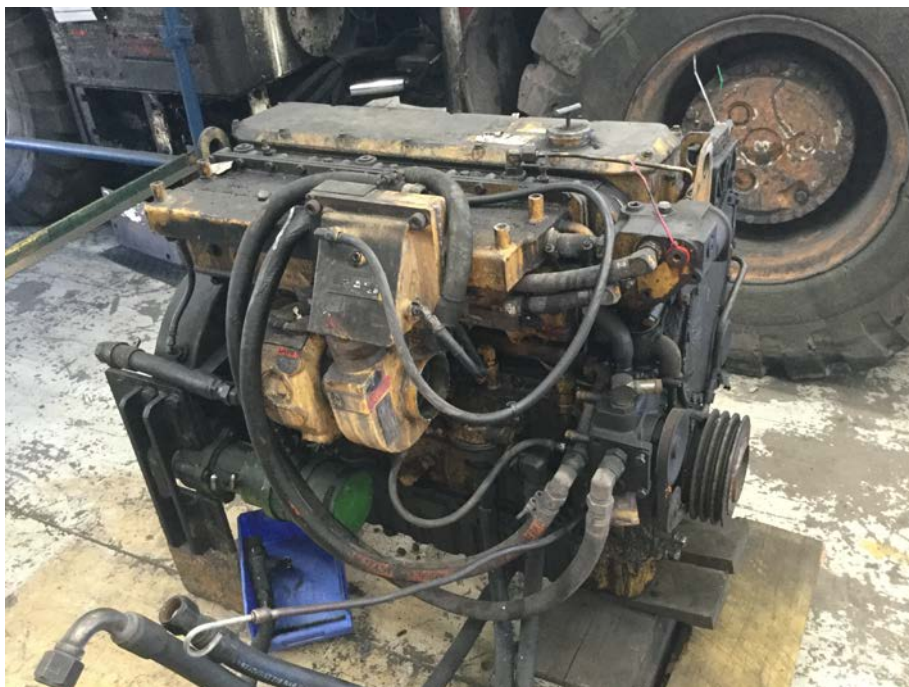
**Figure 2: Engine from FBL10.**

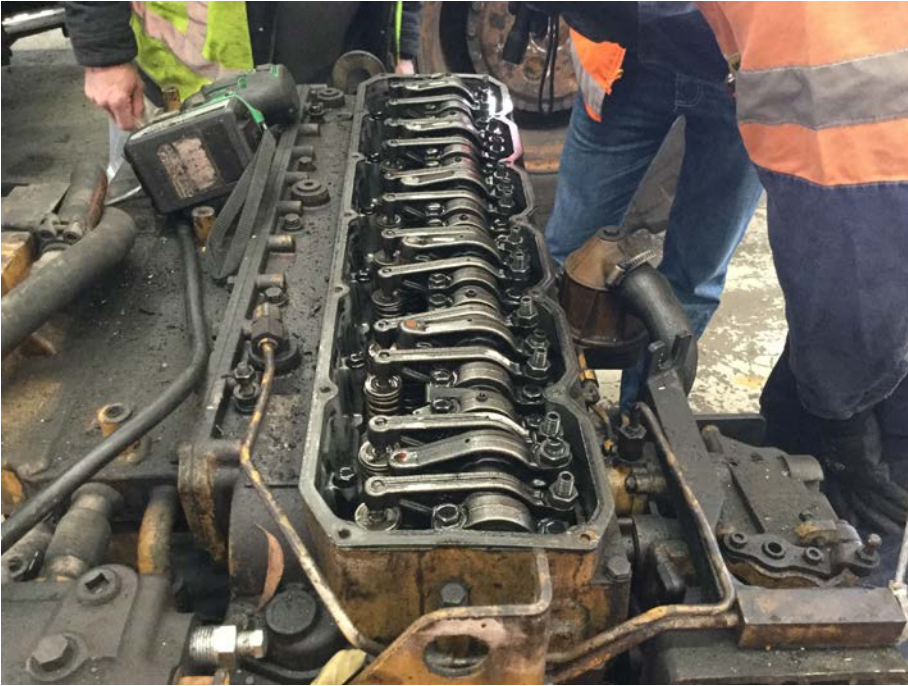
**Figure 3: Rocker cover removed to access valves and fuel injectors.**

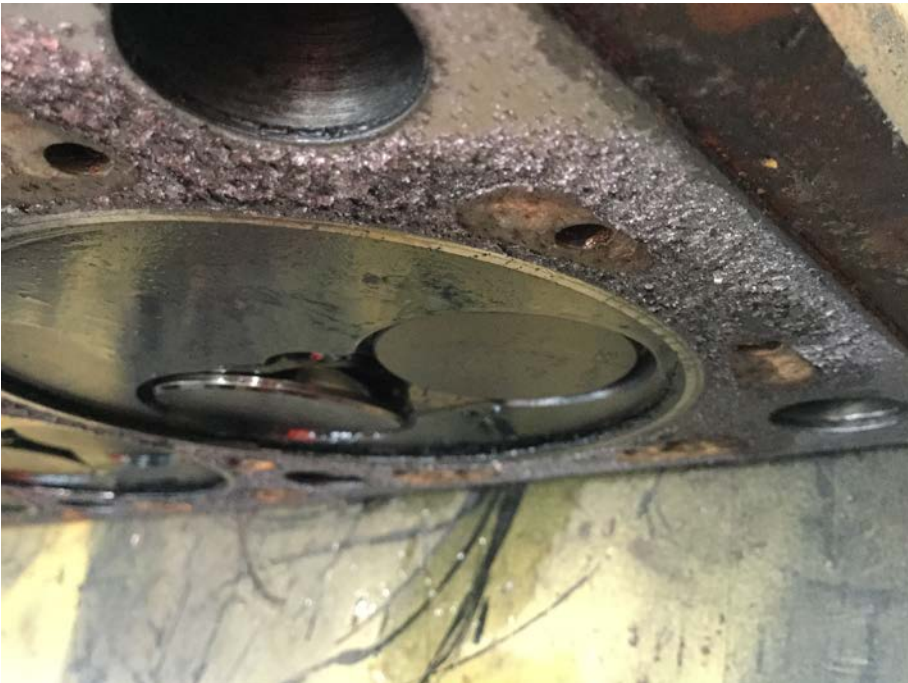
**Figure 4: Valve head from No 6 is not seated indicating bent valve shaft.**

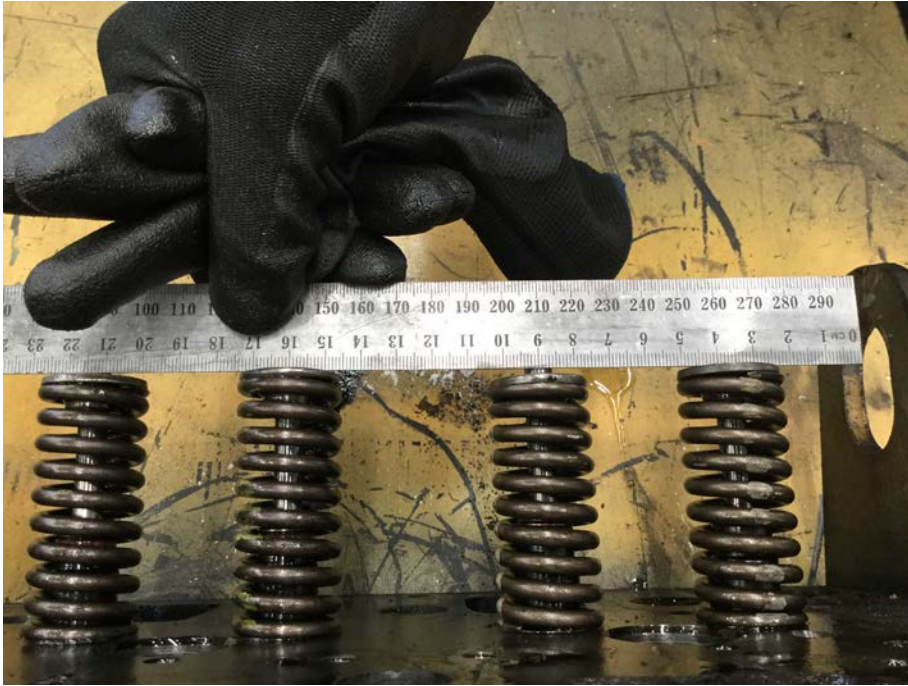
Figure 5: Valve second from left shorter than others due to bent shaft.

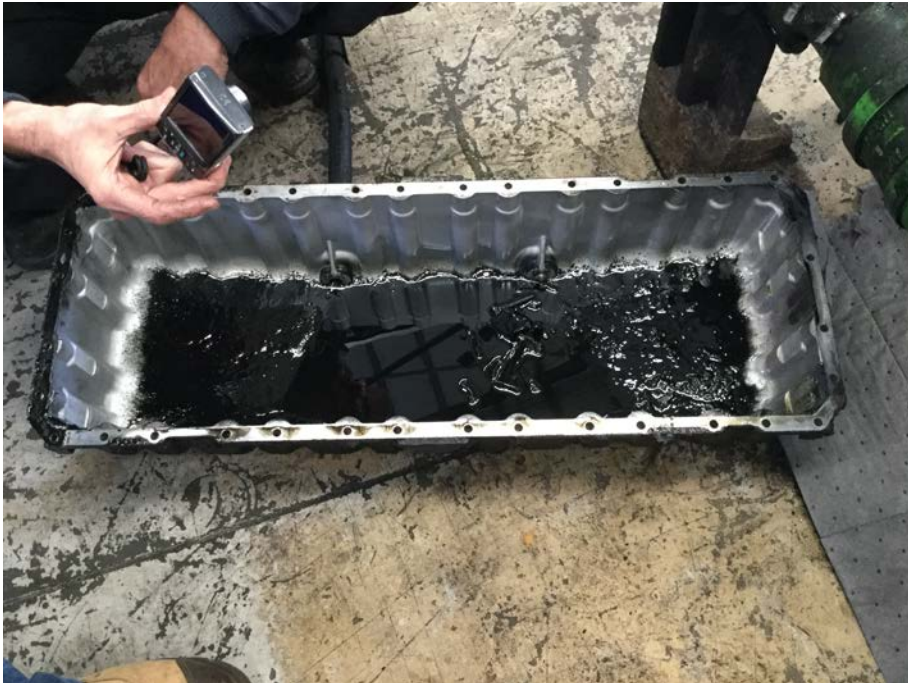
Figure 6: Debris found in sump (fragments of the piston skirt and conrod bolts).

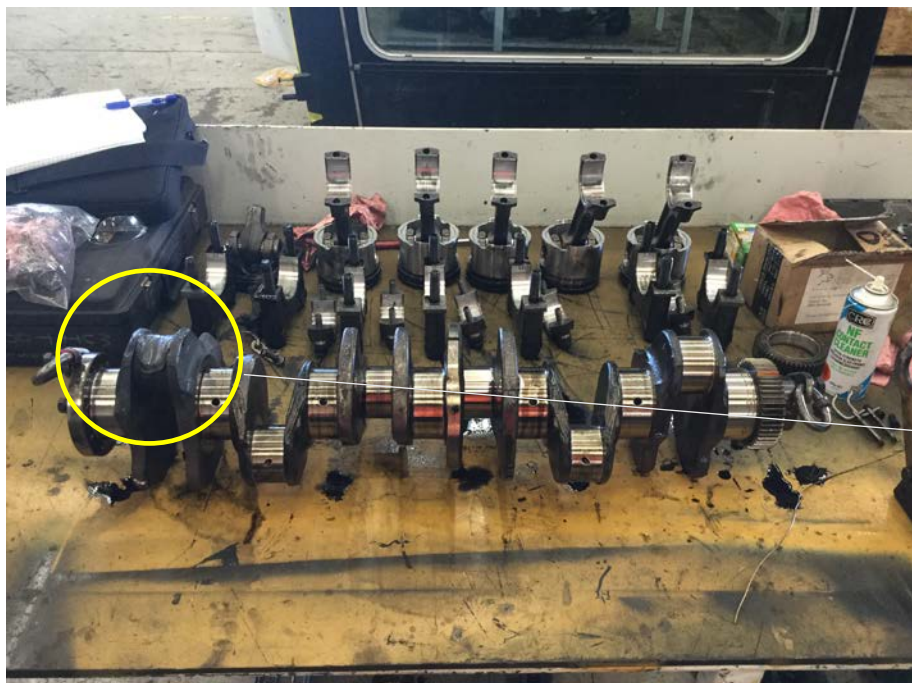
**Figure 7: Crankshaft, main bearings caps and pistons complete with conrods (1-5) on bench. Can see No 6 blackened bearing journal.**

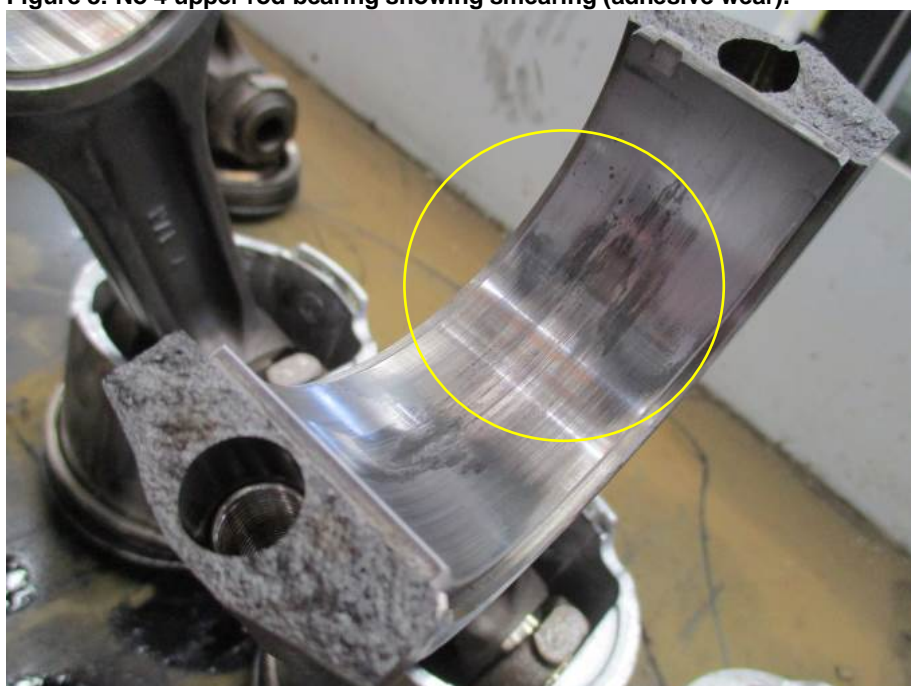
Smearing is adhesive wear and smearing on bearings indicates that there has been a system problem at some time that produced marginal lubrication to the bearing. The No 4 rod bearing showed signs of adhesive wear with corresponding discoloration on the crankshaft journal. This typically is a lubrication-related issue.

**Figure 8: No 4 upper rod bearing showing smearing (adhesive wear).**

*wear on No 4 rod bearings may indicate the root cause of the failure of No 6 rod bearings, as adhesive wear is a precursor to bearing failure.*

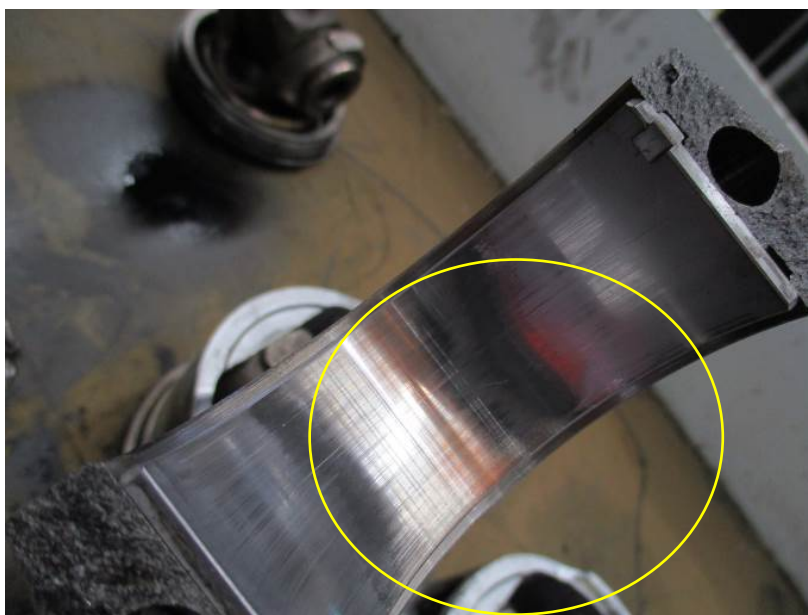
Inspection of the remaining five upper rod bearings showed that the copper bonding layer was visible, which is typically indicative of fine debris wear.

WesTrac advised the causal investigation team that the lead-tin overlay on the bearings was 1/1000 of an inch thick. The copper bond layer was 1/10,000 of an inch thick. It is only when abnormal abrasive wear occurs that the lead tin overlay bearing will display a copper color. This could indicate there has been abnormal abrasive wear created by oil with debris in it. The copper bond layer that can be seen in figure 9 indicates that the top two layers have been worn through.

**Figure 9: Upper rod bearing No 5 showing a copper bonding layer often associated with fine debris damage.**

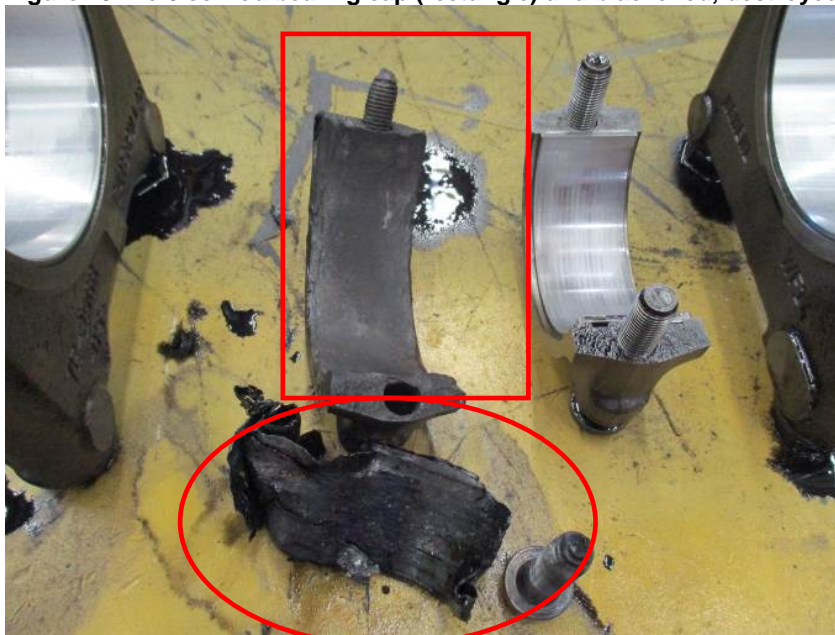
The recovered No 6 rod bearing cap was found to be black in color indicating excessive heat.

**Figure 10: No 6 conrod bearing cap (rectangle) and blackened, destroyed No 6 bearing shell (oval).**

*Failure of the No 6 rod bearing is typical of a marginal lubrication failure. Marginal lubrication can be classed as an oil quality or oil quantity related failure. The extent of the damage to the No 6 rod and bearing components makes it impossible to determine the cause. Observation of the remaining bearings did note fine debris damage to the upper rod bearings and some adhesive wear on the No 4 rod bearings. The adhesive*

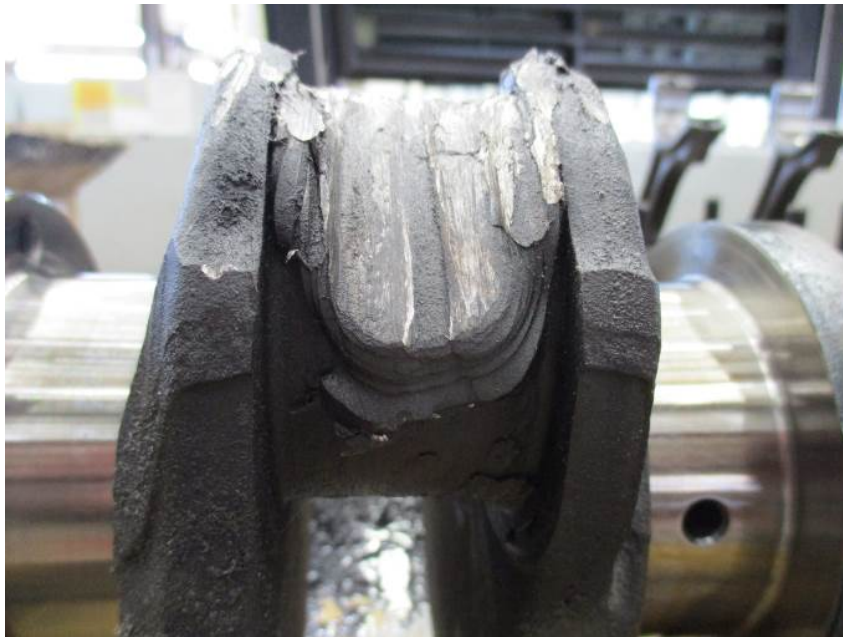
**Figure 11: No 6 rod journal became so hot that impact with the connecting rod caused material flow and left an imprint of rod profile on the crankshaft.**

- no evidence could be found to indicate that the catastrophic engine failure was a result of an engine over-speed event
- molten metal flow does indicate that extreme temperatures were reached, which were clearly above the hot surface ignition temperature of an explosive range methane.

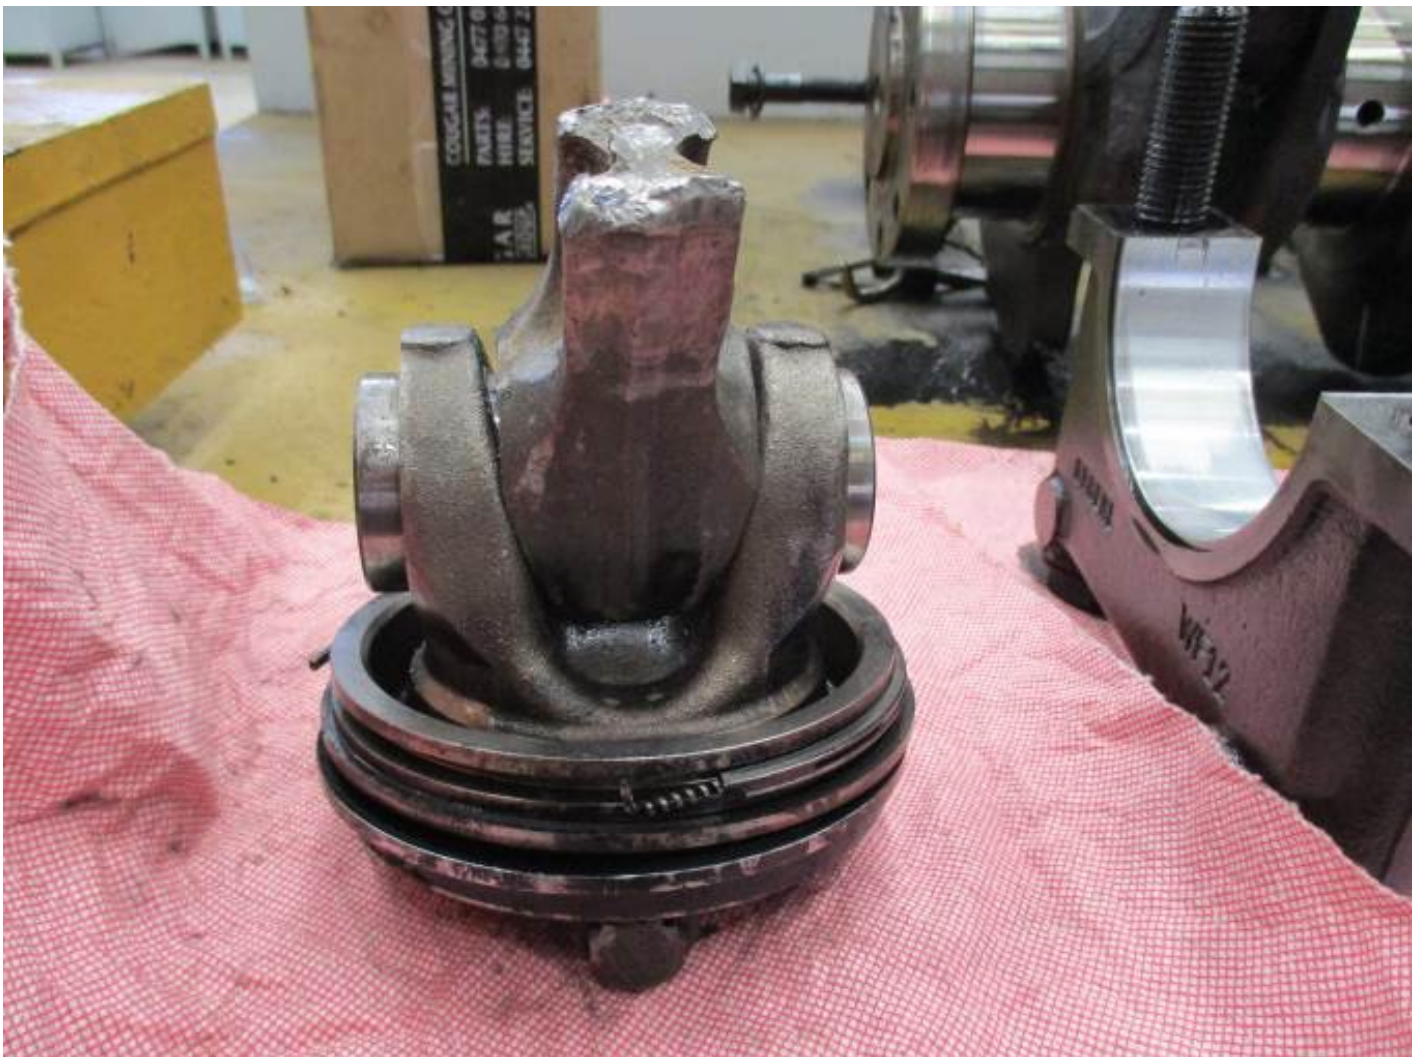
**Figure 12: Piston and wrist pin with remainder of conrod attached (other part never found).**
