CAUSAL INVESTIGATION PRELIMINARY REPORT:

Unintended movement of conveyor boot end unit

- **Incident date:** 29 August 2017
- **Event:** Dangerous incident.
- **Location:** Ulan West Operations, near Mudgee, NSW

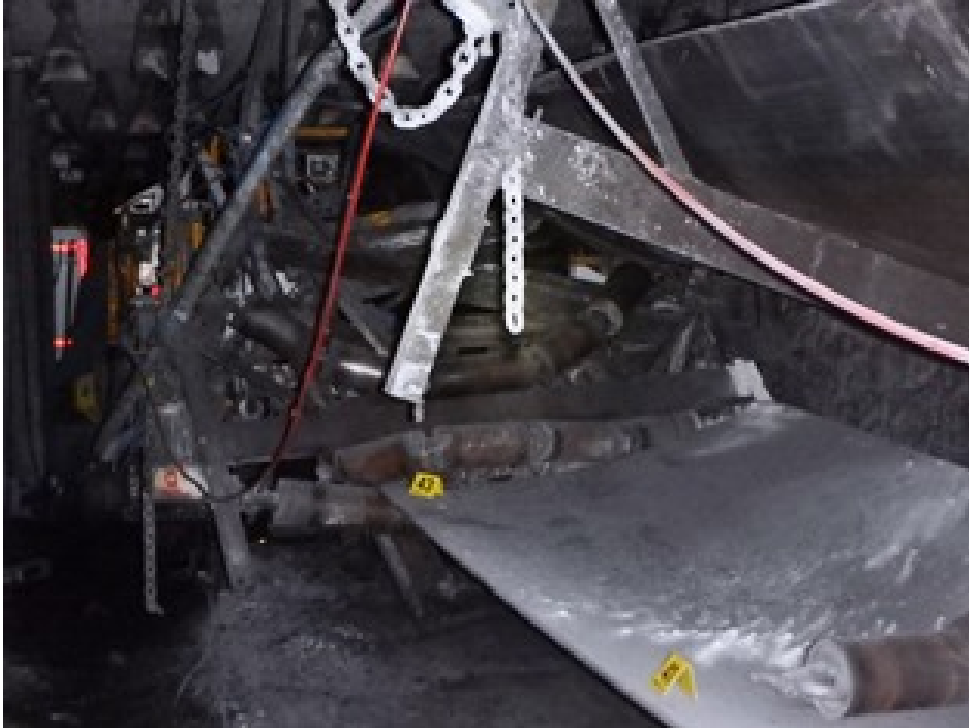
Figure 1: Damaged structure outbye of the tail pulley frame where some of the workers were standing. *Photos supplied by the mine.*

- The boot end was dragged 16.4 m outbye by the belt causing damage to the conveyor structure.

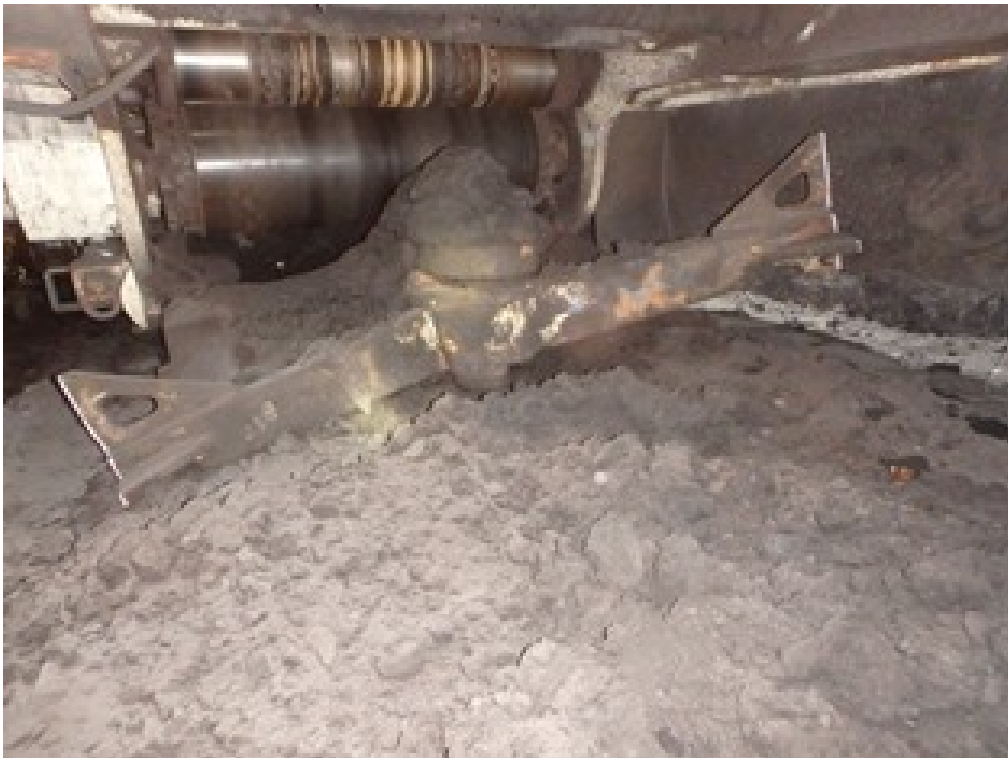
Figure 2: Failed connection hitch looking inbye at the DMU.

- During a scheduled section advance, the FCT/DMU was being advanced when over-tension in the belt caused a failure of the connection hitch between the DMU and the conveyor boot end unit.

The investigation found that an interlock installed (by design) only allows the DMU to advance when the panel belt loop take-up winch is healthy. The parameter *'BeltAdvanceModeEnabled'* in the DMU control system was set to zero (0), which disables this interlock.

3. Recommission the DMU belt system interface and test the logic with the belt system to verify that the DMU will not advance with the correct parameter setting.

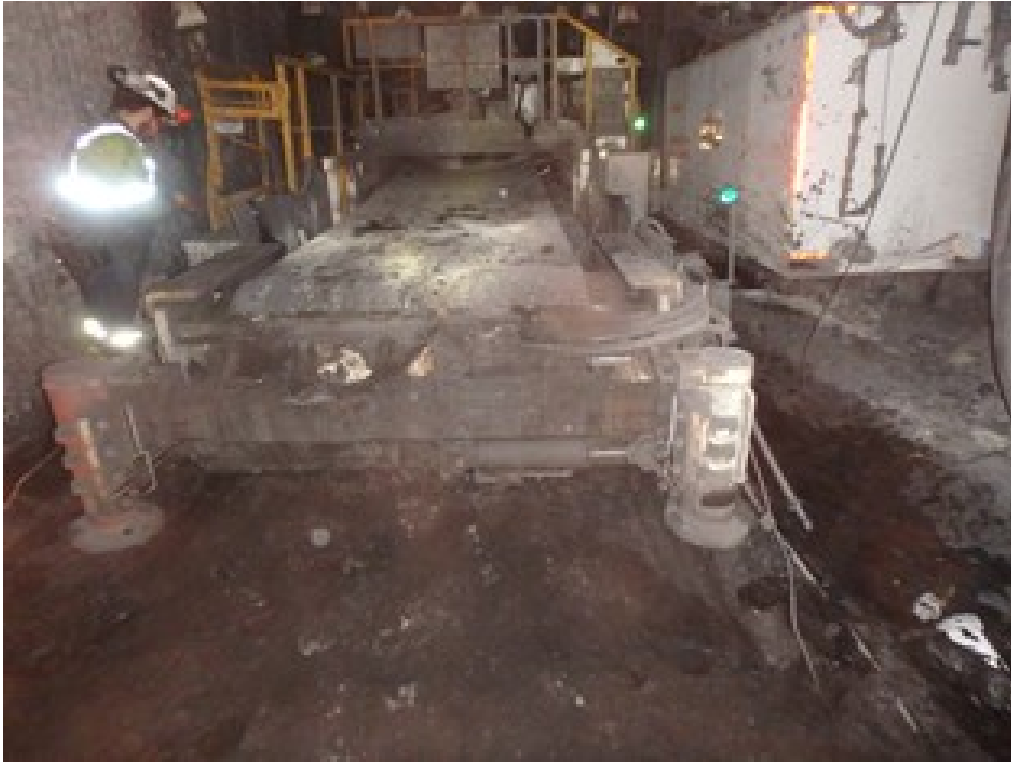
Figure 3: Failed connection hitch where it attaches to the side shift frame on the tail pulley frame.

Note: The distance between the tail pulley frame and the DMU was 16.4 m.
