**UNITED STATES
DEPARTMENT OF LABOR
MINE SAFETY AND HEALTH ADMINISTRATION
Metal and Nonmetal Mine Safety and Health**

REPORT OF INVESTIGATION

**Fatal Exploding Vessels under Pressure Accident
October 2, 2018**

**Empire State Mines
Empire State Mines LLC
Gouverneur, St. Lawrence County, New York
Mine ID No. 30-01185**

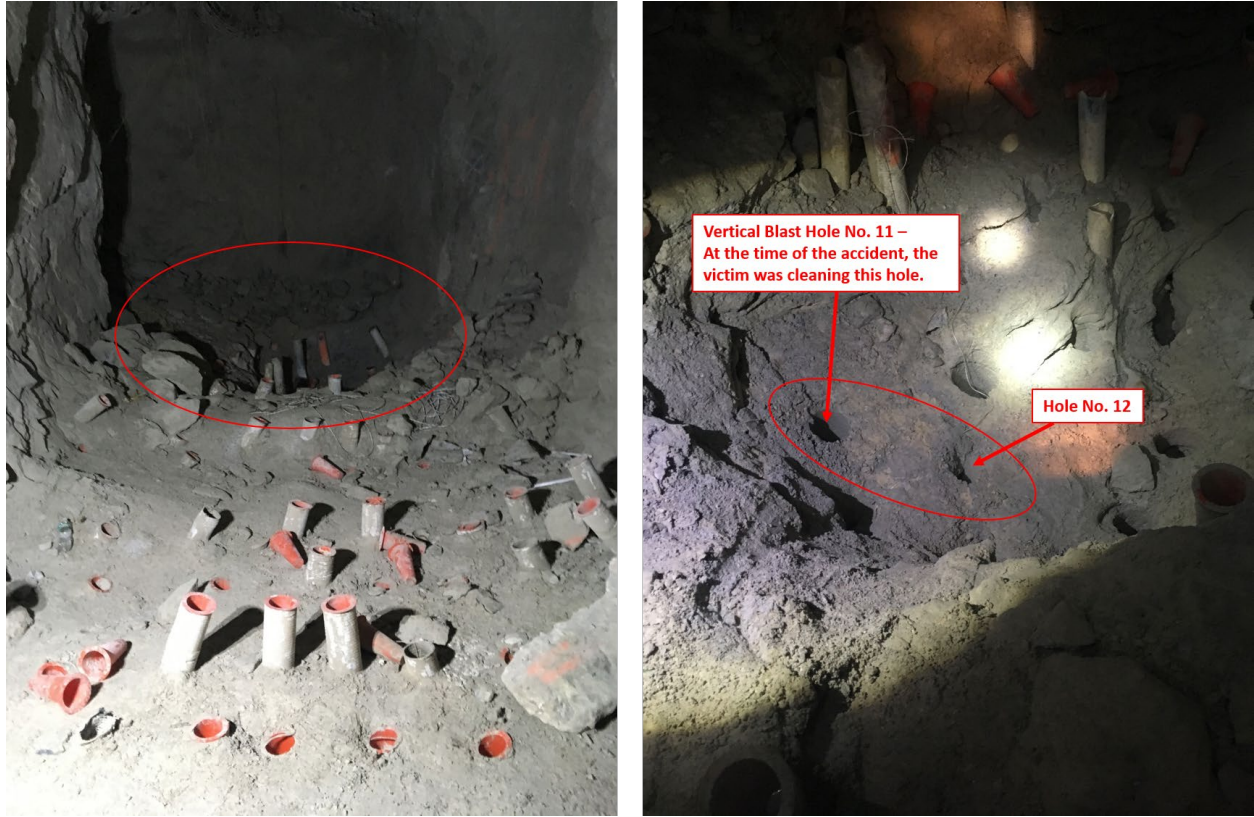
Figure 3 - MP2730 Level - Stope 2805 Development Area - Accident Scene

The accident occurred on the MP2730 level of the underground mine where a vertical stope was being developed to the MP2805 level below (see Figure 3).

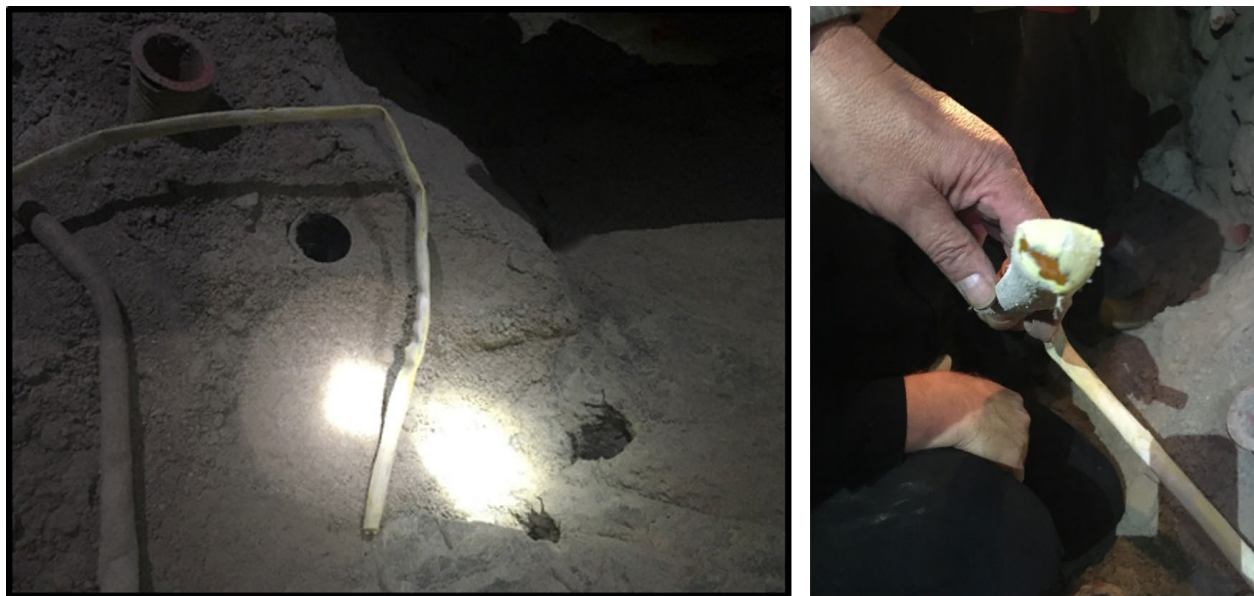
The high-pressure air hose used by the victim to clear the borehole was a high density polyethylene (HDPE) hose used for grouting. The contract employees referred to this hose as the grout line. The 7/8-inch diameter hose had a nominal 3/4-inch internal diameter with a 1/16-inch wall thickness. The specification sheet of the hose listed a working pressure rating of 170 psi and a burst pressure rating of 820 psi. Measurements taken during the investigation showed an approximate pressure of 115 psi at the end of the grout hose. The hose was in a degraded condition with 9 hose splits and multiple kinks in the first 9 feet 4 inches of the hose, as measured from the hose opening (see Figure 4). The hose splits were consistent with a hose burst, as the damage was from the interior of the hose. As shown in Figure 5, the entire working length of the outside of the hose showed very fine, hair-like fibers probably caused by abrasions.

Figure 4 - Photos of Grout Line Used by the Victim (Note: Damaged End)

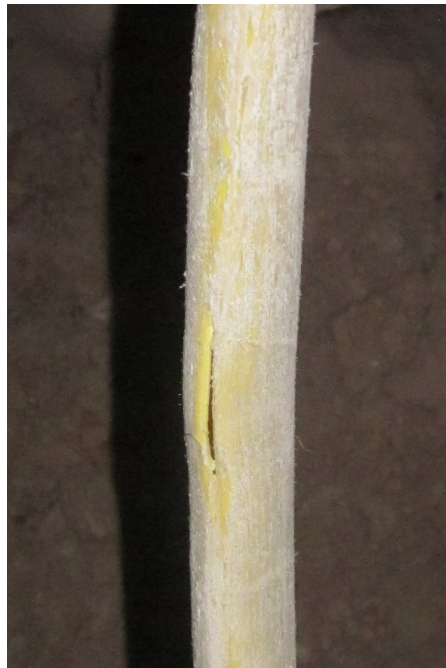
Figure 5 - Photo of grout hose showing a split, abrasions, and fine fibers.

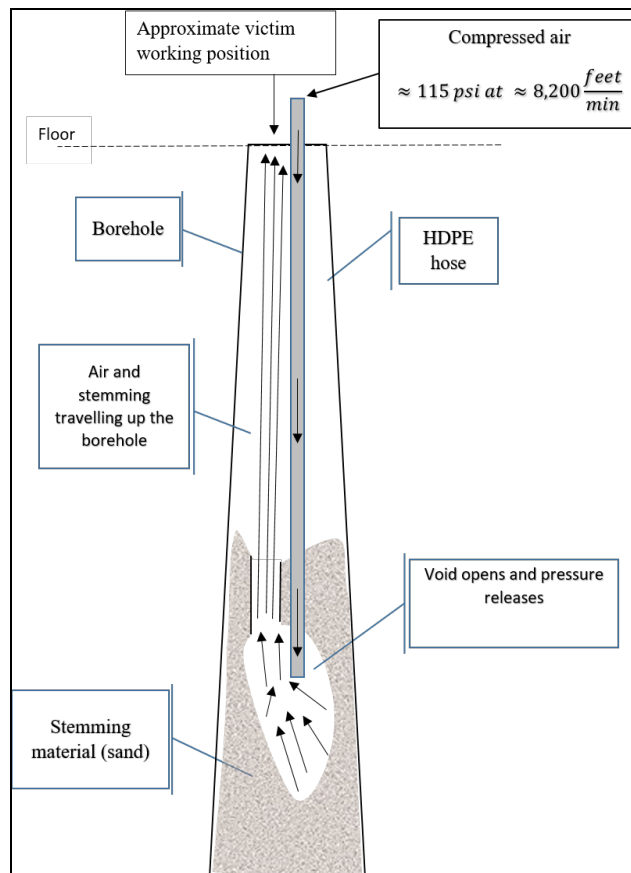
Interviews indicated one 50-pound bag of sand was used as stemming in each borehole, which Major Drilling Underground claimed would fill about 10 feet of a drilled hole. The No. 11 drill hole was a wet borehole and would have caused the sand to bond together, making it harder to clean out the hole. After reportedly blowing out approximately 3 feet of material, the contractor encountered a blockage. As the grout hose was pushed through the blockage, a pressure void was filled with the compressed air until it could no longer be contained (see Figure 6). When the air released, a column of stemming was thrust to the surface of the borehole. This evacuation of air and stemming material struck the contractor foreman, who was in close proximity to the borehole opening, causing fatal injuries. No evidence of residual explosive material was found in the hole.

Root Cause: Contract management did not ensure adequate procedures to protect persons working with compressed air while cleaning out an obstruction in a vertical drill hole, including positioning of personnel during this process.

Figure 6 – Schematic Showing Pressure Release Propelling Stemming from No. 11 Hole.

Corrective Action: The contractor developed a plan and procedures and then trained employees on the new plan with procedures for cleaning previously blasted vertical drill holes when an obstruction has been encountered. This plan addresses safe work procedures and where personnel are to be positioned during the various phases of drill hole cleaning process.
