Week ending 8 November 2017

This incident summary provides information on reportable incidents and safety advice for the NSW mining industry. To report an incident to the NSW Resources Regulator: phone 1300 814 609 24 hours a day, 7 days a week.

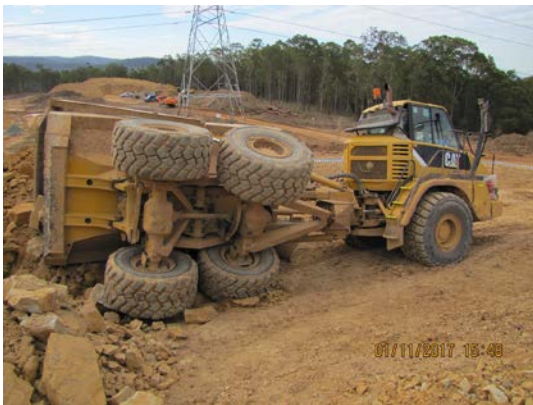
Incident type	Summary	Recommendations to industry
Dangerous incident SinNot-2017/01775	<p>An articulated dump truck rear body rolled onto its side. The operator began tipping a load of rock and saw in his mirror that the second row right hand wheel was coming off the ground. The operator released the hoisting lever and the rear body of the truck rolled over.</p> <p>The cross grade was measured at 1:5. The truck was involved in building an access road.</p>

<ul style="list-style-type: none"> • Tipping areas need to be level without cross grade. • Use level sensors to alert an operator or prohibit tipping on uneven ground. • Ensure that tyre pressures are correct and suspension systems are in good condition. • Tipping areas should be stable and capable of withstanding the truck wheel pressures and should not be prone to subsidence. <p>Refer to: SB17-01 Industry reports more truck rollover incidents SA03-01 Articulated dump truck rollovers</p>

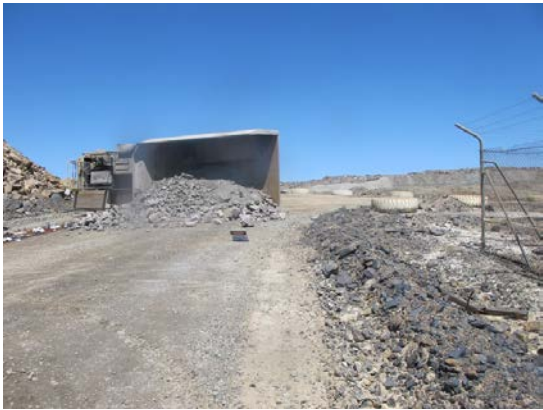
<p>Dangerous incident SinNot-2017/01773</p>	<p>An operator drove a truck out of the pit and in the process of turning the truck around, the truck rolled over. No injuries were reported.</p>

<ul style="list-style-type: none"> • Trucks should be travelling at appropriate speeds when doing U-turns. • Turning areas should be flat with minimal cross grade. • Ensure tyre pressures are correct and suspension systems are in good condition. • Operator practices should be periodically checked. <p>Refer to: SB17-01 Industry reports more truck rollover incidents</p>
<p>Serious injury SinNot-2017/01770</p>	<p>Two fitters were changing a strut on a mining truck. After completing the work, they began replacing the hub. It was unsecured during this process and came loose. The hub struck one fitter, fracturing his arm and dislocating his knee cap.</p>

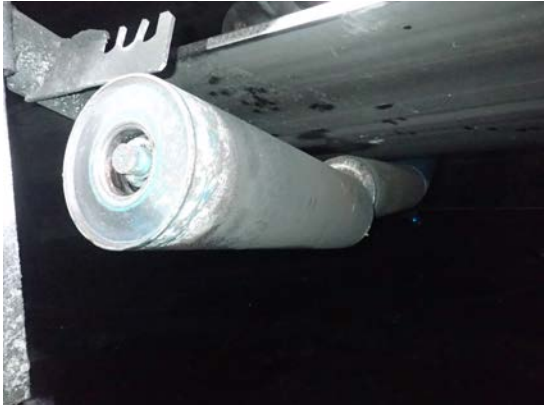
<p>engine and put the fire out with a hand-held extinguisher. There was residual oil in the turbo lagging, which was soaked in oil and the fire reignited. The operator put it out again with the fire extinguisher.</p> <p>There was a loose fitting on the poly-steel braided turbo feed line to the o-ring connection. This was the oil that soaked the turbo lagging. There was mid-life maintenance carried out on the engine about three days previously.</p>	<p>failures.</p> <ul style="list-style-type: none"> Where practicable, hoses should be segregated from hot surfaces using hard barriers along with the use of non-flammable coolants. <p>Refer to: <i>AS 5062:2016 Fire protection for mobile and transportable equipment.</i></p>
<p>Dangerous incident SinNot-2017/01753</p>	<p>A fire occurred on a collapsed conveyor return idler on the main truck belt in an underground coal mine.</p> <p>The outbye deputy smelled smoke and went with another deputy to identify the source. They found fines burning under the collapsed return idler. They put stone dust on the fire, which flared it up. The deputy then went and got a water hose to extinguish the fire.</p>

<ul style="list-style-type: none"> Ensure conveyor idlers are designed with the appropriate life for the intended duty. Install carbon monoxide monitoring or particulates of combustion sensors to assist in the early detection of a fire. Use appropriate trigger action response plans. Ensure that a water source is readily available to quickly extinguish a fire. Check defected conveyor idlers in a timely manner and carry out conveyor inspections regularly. Consider the recommendations in MDG 1032 and AS/NZS 4024.3611 <p>Refer to:</p> <ul style="list-style-type: none"> Mechanical engineering control plan code of practice MDG 1032 Guideline for the prevention, early detection and suppression of fires in coal mines <i>AS/NZS 4024.3611 Safety of machinery, Conveyors – Belt conveyors for bulk material handling is incorporated into the mechanical engineering control plan code.</i>

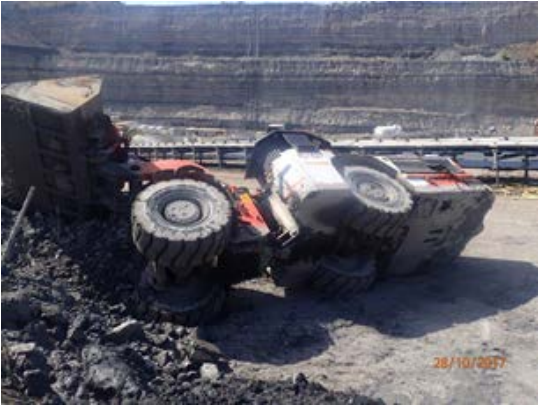
<p>room that had an operator inside.</p>	
<p>Dangerous incident SinNot-2017/01751</p>	<p>A load haul dump (LHD) vehicle, was preparing to dump a load of shot-fired roof material at a nominated surface dump. The LHD travelled up a ramp and turned into the dump site, placing the LHD across the grade of the ramp. Approaching the dump site, the operator began raising the bucket. He brought the LHD to a stop and continued raising the bucket to full height to allow him to tip the load. The operator felt the front off-side (down dip) of the machine subside then the machine tipped over/rolled until the bucket and boom of the machine stabilised on the muck-pile. The operator assessed his position and determined a safe exit from the cab. He climbed over the door and down the top of the machine on the low side then reported the incident.</p>

<ul style="list-style-type: none"> • Articulated loaders should not be tipping on a cross grade when the bucket is lifted and the machine is articulated. • Pads and areas where LHD-type vehicles are required to tip should be checked as being suitable by a supervisor. • LHD vehicles should be operated within the OEM specified limits, including tipping lines for stability. • Training packages should be reviewed for all machinery to ensure that it includes the limitations of the machine. • Seat constraints fitted must be worn.

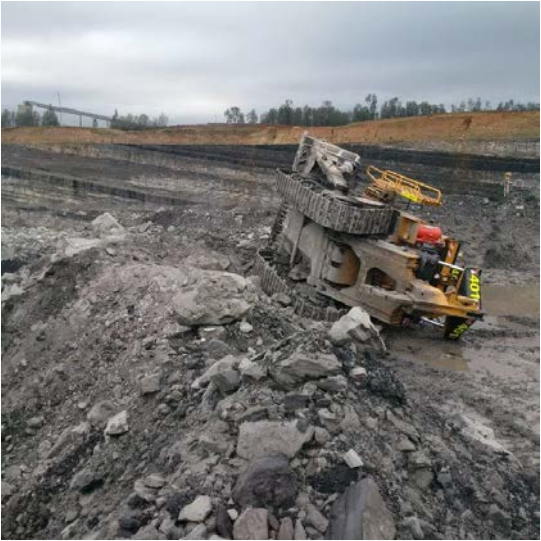
<p>approximately 4 m. Upon reaching the crest of the rill, the operator steered the dozer to the left as it drove over the windrow on the edge of the bench. The right hand track sank into the loose material, causing the dozer to roll onto its right hand side. The operator was uninjured and was able to safely exit himself from the cab and raise the alarm. He was wearing a seat belt at the time of the incident.</p>

<ul style="list-style-type: none"> • Dozer operators should carry out an inspection of an area before entering as part of their personal risk assessment. • Dozer operators should always wear seat belts. • Consider tilt alarms to alert operator when excessive cross grades occur. <p>Refer to:</p> <p><u>MDG 28 Safety requirements for coal stockpiles and reclaim tunnels</u></p>
<p>Dangerous incident SinNot-2017/01741</p>	<p>An operator of an underground LHD was pushing an auxiliary fan around a corner when it rode up on a cable boat frame. This put the fan up on one wheel. The operator stopped pushing and tried to pull the fan back off the cable boat. During this, the fan rolled onto its side.</p>
