REPORT OF INVESTIGATION

Fatal Equipment Fire Accident  
September 7, 2018

Bear Run Mine  
Peabody Bear Run Mining LLC  
Carlisle, Sullivan County, Indiana  
ID No. 12-02422

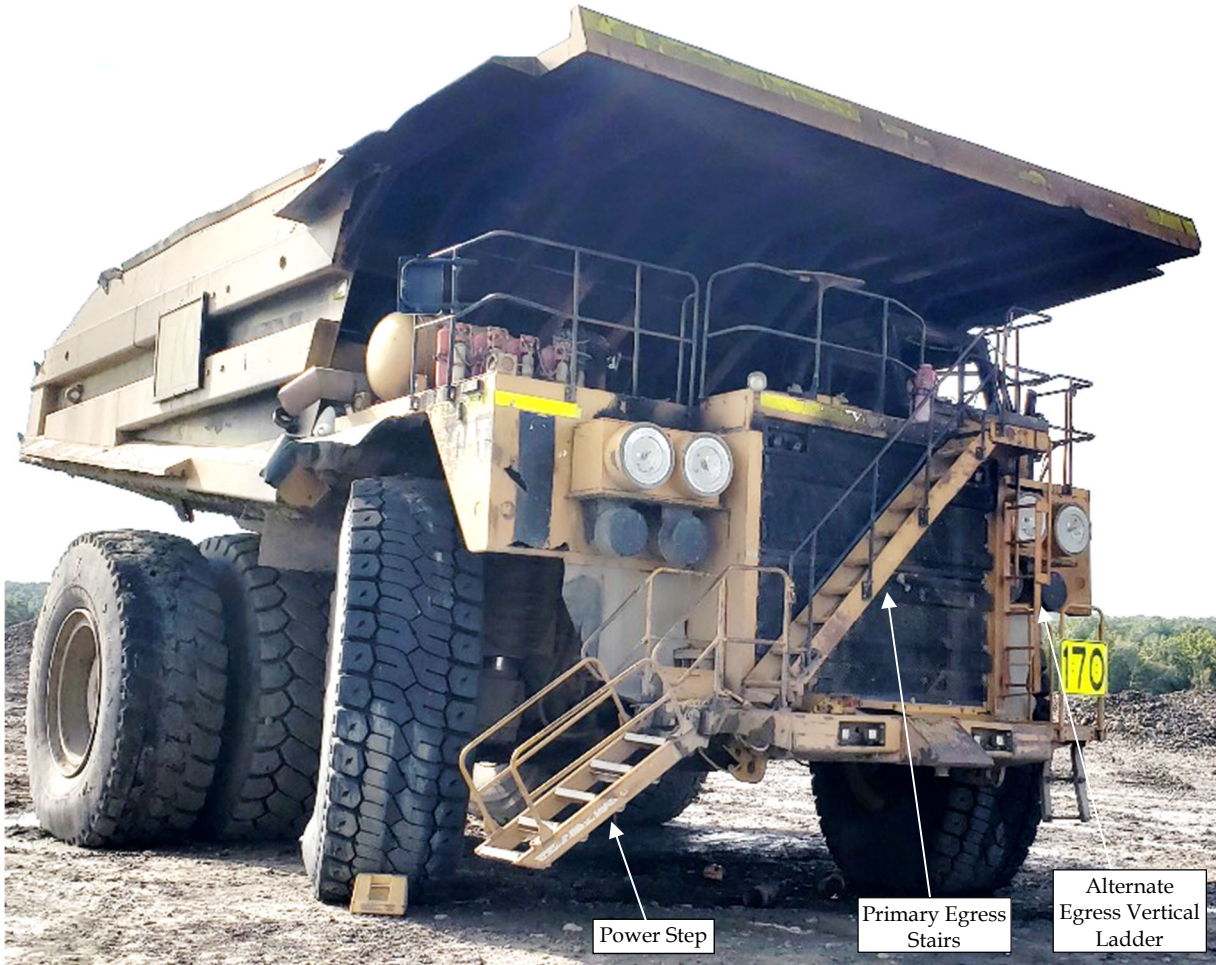
APPENDIX B  
Company Truck 2-170 with Power Step Lowered

A folding stairway -- Power Step model number TS793C2 -- had been installed to provide safe access to the ground from the end of the primary stairs, which ended more than 5 feet above the ground (see Appendix B). The electro-hydraulic unit was powered by the truck's battery and controlled by switches at the top of the stairway and at ground level.

Tests and visual observations of the step assembly concluded that the electro-hydraulic unit itself was functional but the power supply cable had sustained fire damage. It is likely that fire damage to the power supply cable caused the unit to malfunction when Grostefon tried to use it.

The hydraulic system had an internal leak which allowed the stairs to drift down when not latched, which explains why it was found by investigators in the fully lowered position even though a witness reported that it had been stuck halfway during the accident. A manual release intended to lower the folding stairs when electrical power was lost was inoperable because the pull rod was broken off inside the power unit housing.

A fuse that should have been installed inside the haul truck's battery box to protect the electrical wiring from damage due to excessive current, per the Power Step installation manual, had not been installed.

The toggle switch, located at the top of the folding stairs, used to lower and raise the stairs was labeled incorrectly, reversing the up and down functions. Also, the ground level switch, which was designed to be mounted on the top of the front bumper, was found stuck between the platform frame and the front bumper.

Corrective Action: The mine operator removed all of the Power Step boarding ladders from the Caterpillar 793 end dumps and replaced them with a fixed boarding ladder that is similar to the one installed by the original equipment manufacturer. The mine operator examined all alternative vertical egress ladders on end dumps and repaired/replaced any deficiencies to make sure they are readily accessible as per the original equipment manufacturer's design. The mine operator has trained miners on the installation, maintenance, and preoperational examination of the alternative egress vertical ladder.

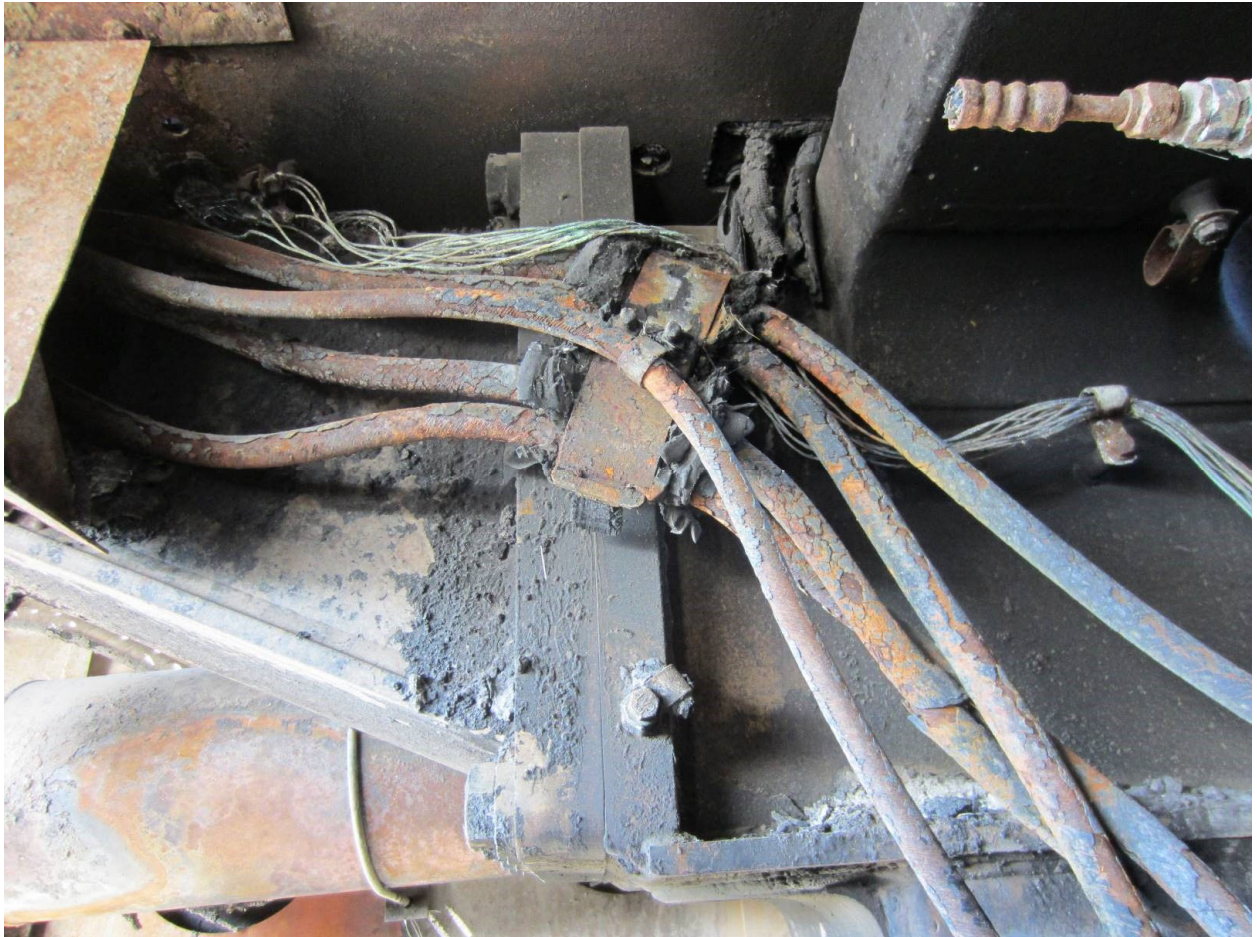
APPENDIX C  
Ruptured Steering Hose

The likely cause of fire was traced to a ruptured steering hose underneath the operator's cab (see Appendix C). The hose, which supplied the primary hydraulic pressure from the steering valve to the steering metering pump, had multiple broken steel wire braids in an area about 1-1/2" by 1-1/2". The interior hose liner also had a hole about 1/8"-inch wide by 1-inch long. Investigators were not able to determine why the hose ruptured.

According to the manufacturer, pressure in the hose can reach 3,100 psi during steering operations. At the time the fire started, the operator would probably have been making a sweeping turn to line up the truck with the dump point location. That turn would have provided full pressure to the hose that failed, possibly causing the rupture and allowing high pressure hydraulic fluid to spray onto the hot surfaces of the engine. This would have resulted in a fast-growing fire.
