# SAFETY ALERT

## Catastrophic failure of auxiliary fan

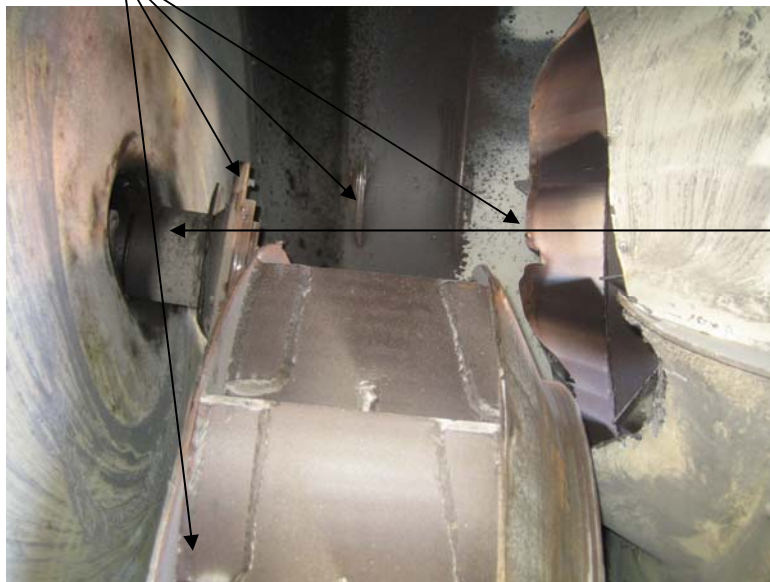
#### Figure 1

*Fan housing impeller damage*

*Bent motor shaft*

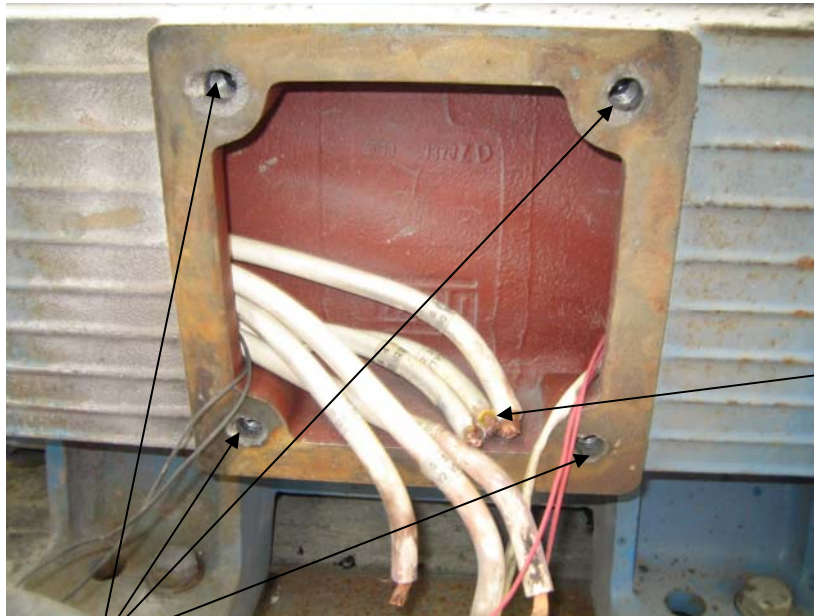
**Figure 2**

*Arcing to motor  
leads as  
connection box  
torn off*

*Four connection box holding bolts torn out of motor body*
