REPORT OF INVESTIGATION

Underground Coal Mine

Fatal Rib Fall Accident
February 6, 2018

Sentinel Mine
Wolf Run Mining LLC
Philippi, Barbour County, West Virginia
ID No. 46-04168

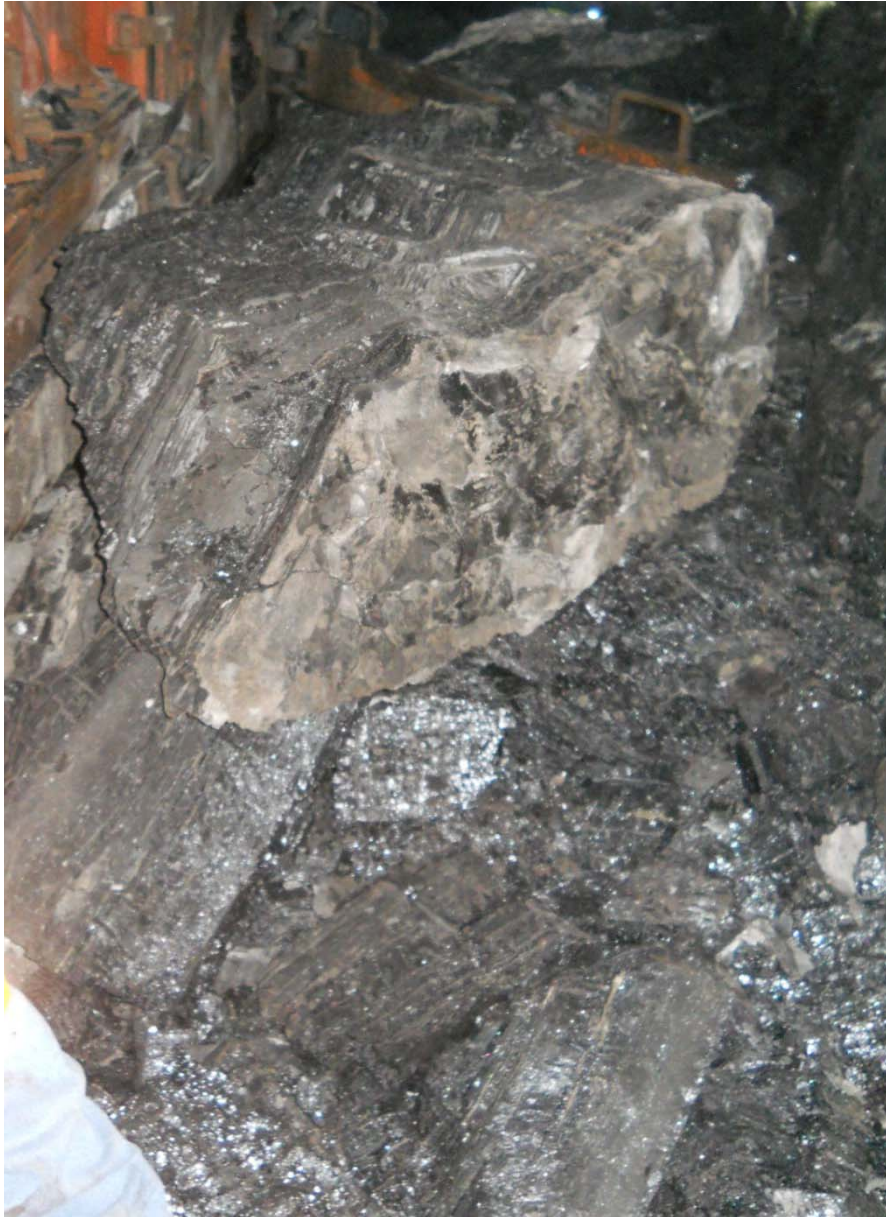
APPENDIX A
Photograph of Piece of Fallen Rib

The fallen rib measured approximately 18 feet long by 7 feet high and up to 14 inches thick. The fallen rib material had a fragmented texture with slabs and blocks of varying sizes. The large portion of the rib removed from on top of Griffith was 36 to 42 inches long by 28 inches high and up to 14 inches thick.

A fatal accident occurred at this operation on February 6, 2018. The solid side rib at the Number 16 crosscut, Number 1 entry of 3-Section, MMU 005, was not adequately supported or otherwise controlled to protect persons from hazards related to falls of rib. A large portion of the rib fell and struck an electrician who was servicing the continuous mining machine, causing fatal injuries. The fallen rib measured approximately 18 feet long by 7 feet high and up to 14 inches thick. The largest piece of rib pinning the victim measured 36 to 42 inches long by 28 inches high and up to 14 inches thick.

36 to 42 inches long by 28 inches high and up to 14 inches thick.

Corrective Action: The mine operator revised the roof control plan to require the installation of rib bolts in all entries on development.

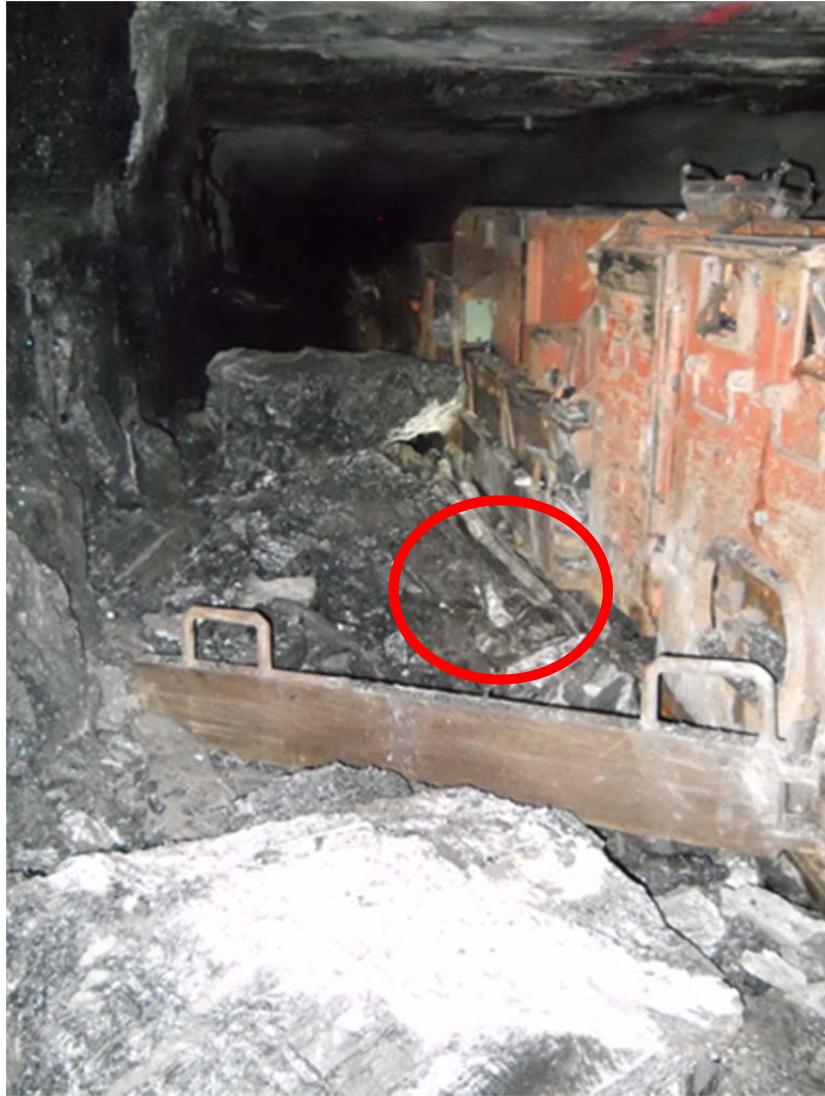
APPENDIX B
Photograph at Accident Scene

The rib roll occurred because of geologic features that were difficult to see. These features became apparent during the investigation. The rib was weakened by the interaction of coal cleats, inconsistent rock partings scattered within the seam, and barely perceptible small discontinuous slickenside structures, along with the normal pillar surface yielding after an area has been mined.

Approximate Location of Victim

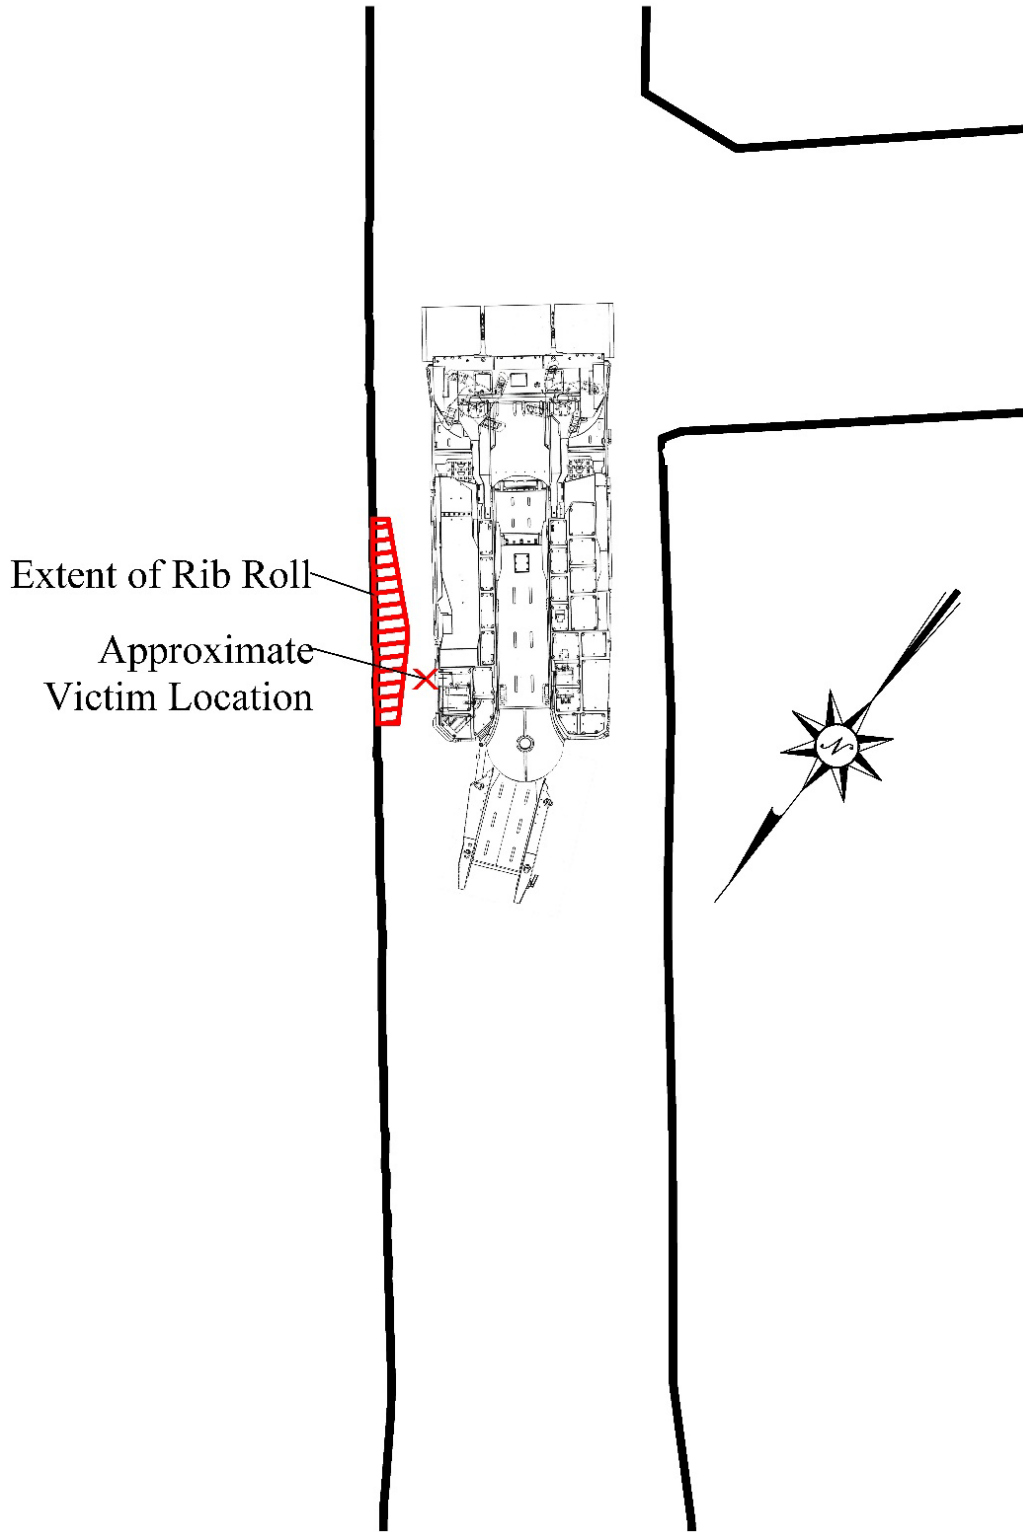
APPENDIX C
Drawing Showing Victim Location
(Not to scale)

The accident took place in the No. 1 entry just outby the No. 16 crosscut on 3-Section. The entry was mined uphill at a 15 percent grade from the No. 15 crosscut to follow a change in the orientation of the coal seam. The original mine entry at the accident site was approximately 7 feet high by 18 feet wide. The average width at the accident site after the rib roll occurred was 18.9 feet. The depth of cover was approximately 700 feet with no overmining or undermining in the vicinity.
