DATE: JULY 2018

Rib failures in underground coal mines

This safety bulletin provides safety advice for the NSW mining industry.

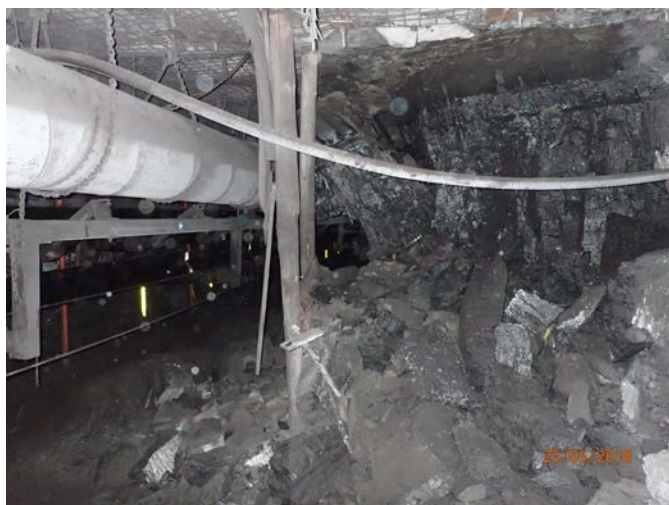
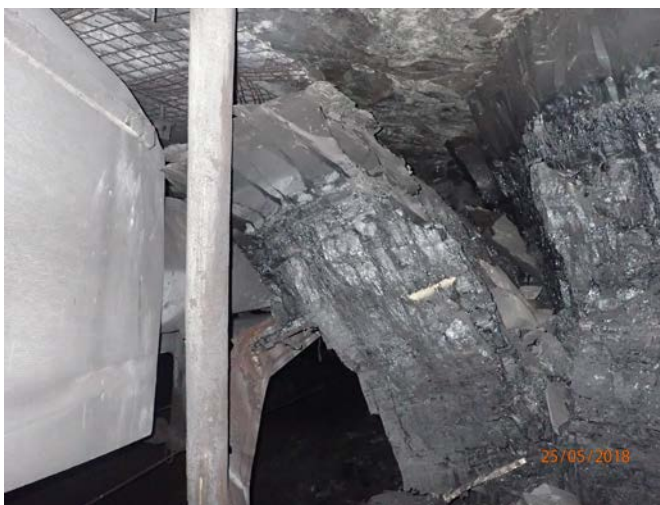
Incident 1: A rib failure was found during a routine inspection. The failure occurred on the off-walk side of a conveyor. A section of rib (one metre thick) was supported by a gas drainage pipe and smaller pieces of coal falling into the walkway. Failure was attributed to continuing deterioration due to the area being mined some time ago.

Figure 1 & Figure 2– Rib failure on the off-walk side of a conveyor (SInNot-2018/00877)

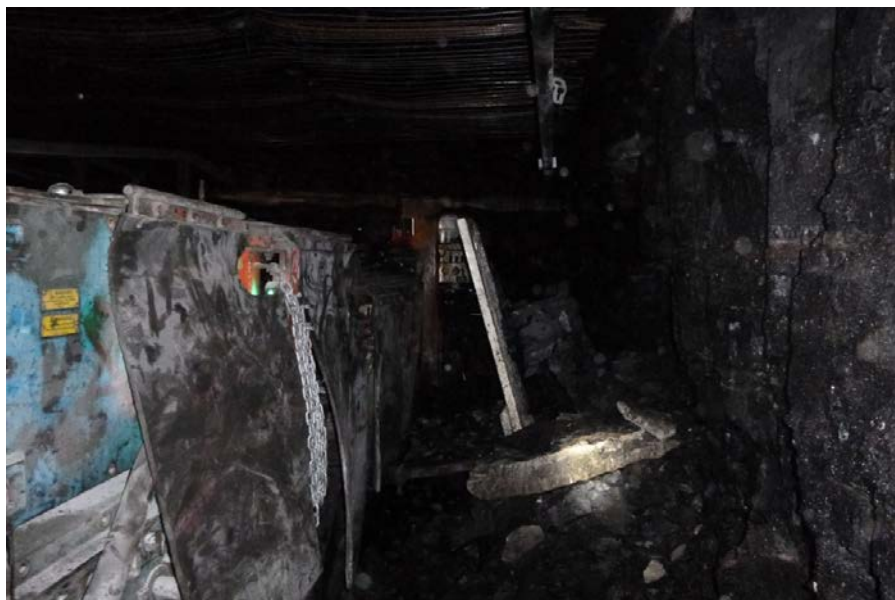
Incident 2: In a development drivage, workers were retracting the onboard rib protection on a continuous miner when a piece of rib failed, falling under the platform and pivoting the platform up. The worker had his arm briefly pinned between the rib protection and continuous miner chassis.

Figure 3 – Rib failure striking platform. Note that the platform has been rotated back down towards the normal operating position (SinNot-2018/00854). Photo courtesy of the mine.

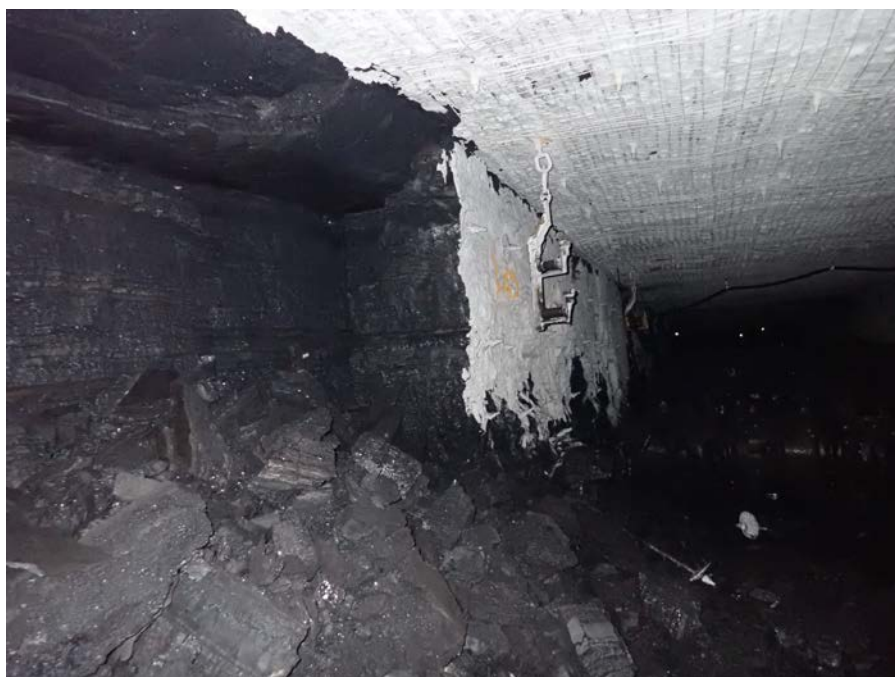
Incident 3: A mine had continuing reports of poor ribs that were rated red on the mine’s trigger action response plan (TARP). A mine worker was hit with a large piece of rib that failed, breaking his ankle. The piece that hit the worker was 0.6m x 0.5m x 0.5m. Larger pieces also fell. The total fall was 4.7m long, 0.85m deep and 3m high. When the area was inspected, broken fibreglass bolts were found in the panel and deputy reports showed rib conditions had been reported as poor for some time.

Figure 3 – Failed section of rib (SinNot-2018/00638).
