DATE: JULY 2018

## Rib failures in underground coal mines

This safety bulletin provides safety advice for the NSW mining industry.

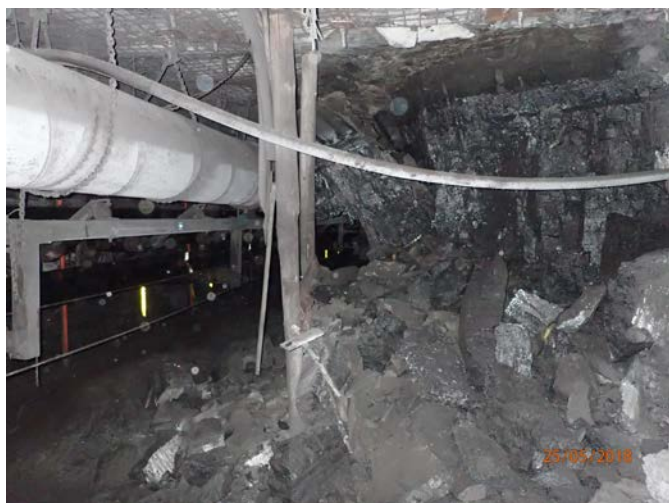
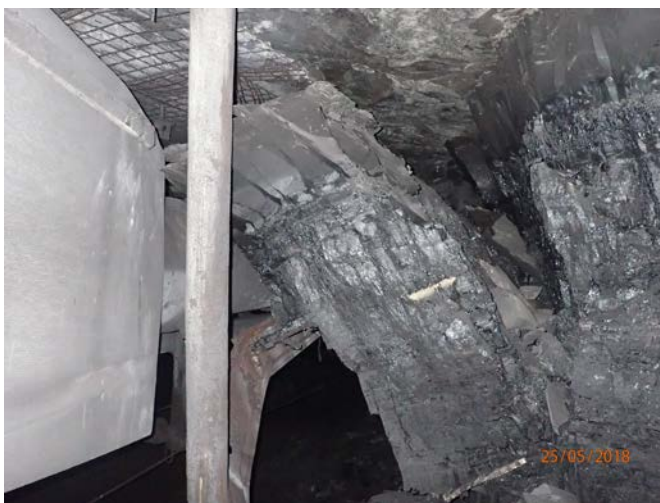
**Incident 1:** A rib failure was found during a routine inspection. The failure occurred on the off-walk side of a conveyor. A section of rib (one metre thick) was supported by a gas drainage pipe and smaller pieces of coal falling into the walkway. Failure was attributed to continuing deterioration due to the area being mined some time ago.

**Figure 1 & Figure 2– Rib failure on the off-walk side of a conveyor (SInNot-2018/00877)**

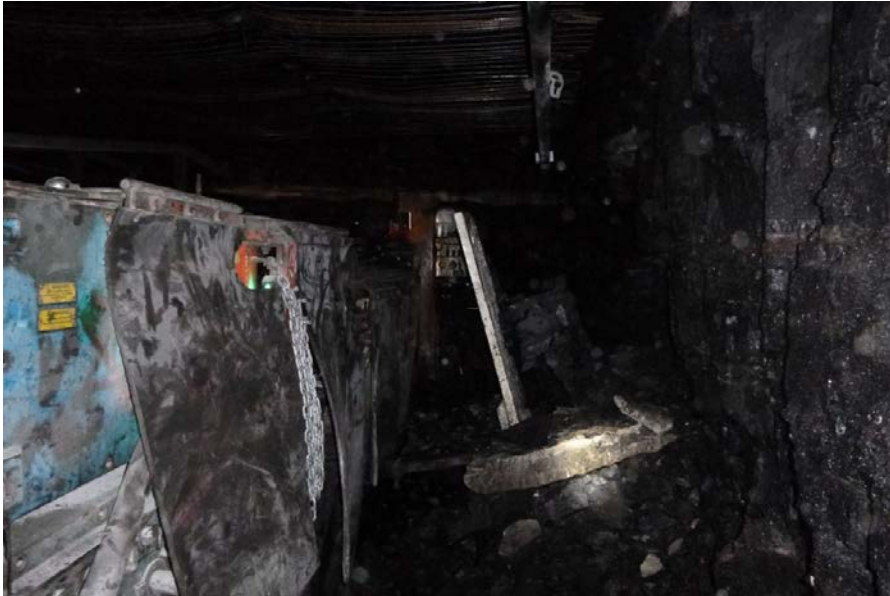
**Incident 2:** In a development drivage, workers were retracting the onboard rib protection on a continuous miner when a piece of rib failed, falling under the platform and pivoting the platform up. The worker had his arm briefly pinned between the rib protection and continuous miner chassis.

Figure 3 – Rib failure striking platform. Note that the platform has been rotated back down towards the normal operating position (SinNot-2018/00854). Photo courtesy of the mine.

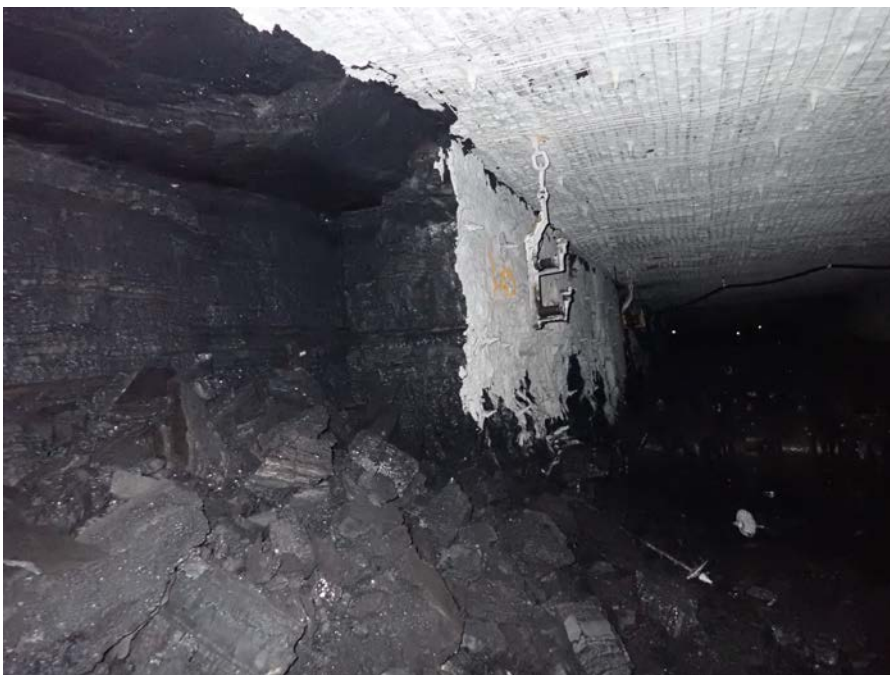
**Incident 3:** A mine had continuing reports of poor ribs that were rated red on the mine's trigger action response plan (TARP). A mine worker was hit with a large piece of rib that failed, breaking his ankle. The piece that hit the worker was 0.6m x 0.5m x 0.5m. Larger pieces also fell. The total fall was 4.7m long, 0.85m deep and 3m high. When the area was inspected, broken fibreglass bolts were found in the panel and deputy reports showed rib conditions had been reported as poor for some time.

Figure 3 – Failed section of rib (SinNot-2018/00638).
