Engineering Failure Analysis 8 (2001) 145–156

Pump impeller failures — a compendium of case studies

A. van Bennekom^{a,*}, F. Berndt^b, M.N. Rassool^a

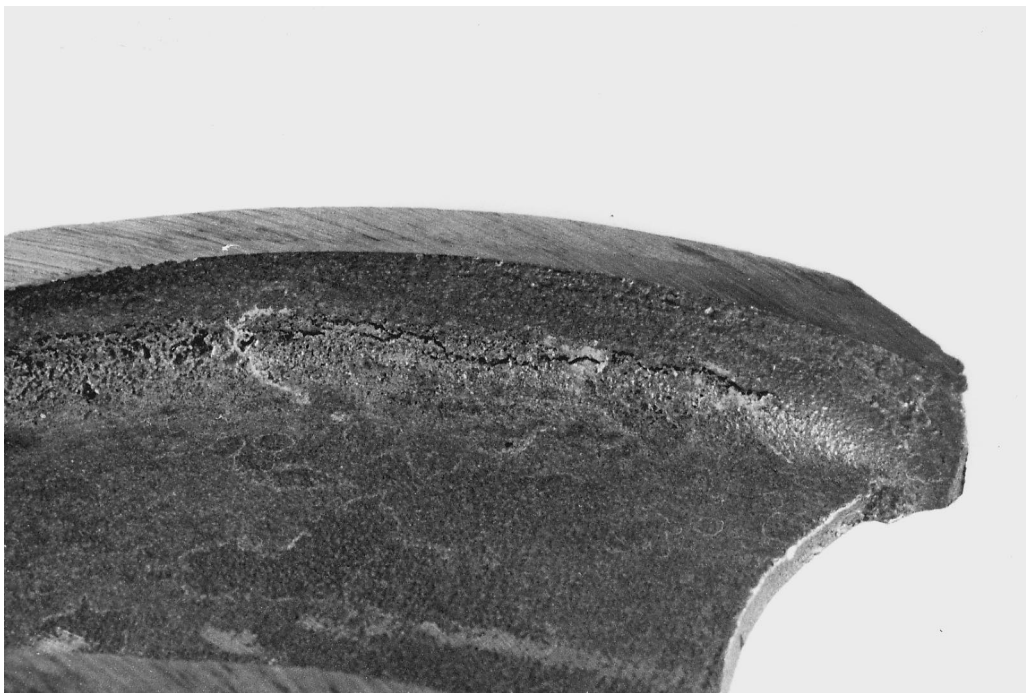
This CF-8M (cast equivalent of type 316 stainless steel) impeller, which was used to pump a nickel sulphate solution, fragmented after only a few hours in service. The failure of this impeller resulted in a significant financial loss due to subsequent damage and loss of production. On removal of the impeller, it was noted that some 'pitting' and slight cracking was evident along the interface between the web and flange of the impeller (see Fig. 1). The plant personnel assumed the failure to be due to pitting corrosion in the nickel sulphate solution, but this was obviously not the case since the previous impeller, which was also made from CF-8M stainless steel, operated for several years without pitting being observed. Also, pitting would not be expected to occur this rapidly.

Fig. 1. 'Pitting' and cracking at the junction between web and flange of a cast 316 type stainless steel impeller.

It can thus be seen that this failure was due to insufficient feeding of the casting with molten metal during the solidification process. This failure could have been avoided if additional runners and risers

had been used in the casting. It is also evident that a lack of quality control at the foundry that cast this impeller allowed the impeller to be dispatched and subsequently be installed in the pump where it failed.

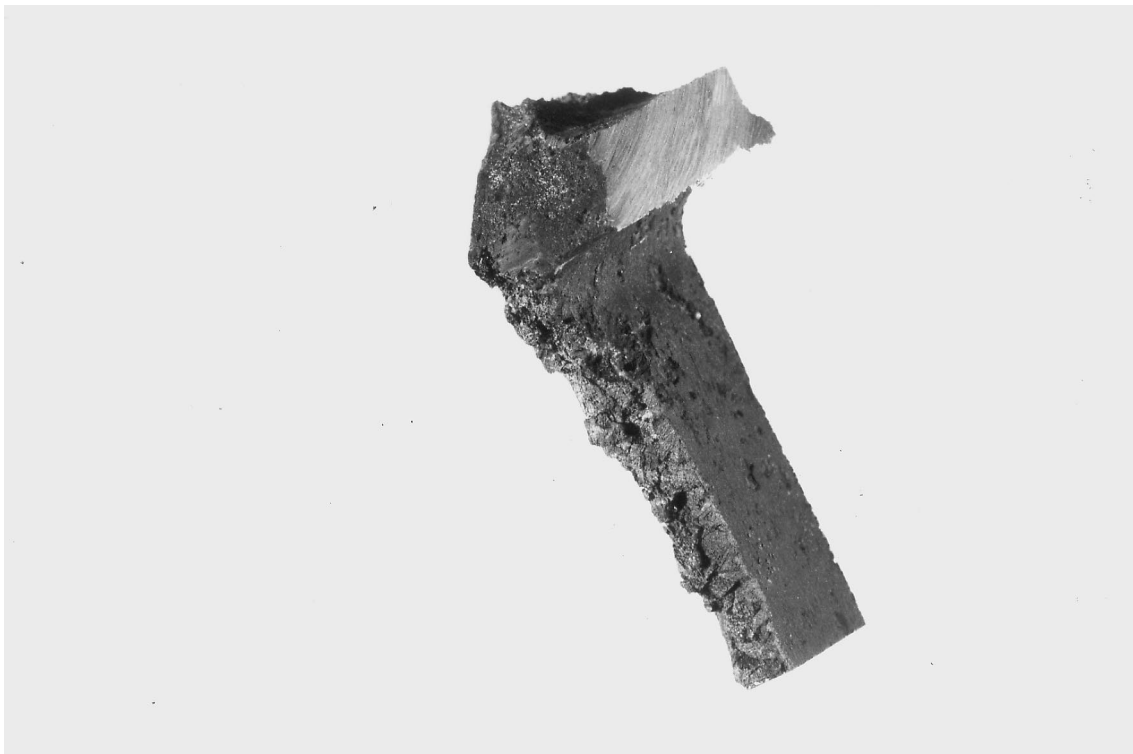
A similar failure was observed in a bronze impeller which also failed after a relatively short time in service. Examination of the fragments of this impeller showed that failure was due to the presence of porosity in the casting. In fact, the porosity that was present on the fracture surface was so pronounced (see Fig. 3), that it was not necessary to perform a microstructural examination to confirm the presence of extensive shrinkage porosity.

Fig. 3. Porosity in a failed bronze impeller.

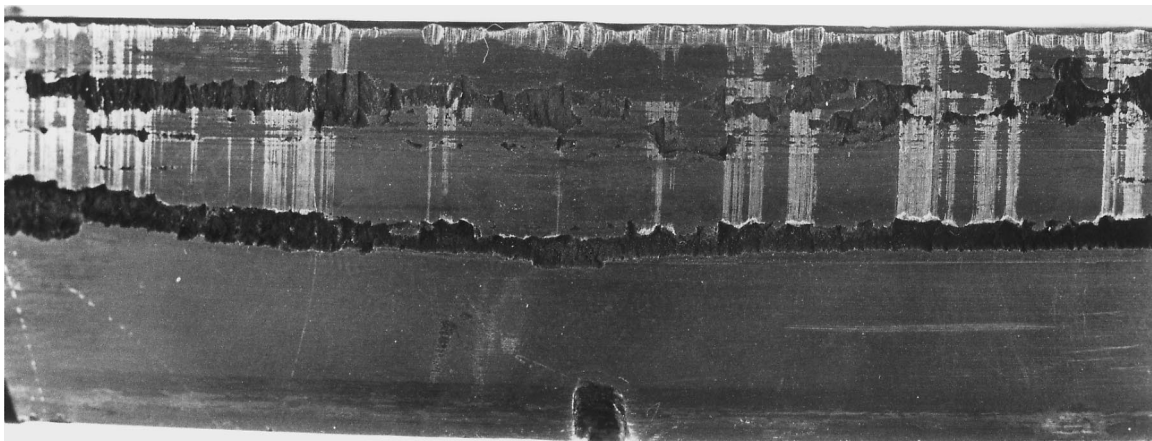
This case study is concerned with the failure of a stellite coating on an impeller wear ring. The problem manifested itself when severe vibration was detected on a pump in which a new stainless steel impeller had just been installed. This vibration was found to become steadily worse until the pump was stopped. The impeller was removed to determine the cause of the vibration. On removal of the impeller, it was noted that the wear ring had suffered from extensive galling damage (see Fig. 5). Examination of the wear ring showed that it had been stellite-coated. The reason for coating the wear ring with a stellite coating is to prevent or minimise the amount of galling damage that would usually occur between two stainless steel surfaces. As a general rule the coating that is used should be at least 50–60 Brinell hardness units higher than the hardness of the stainless steel.

Fig. 5. Galling damage to a stellite-coated wear ring.

dependent on the operating stresses and type of coating, disbonding and spalling of the coating will occur resulting in the damage observed in Fig. 5.

The specification of a Ni based, self-fluxing type of coating applied by powder flame spraying followed by fusing is correct, but it can be seen that some of the spraying parameters were not optimised resulting in an inferior coating. Once again, there is nothing that the operator of the pump could have done to prevent failure of this type other than to insist that proper quality control measures are implemented by the supplier of the pump components.

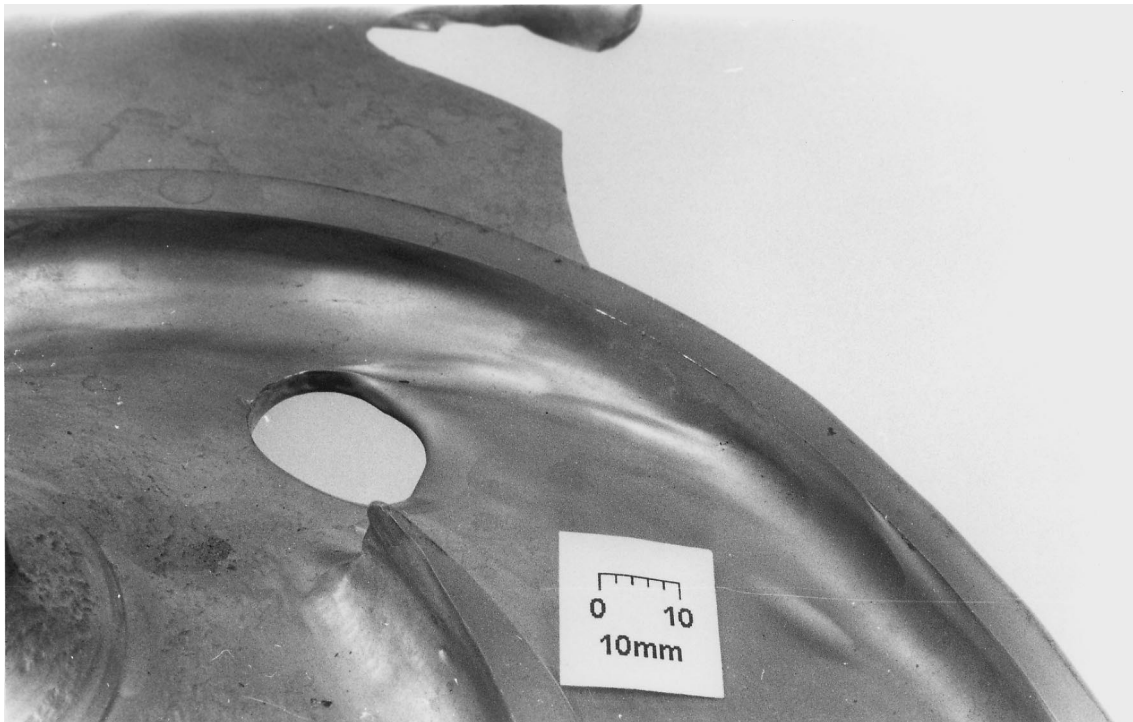
Fig. 10. Erosion–corrosion grooves and depressions on an impeller surface.

Variation in the rate of erosion with the concentration of solids in a slurry appears to follow a definite pattern. This is a linear increase in the rate of material damage with increasing concentration of solids up to a certain level, followed by a much slower rate of increase at higher concentration. Erosion–corrosion is characterised by the presence of grooves, as illustrated in Fig. 10, and holes on the surface of the metal, which usually exhibit a directional pattern.
