ATTACHMENT "C"
New Zealand Coroner's Finding

FINDING OF CORONER UNDER
CORONERS ACT 1988

OCCUPATIONAL SAFETY AND HEALTH SERVICE

Accident Alert Bulletin
Driller fatally injured in a Northland quarry

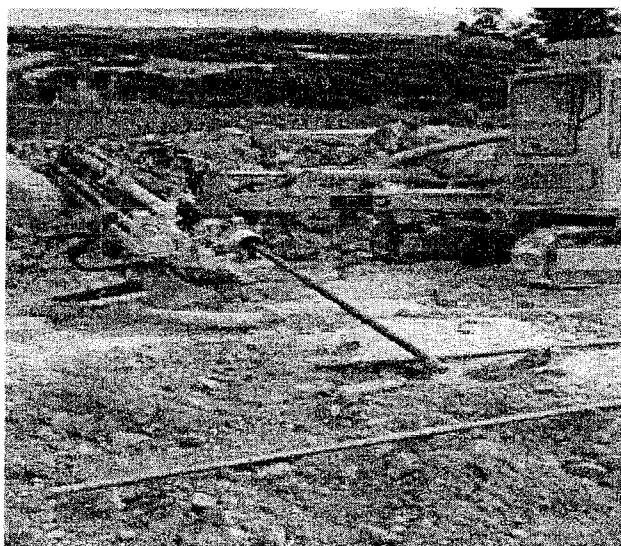
The drill mast was set nearly horizontal as can be seen in the photo below and the accident happened as the driller attached a new rod to the shank adapter on the drifter while it was rotating.

No one saw what happen but it is evident that as the connection was made and the rod began to rotate, it caught on his clothing. He was spun around on the rod for a considerable period of time sustaining multiple bone fractures and was found tightly bound to the rotating drill steel by his overalls.

The drill-rig at the accident site

1. That operators be given the assistance of a tool hand when performing this operation (so that operators remain in the cab ready to react to emergencies) and/or
2. That the engine be stopped or at least the drill shank be prevented from rotating while new drilling rods are fitted and
3. That machines which do not have safety devices designed to operate when the driver leaves the controls be retro-fitted with such devices and
4. That OSH issue an Accident Alert Brochure dealing with these issues as this is the type of accident which could easily recur.
