Mine ERZ Controller sustains injuries trapped by an airlock door

Mines safety bulletin no. 180 | 14 March 2019 | Version 1

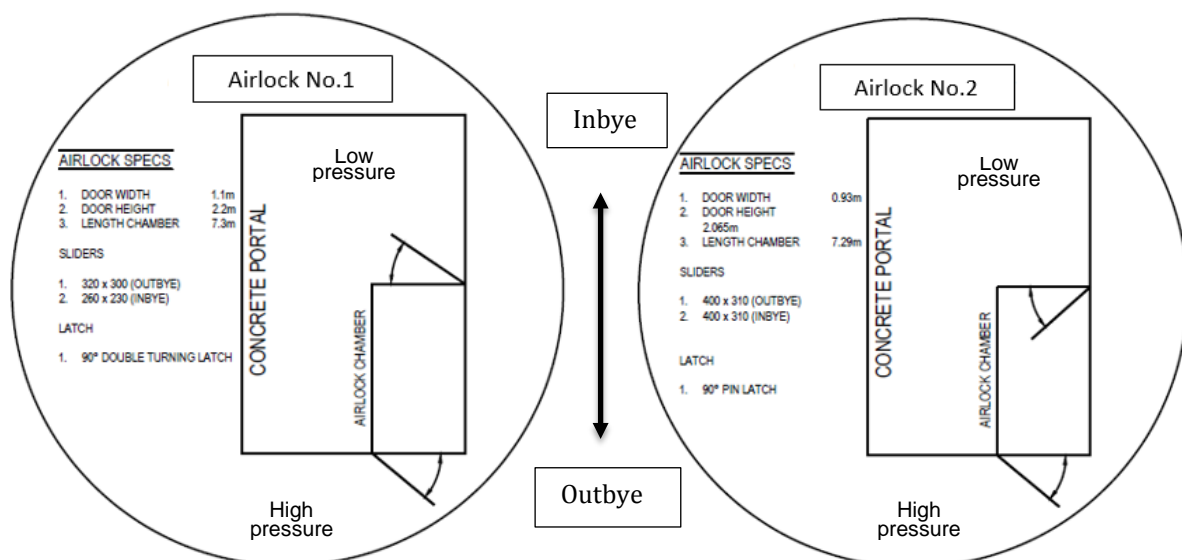
Airlock 1 (see image 1) is the design of the airlock the ERZ Controller was trapped in at the outbye door.

Airlock 2 is a common airlock design normally used for access at points with high pressure differentials.

A third design (not shown) had both doors opening toward the return airway (inbye). The mine had no established standard for airlock design at the time of the serious accident.

At the time of the serious accident, up to 1981pa pressure differential appeared across the airlock where the serious injury occurred, calculated to produce 426.4kg force against the ERZ Controller's leg.

8. It is recommended Ventilation Officers establish standards for airlock design for their mine. S341(d), S350 CMSHR 2017. S30, S38, S44 CMSHA 1999.
9. Audit compliance to procedures, forms and processes for changing gas monitoring equipment locations or changing / disabling alarms. S223 & S224 CMSHR 2017.

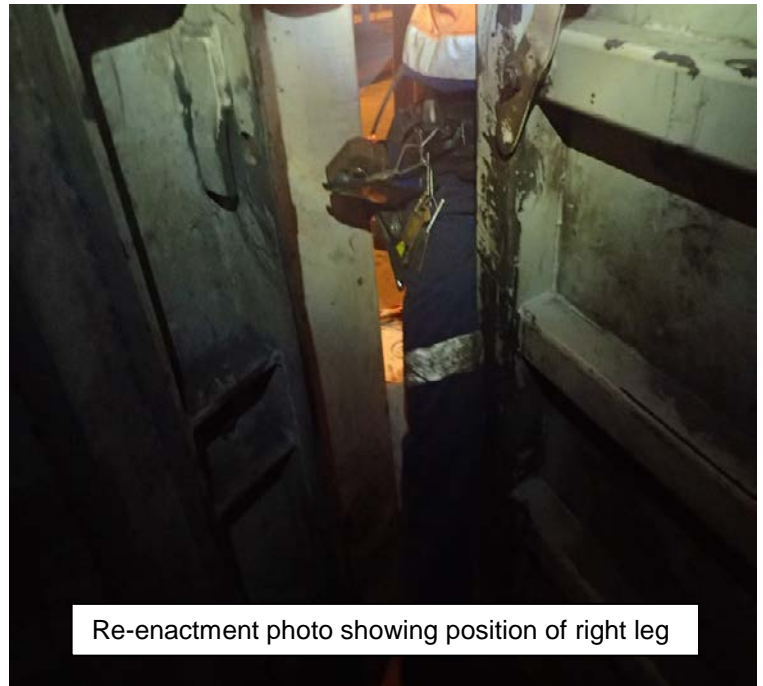
When the ERZ controller began to open the outbye door he stepped into the doorway of the airlock to push the door further open. As this occurred the inbye door of the airlock swung open, short circuiting the ventilation and causing the outbye door to slam closed, trapping the ERZ controller by the leg.

The investigation identified the mechanism for the inbye door opening was the brattice covering the inbye door shifting, as the change in pressure against it increased, and that the inbye door handle had been modified during a repair and could no longer fully latch closed.

It is plausible that the brattice shifting rapidly, the lesser area of the handle contacting the door frame and the high pressure differential, all contributed to the uncontrolled opening of the inbye door.
