COLLISION - COULD HAVE BEEN DOUBLE FATALITY

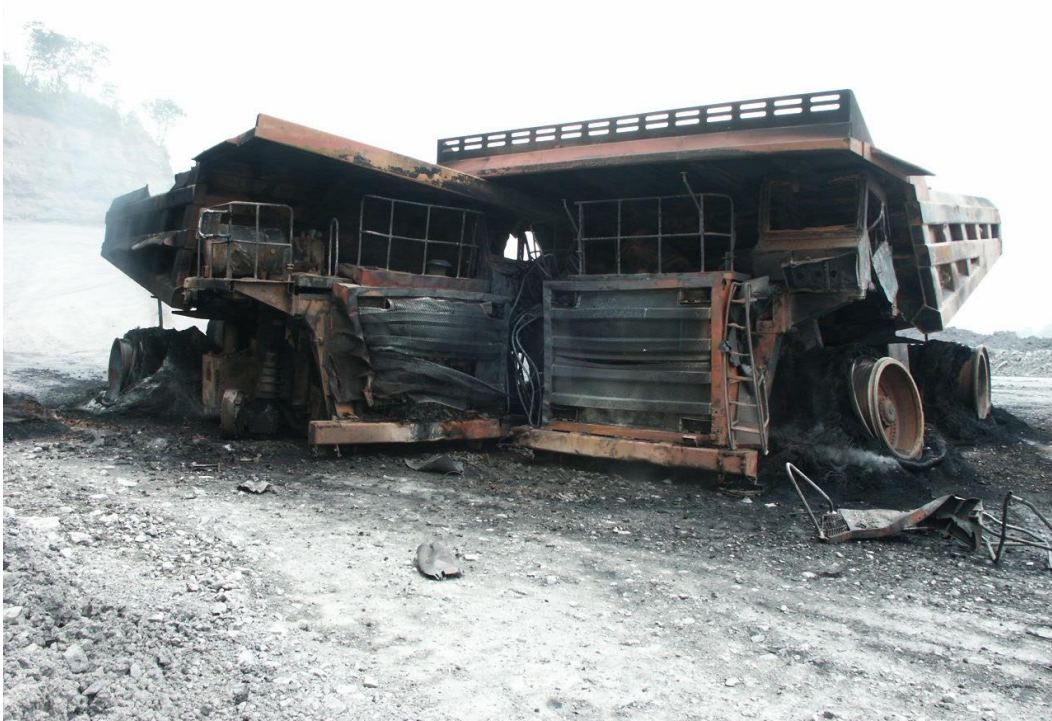
On August 10, 2004, an accident occurred at approximately 1:15 a.m. when a 789 hauler was traveling up an approximate 4% grade. While negotiating a right switchback, the 789 hauler was struck in the left front side by a 785 hauler traveling downgrade in the switchback. This collision resulted in an immediate fire in the engine compartment area of the 789 hauler resulting in loss of both haulers.

- Always maintain control of vehicle.
- Maintain good communications with other employees in your work area.
- Adjust speed as required for adverse road and weather conditions.
- Always be aware of other equipment operating in close proximity to your work area.
