Drilling

New application of directional drilling and gas-enhanced foam for suppression of abandoned underground coal mine fires

by A. Ozment and M.A. Trevits

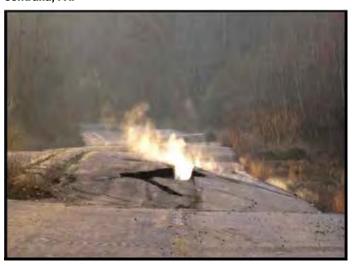
Figure 1

Smoke and steam emanating from cracks in a highway in Centralia, PA.

refuse material and then to nearby coal mine workings (PA DEP, 2017). As time went on, the fire grew and spread under the Borough and directly affected the residents despite various efforts to extinguish the fire by the state and federal governments (Fig.1). In 1984, a voluntary program was begun to move residents from their homes. Many accepted buyout offers for their properties and moved elsewhere and after leaving, their homes were demolished. In 1992, the state used eminent domain to take control of all the property within the Borough. In 2013, after years of litigation, the eight remaining residents were allowed to stay for as long as they lived. Today, only a few buildings remain within the Borough (Centralia, PA, 2014). This fire has been burning for more than 55 years.
