Serious injury

Incident date: 5 July 2018

Event: Serious injuries at an underground coal mine

Location: Springvale Mine, Lidsdale NSW

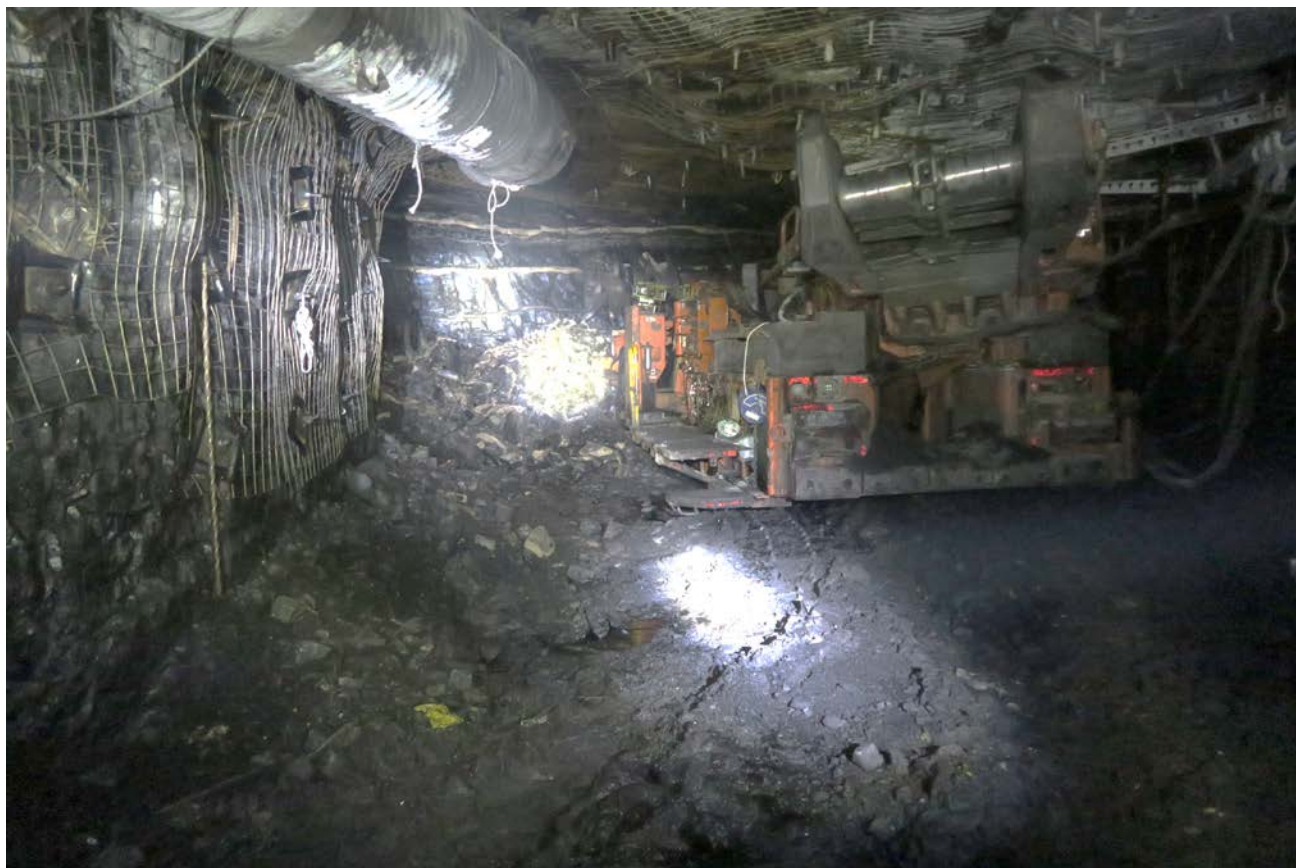
Photo 1: Continuous miner in underground heading showing conveyor. Picture by Resources Regulator investigators.

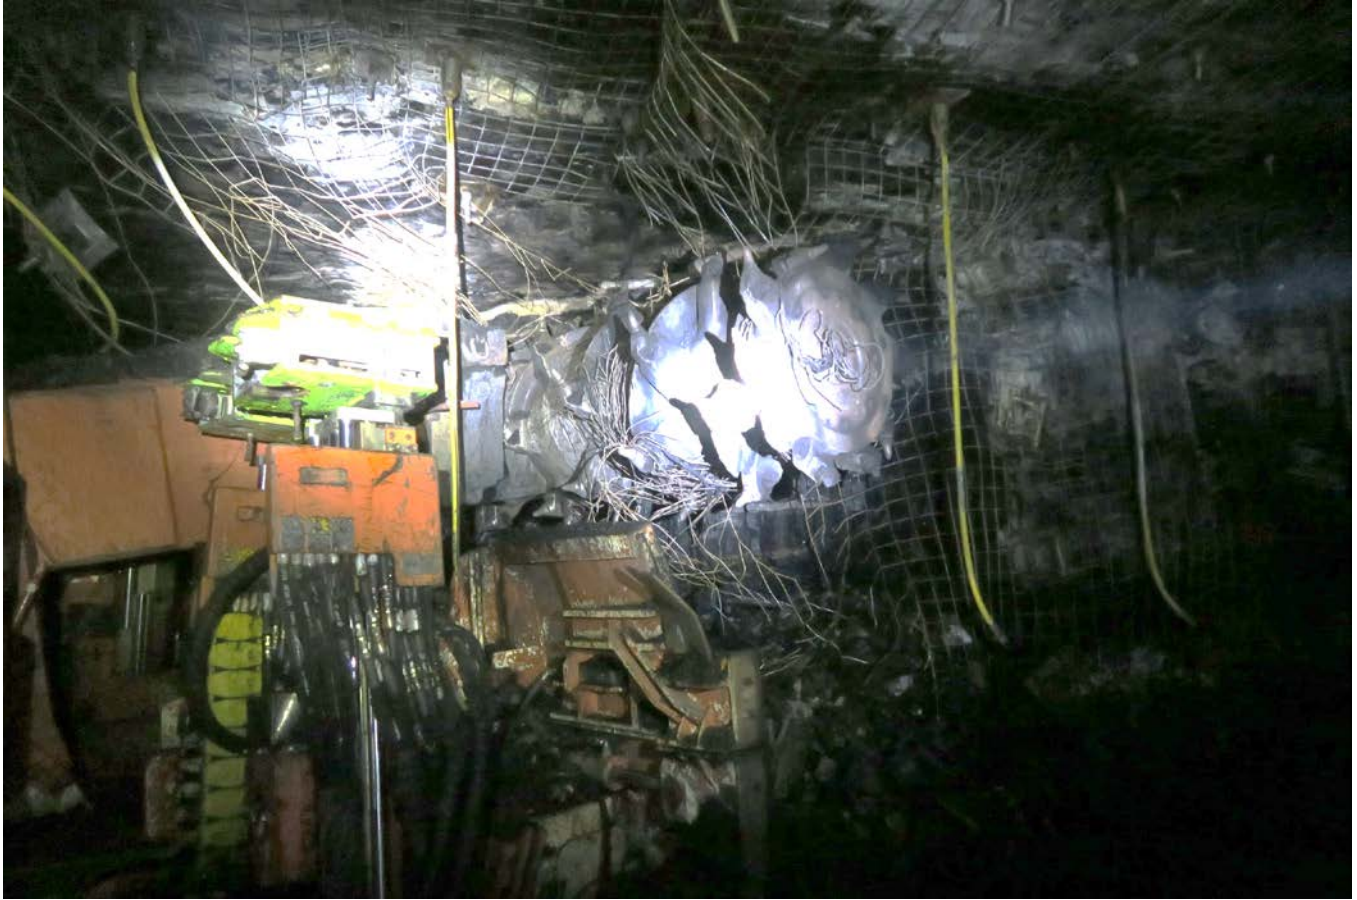
The seven cut-through breakaway was moved 30 metres inbye (closer to the mining face) of the planned position due to adverse strata conditions. The change in breakaway position resulted in the continuous miner cutting through steel rib mesh and steel rib bolts.

Preliminary enquiries indicate that the object that hit the worker may have been the plate from a rib bolt.

Photo 2: Continuous miner showing cutter heads and entangled rib mesh and bolts. Picture by Resources Regulator investigators.

A risk assessment must be conducted whenever a change to the mining sequence, such as pillar size and breakaway distances, is considered. Continuous miners and the steel picks on the cutter heads are not designed to mine through steel strata supports, such as steel rib bolts and rib mesh. Using the continuous miner to cut steel increases the risk of mesh and other materials getting caught around and

entangling the cutter heads and spark generation with potential frictional ignition of flammable materials on the continuous miner and methane gas if it is present in the workings.
