NSW Resources Regulator

INVESTIGATION REPORT

Report into the serious injury of an operator at the Mannering Colliery, Doyalson, NSW on 22 January 2016

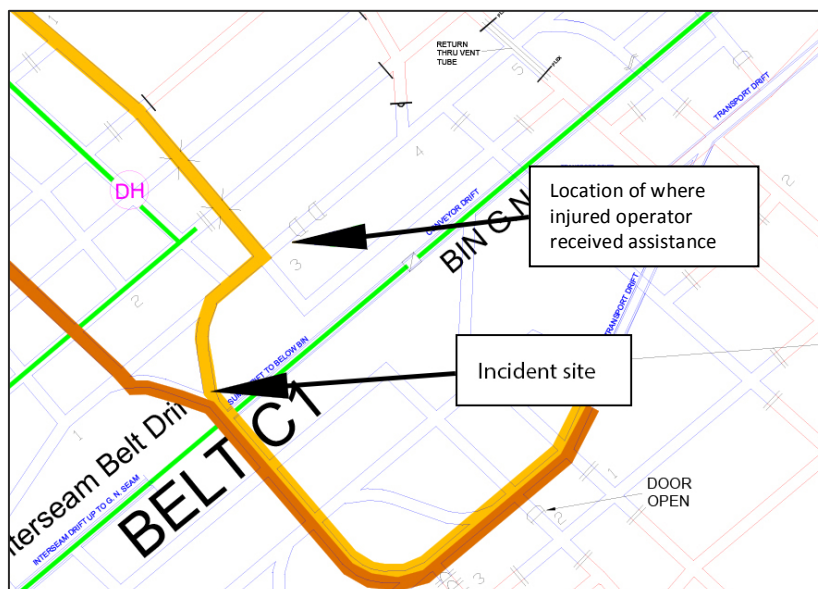
Figure 8: Map showing incident site and double doors.

The vehicle in front had stopped about 120 m inbye from the incident site to wait for the arrival of the LHD to allow both vehicles to go through the doors together. The doors and the incident site can be seen in the figure 8.
