Investigation Report

Fire and explosion on Longwall No 1 Tailgate
at the Blakefield South Mine
5 January 2011

Published report prepared by the
Investigation Unit, Thornton

May, 2012 www.resources.nsw.gov.au/safety

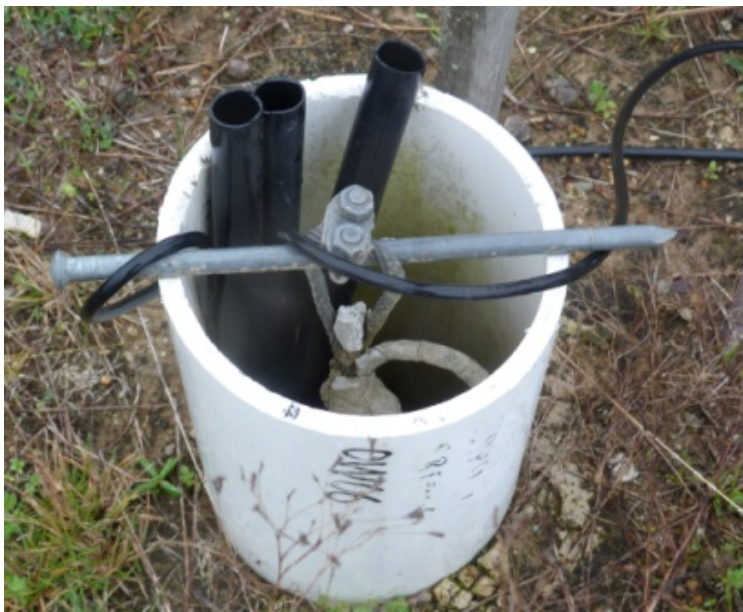
Figure 29 - Photo looking at the top of typical piezometer hole at Blakefield South Mine.

Note that the photo in figure 29 the piezometer hole (otherwise known as an environmental monitoring hole) at the surface, the piezometer is suspended in the borehole via a wire rope attached to a steel nail and insulated from earth via a polyethylene pipe. These piezometer holes extend all the way into the Blakefield seam in LW1 and as the longwall passes them, they are then cut out and the remainder of the piezometer is left in the goaf still attached to the surface piezometer infrastructure. Mr Gillespie's report identifies that the closest piezometer hole is some 400 metres from where the major ignition point is thought to be from the eye witness accounts. However, this does not preclude the possibility that at the time of the incident an explosive fringe may have extended across the back of the longwall in to the goaf to a point adjacent to where this borehole entered the mine.³⁵ Figure 30 shows the location of the piezometer holes with respect to LW1.
