SAFETY BULLETIN

Exploding lead acid batteries

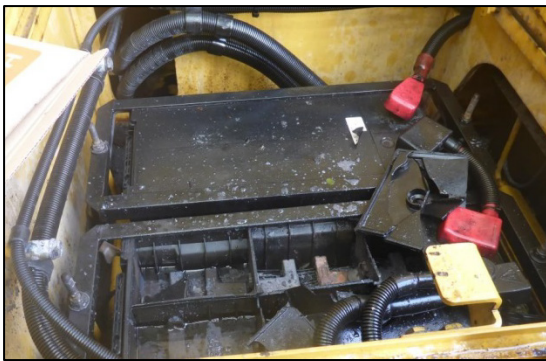
Image 1: Failed battery in Cat 993K front end loader

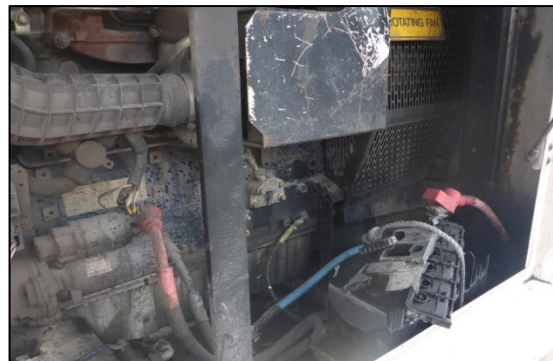
Image 2: Failed battery in 100kVA generator

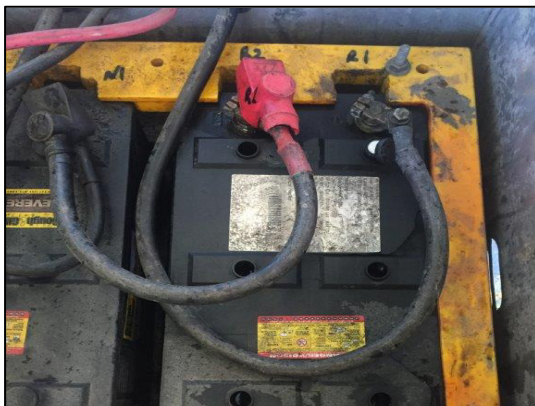
Image 3 – Failed battery in portable charging trolley
